Subject: Engine Flywheel Housing Requirements and Fault Code 250 – Endurant HD and PACCAR Transmission

Document Number: TAIB-0878

Updated: May 17, 2021

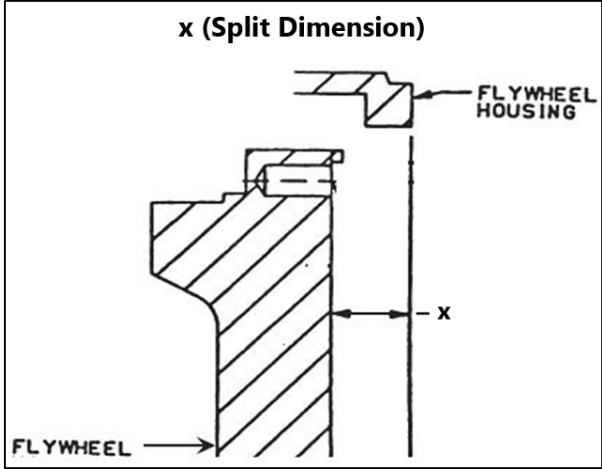
The Endurant Transmission requires a specific engine flywheel housing to ensure the correct Split Dimension. The Split Dimension is the distance from the engine flywheel machined surface to the engine flywheel housing where the transmission clutch housing attaches.

Endurant and PACCAR Transmissions				
OEM	Engine	x (Split Dimension)		Details
		mm	in	
Navistar	A26	65.70-67.59	2.59-2.66	66.645mm (+/-0.9445)
Navistar	X15	65.70-67.59	2.59-2.66	
PACCAR*	MX13/15	65.70-67.59	2.59-2.66	
PACCAR	X15	65.70-67.59	2.59-2.66	
Volvo	X15	59.8	2.35	
DTNA	X15	59.8	2.35	
DTNA	DD13/15	56.63-59.17	2.23-2.33	57.9mm (+/-1.27)
UltraShift PLUS/Fuller Advantage Automated				
All	All	63.50	2.50

1. If the engine or engine flywheel housing requires replacement, contact the OEM and/or engine manufacturer to identify the engine flywheel housing part number based on the transmission model.
2. To verify the correct engine flywheel housing is installed, measure the Split Dimension and reference the chart below:
3. Fault Code 250 may also be set if the incorrect clutch release bearing is installed. Reference TRSM0950 for release bearing dimensions.
4. Fault Code 250 may also be set if a replacement transmission has the incorrect input shaft dimension. Reference TRSM0950 for input shaft dimensions and service transmission identification.
