NUMBER: 08-019-17 REV. B

GROUP: 08 - Electrical

RG3 RG4 RJ3 RJ4 Radio Enhancements

This bulletin involves inspecting and if required, updating the radio software.

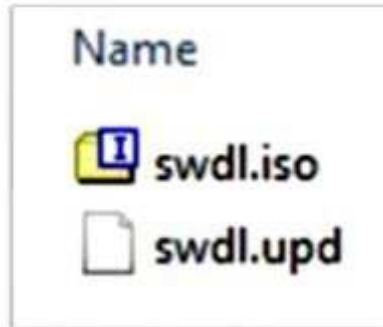
Fig. 1
Two USB Files

NOTE: Two files will be loaded onto the USB flash drive (Fig. 1) .

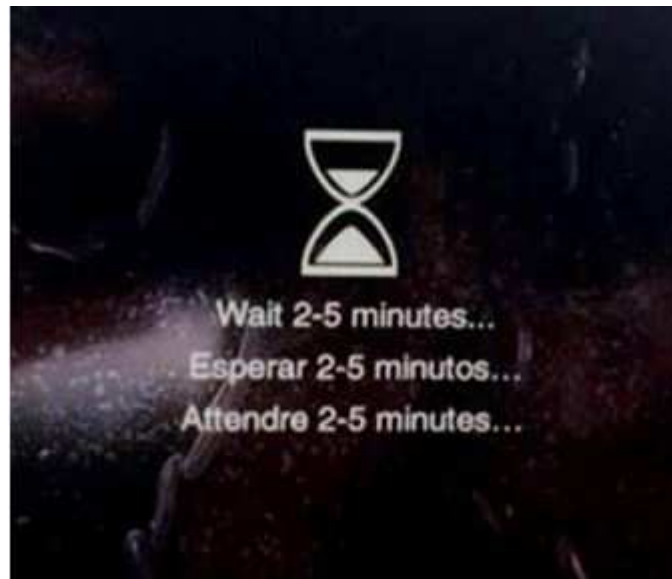
Fig. 3
Hourglass Screen

NOTE: During the update process you will see multiple hourglass and "Please Insert Update USB" screens for extended periods of time (several minutes) (Fig. 3) or (Fig. 4) . DO NOT remove the USB flash drive at this time. Only remove the USB flash drive when the update has completed, when the screen displays the software levels again. The screen will say "Software updated successfully".

NOTE: During the update process, the screen on the radio will display an hourglass and blue screen that said “Please Insert Update USB” for approximately two to five minutes at a time ([Fig. 3](#)) and ([Fig. 4](#)) .
