Preliminary Information

PIT5921 Rear View Camera Coaxial Related Issues-B395A - B395B - B395C - B101E - B101D

Product Investigation Review Required

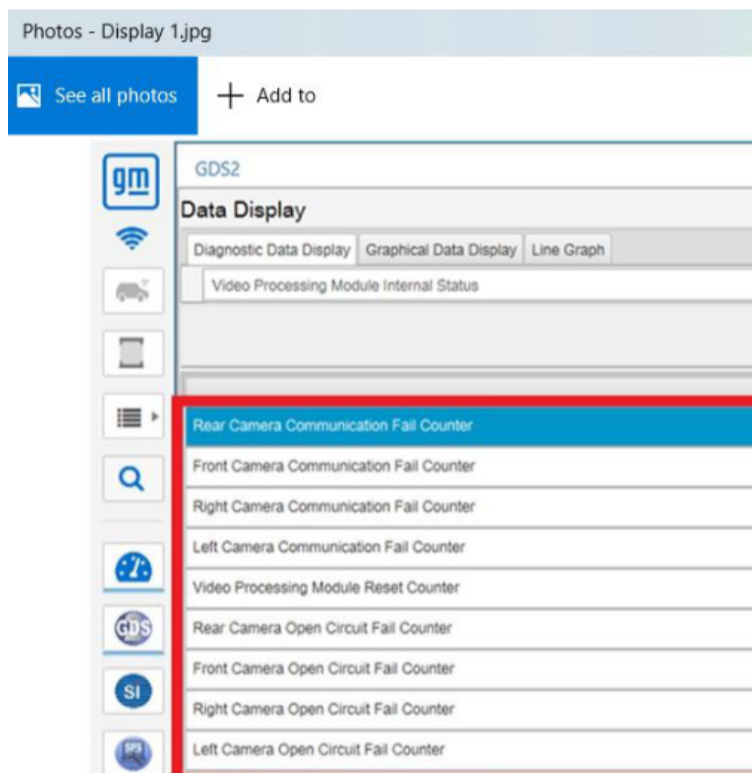
Module Diagnostics / K157 Video Processing Module / Video Processing Module Internal Status.

3. The three most critical parameters to look at are:
 - a. Camera Communication Fail Counter
 - b. Video Processing Module Reset Counter
 - c. Camera Open Circuit Counter
4. Write down the counters found in the VPM using the scan tool.
5. Cross-reference the DTC's and counters with the trouble shooting table below to determine most probable cause.

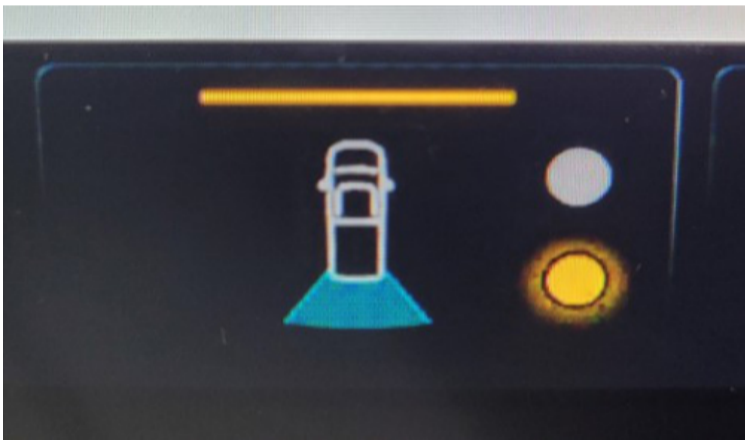
7. If it's difficult to determine the causal component, unplug all the cameras.
- Leave the rear camera input and video output at VPM.
 - Activate the Rearview Camera (RVC) using the "Cameras" touch button.

- If there is no image output, swap to the front, left, or right cameras into VPM rear camera input and repeat previous steps to check images again.
8. If concern(s) persist, refer to published diagnostics in SI.

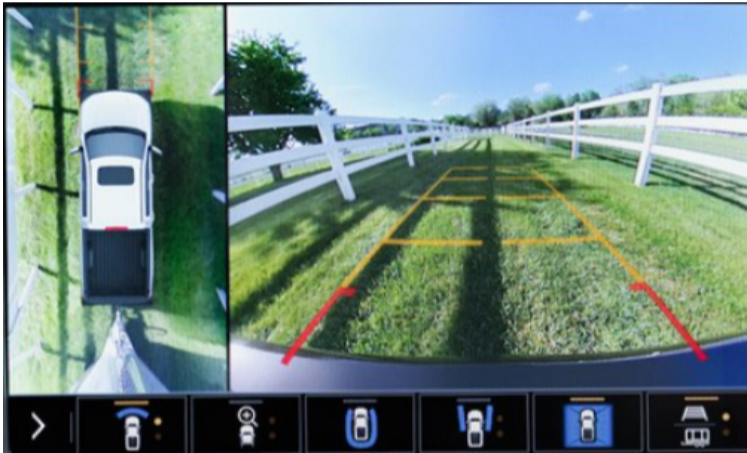
Flicker Issue

- If the "Cameras" Icon is greyed out and not working. The connection issue may be between the VPM and Radio.
- If the touch buttons are working properly, it could be an issue with the coax cable connection from the VPM to the Rear Vision Camera.

Note: Before testing the coax cable, check the cable's exterior for being pinched, cut, damaged, or having loose connections at the components, all of which can cause reception issues.

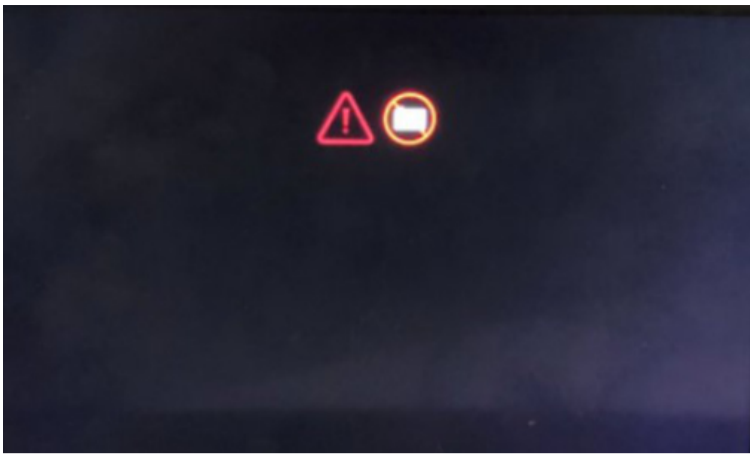
If the rear camera or the VPM do not provide the rolling counter, you will see the following black screen with an icon:

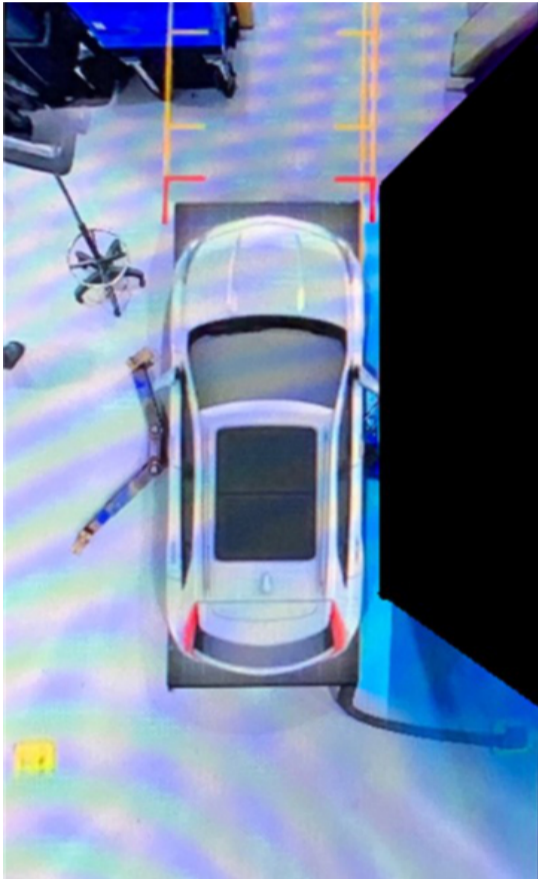
The VPM does not monitor the left, right or front cameras with a rolling counter. These camera's will display in black on their perspective side if there is an issue.

Figure below is of a right camera issue:
