## PIC6461 Information on the Elimination of the Rear Compartment Lock Cylinder

Brand:	Model:	Model Years:	VIN:		Engine:	Transmissions:
			from	to		
Chevrolet	Corvette	2020 - 2023	All	All	All	All

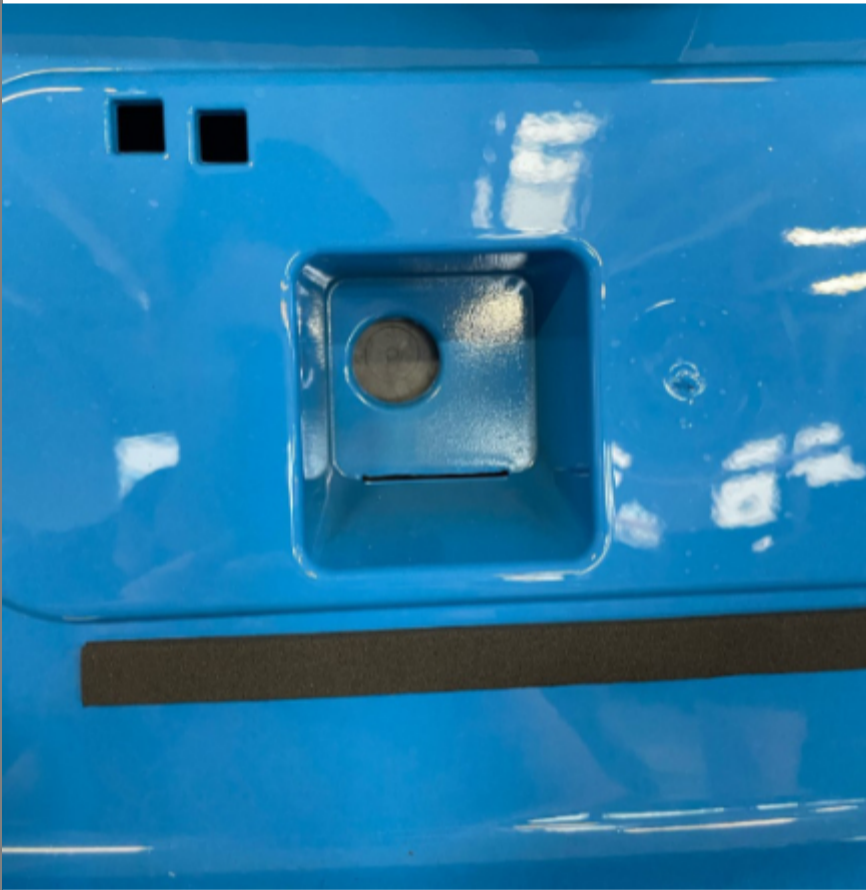
Concern	Starting with the 2023 model year, the rear access lock cylinder has been eliminated from all Corvette models. This lock cylinder will only be found on 2020-2022 model year vehicles. The rear fascias still have the provision for the feature, but there is no cylinder installed, as seen in the photo below.
---------	---

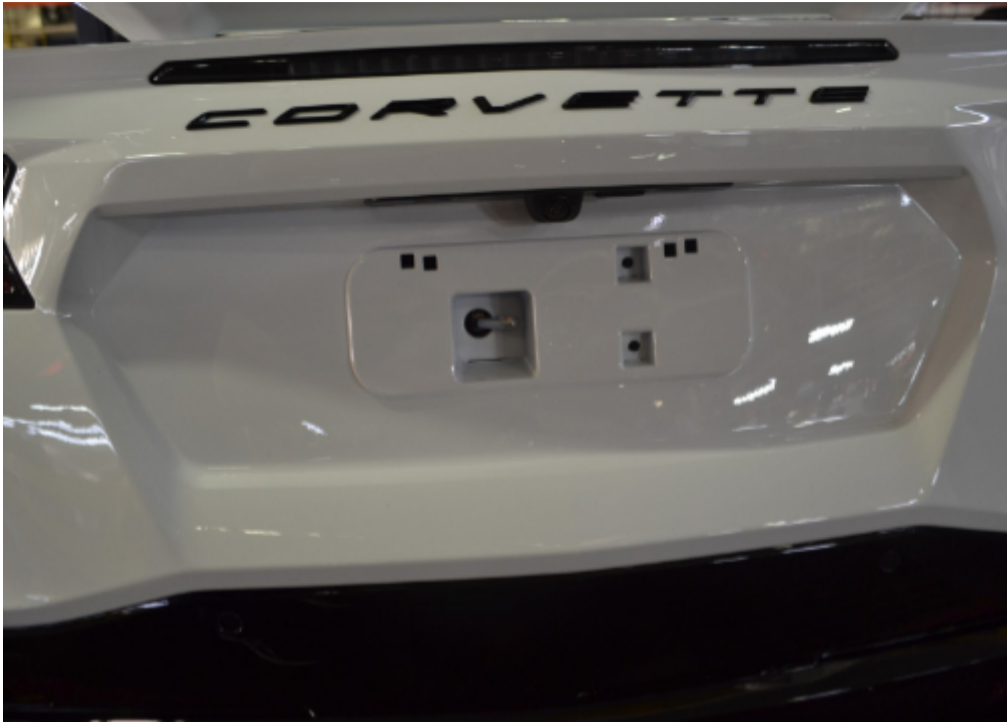
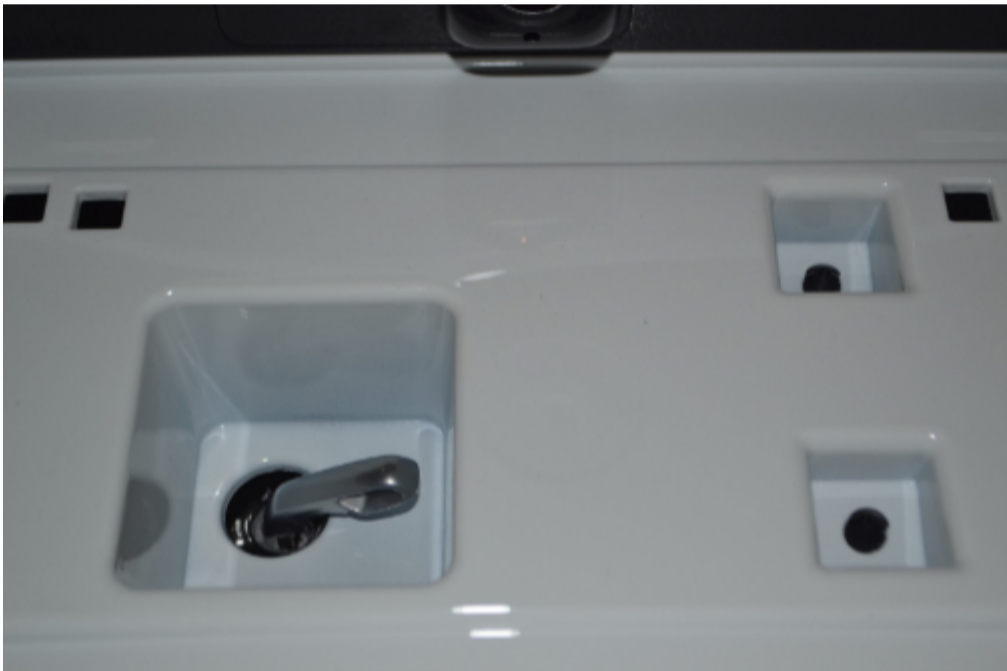
through an access hole in the rear fascia. In the photos below, the lock cylinder can be seen, as well as how to insert the mechanical key, which is housed in the key fob.

Remove the key shank from the key fob, insert it into the lock cylinder, and rotate. This should mechanically release the rear hatch / rear compartment. If access is still not gained through the back up mechanical method, see the section later in this document titled, "Accessing the rear hatch / rear compartment with a seized up latch."

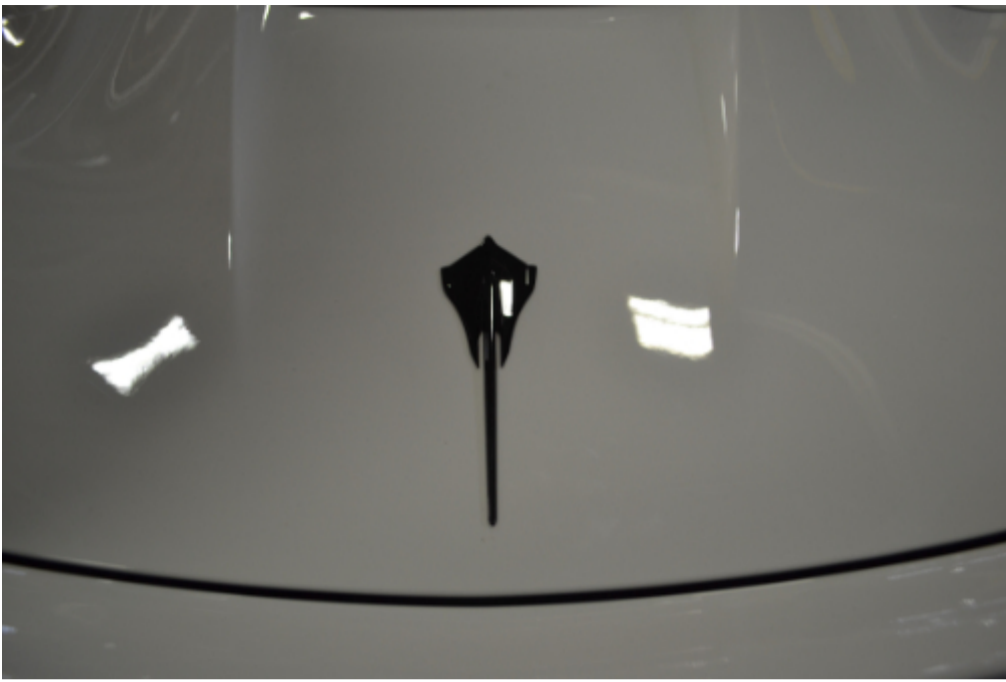
Accessing the rear hatch / rear compartment with a seized up latch:

First obtain a 3" hole saw for the following procedure. Send the vehicle to a body shop as needed. Starting at the trailing edge of the rear hatch / rear compartment, measure forward 3 and 1/2". Make this mark at the centerline of the panel. This will be the center of the hole that will have to be drilled into the panel. This will place the pilot hole location right in a portion of the stingray emblem when it has been positioned properly. Drill a 3" hole through the rear hatch / rear compartment panel. This will allow the technician to lift the rear panel upwards and the small 3" cut-out portion of the panel will stay attached to the rear latch / striker assembly. The servicing technician will then have access to the fasteners that hold the latch to the vehicle and can continue servicing the vehicle from there.
