Preliminary Information

PIP5792D 6L80 6L90 8L90 10L80 10L000 Equipped Vehicles With A Harsh Shift Shudder Surge Stall Or High Transmission Fluid Temperature Concern With Low Mileage

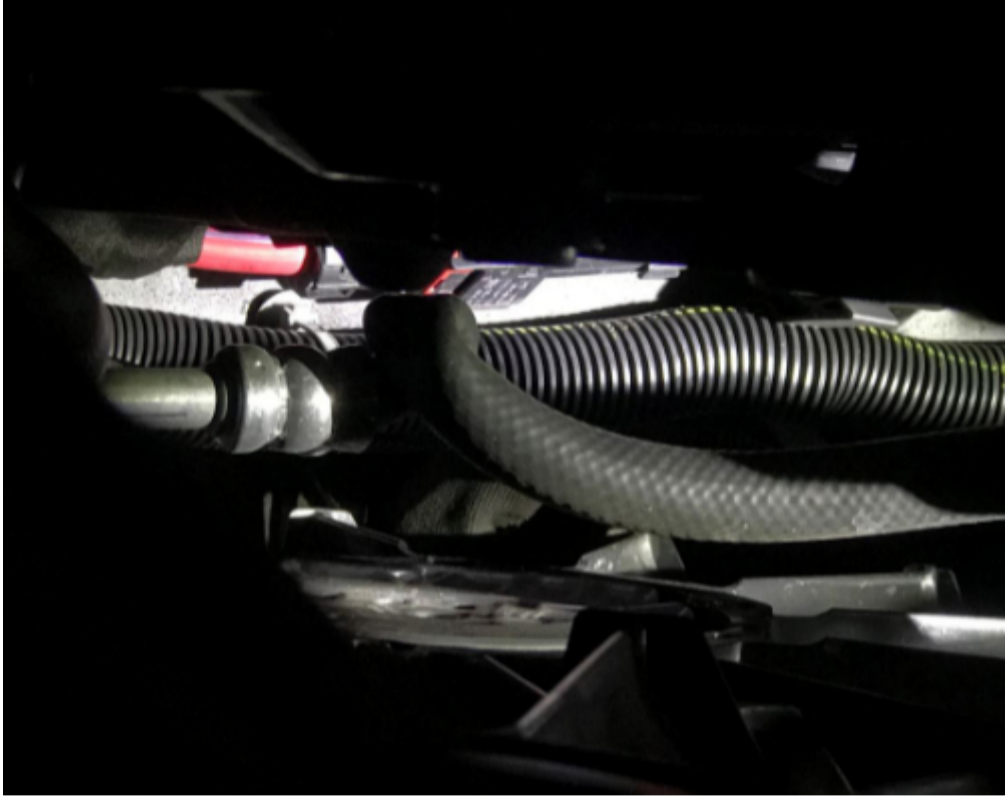
| Cause | Root cause may be a twisted cooler line on low mileage vehicles. |

Note: A twisted cooler line may cause DTC P27EC to set in the TCM on ETRS transmissions. (RPO MHS MQC)

Inspect for a twisted cooler line, example shown in the picture below.

If the cooler line is twisted disconnect the cooler line from the transmission auxiliary cooler and untwist it then reconnect the cooler line.

If no concerns are found with the rubber being misshaped check the transmission fluid level following SI and add fluid if needed.

If the cooler line is misshaped the cooler line should be replaced then check the transmission fluid level following SI and add fluid if needed.
