PIP5212D Concern Of An Engine Thermostat Tick Noise And/Or Running Hot

A vehicle may have a concern of the engine running hot and/or has a tick noise from the thermostat.

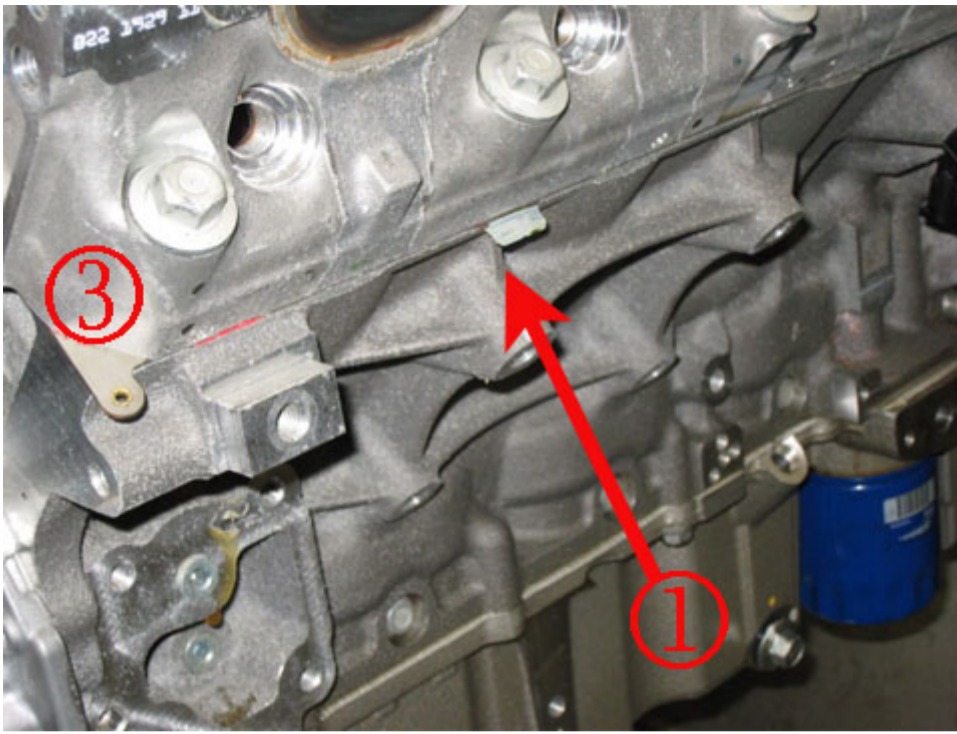
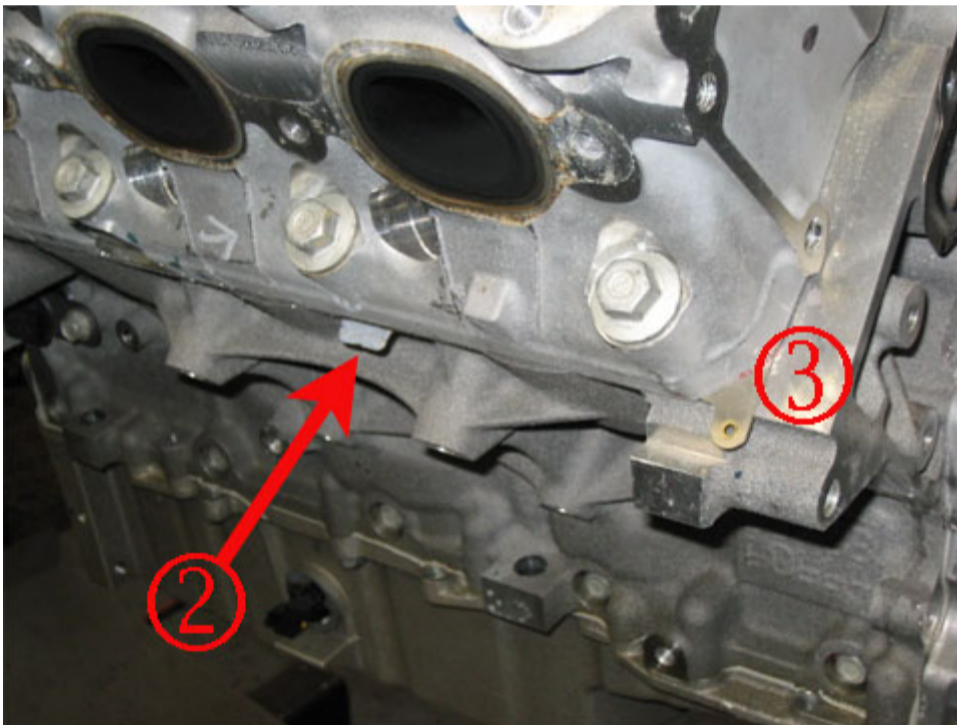
Per the attached pictures, the head gasket locating tabs for both of the engine cylinder banks should be toward the front of the engine.

1. Bank 1 tab near cylinder 3

2. Bank 2 tab near cylinder 4

3. Is the front of the engine

If the head gasket locating tabs are found to be closer to cylinders 5 or 6, this indicates the head gaskets were installed incorrectly restricting the engine coolant flow.

Replace the head gasket to repair for this concern.
