Technical Service Bulletin

01 MIL on (DTC P2070, P2006 or P2007 stored in ECM)

01 14 76 2019485/3 April 15, 2014. Supersedes Technical Service Bulletin Group 24 number 10-22 dated June 2, 2010 for reasons listed below.

Model(s)	Year	VIN Range	Vehicle-Specific Equipment
A6	2005 - 2008	All	3.2l FSI
A4	2005 - 2008	All	3.2l FSI
A4 Cabriolet	2007 - 2008	All	3.2l FSI

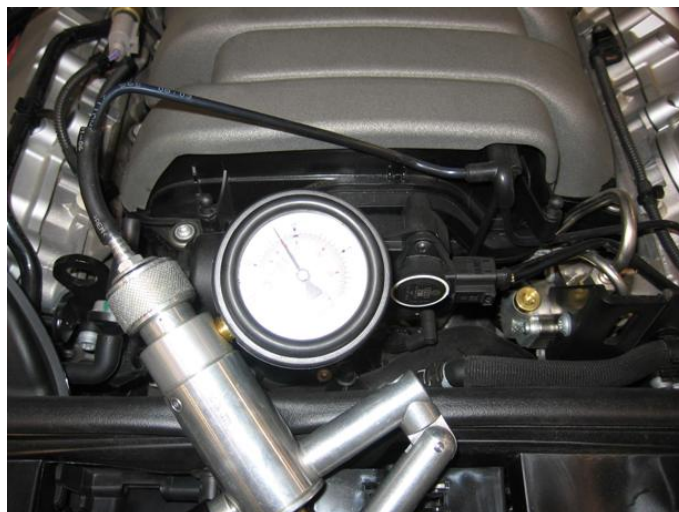
Figure 1. Vacuum pump, attached.

Tip: The vacuum line (**06E133633**) attached to the vacuum pump (Figure 1) is usually the causal part.

1. Use the vacuum pump to identify the vacuum leak in the system. Attach vacuum pump as shown (Figure 1).

4. If a vacuum leak is identified, replace the appropriate vacuum line.
5. If vacuum stays stable during the test procedure, check corresponding actuator diaphragm:
 - **DTC P2070** may be caused by a leak in the IMT actuator diaphragm.
 - **DTC P2006 and P2007** may be caused by a leak in the manifold runner actuator diaphragm.
