Technical Service Bulletin

21 Mil on - P0299 Negative pressure deviation, turbocharger excessive wastegate play

21 13 14 2031245/5 June 7, 2013. Supersedes Technical Service Bulletin Group 21 number 13-13 dated April 4, 2013 for reasons listed below.

Model(s)	Year	VIN Range	Vehicle-Specific Equipment
A4	2009 - 2012	All	CAEB engine code
A5	2009 - 2012		
A5 Cab	2009 - 2012		
Audi Q5	2009 - 2012

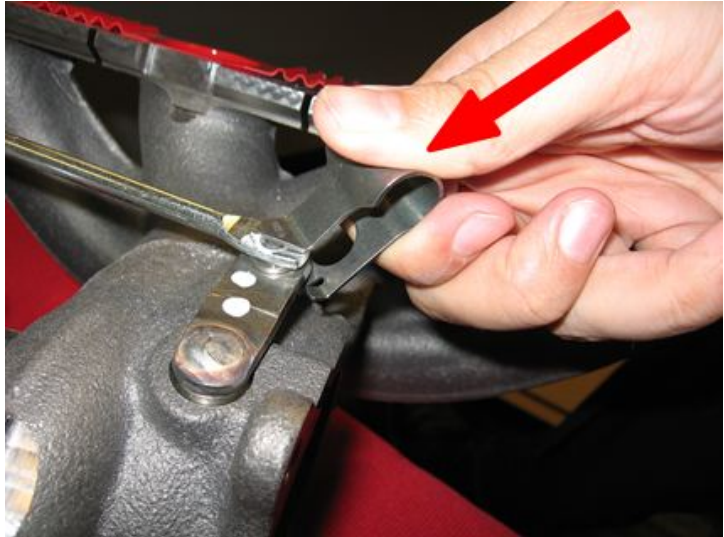
Figure 1. Fit the clip from the side.

1. Remove turbocharger as per ELSA instructions: *Repair Manual >> Engine / Engine Mechanical >> 21 Turbocharger, G-Charger >> Removal and Installation >> Turbocharger.*
2. Install clip **06J145220B** on a replacement turbocharger's link plate and actuating rod joint as illustrated (Figures 1 and 2).

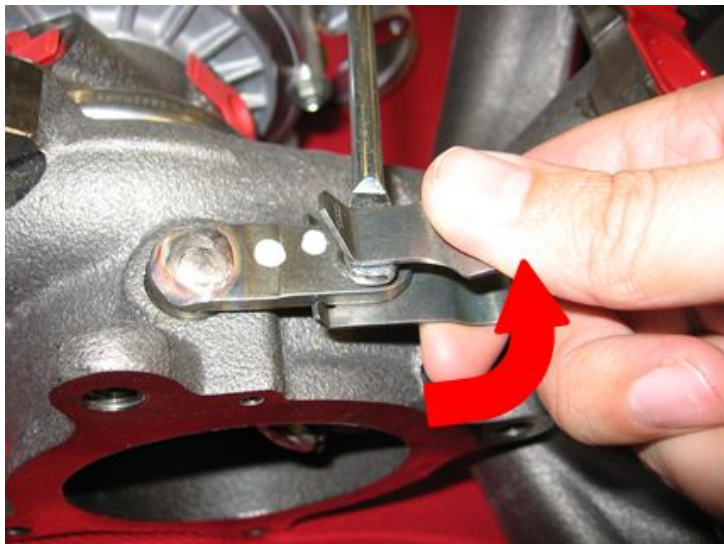
Figure 2. Turn the clip counter clockwise till the lugs slot in.

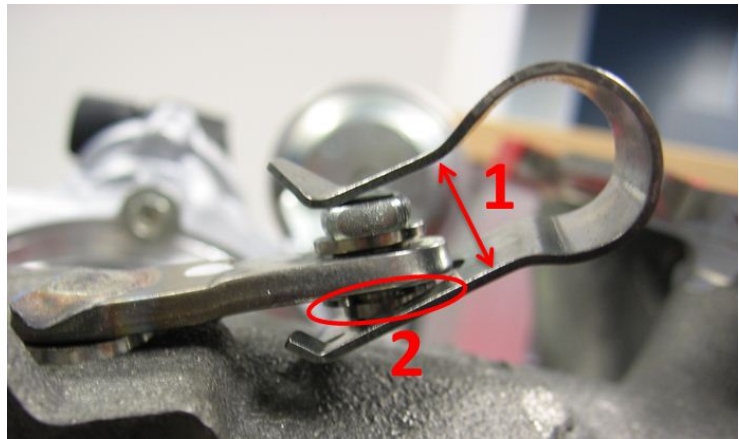
Figure 3. (1) Maximum opening of clip, (2) Position of original circlip

- The spring clip must not be overstretched. The maximum opening of the spring clip is 14 mm (Figure 3, 1).
- The spring clip must be replaced after every removal.

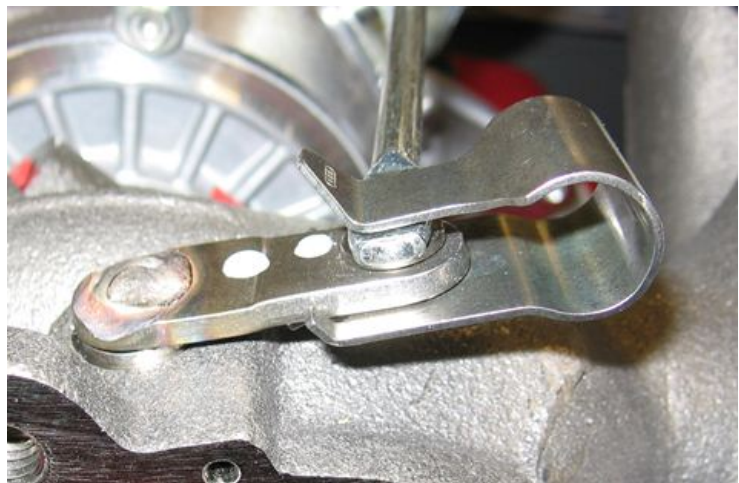
Figure 4. Correctly-fitted clip.

3. After fitting the spring clip, check for correct fit (Figure 4).

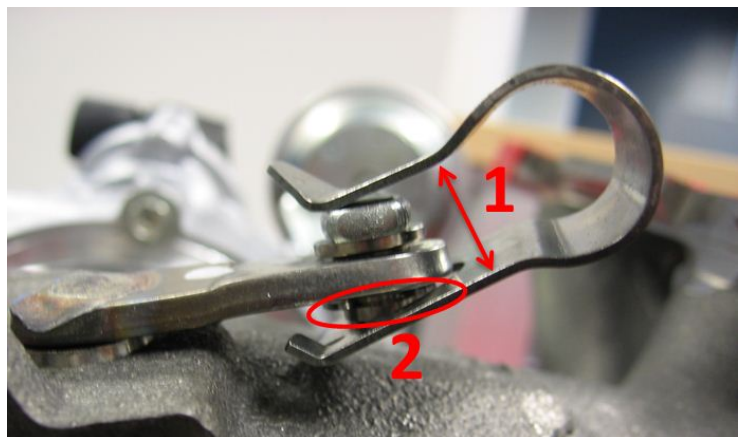
Figure 5. (1) Maximum opening of clip, (2) Position of original circlip

4. After fitting the spring clip, check the position of the original circlip (Figure 5, 2) and correct it if necessary.
