Technical Service Bulletin

21 Mil on (DTC P0299 - negative pressure deviation); turbocharger excessive wastegate play

21 13 16 2031245/6 July 9, 2013. Supersedes Technical Service Bulletin Group 21 number 13-14 dated June 7, 2013 for reasons listed below.

Model(s)	Year	VIN Range	Vehicle-Specific Equipment
A4	2009 - 2010	All	CAEB engine code
A5	2009 - 2010		
A5 Cab	2010

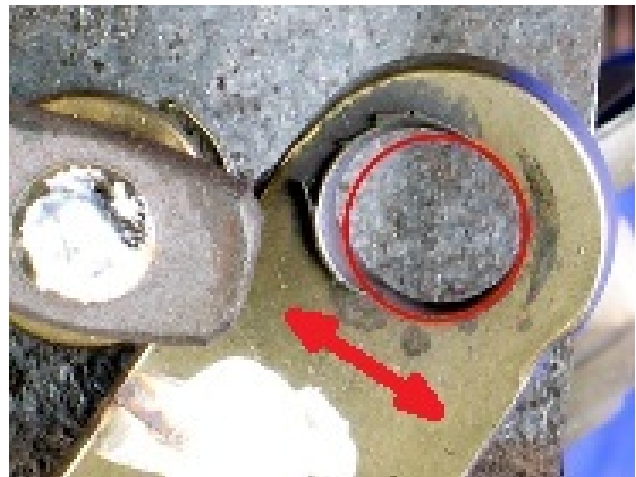
Under certain driving conditions, the linkage for the waste gate actuation can encounter excessive wear which leads to play at the waste gate flap. This leads to boost escaping through a loose flap, which sets **DTC P029900** (Negative Pressure Deviation).

Figure 1. Worn eye on wastegate link plate allowing excessive play.

- ### 2. Remove turbocharger according to the instructions in ElsaWeb: *Repair Manual* >> *Engine / Engine Mechanical* >> *21 Turbocharger, G-Charger* >> *Removal and Installation* >> *Turbocharger*.

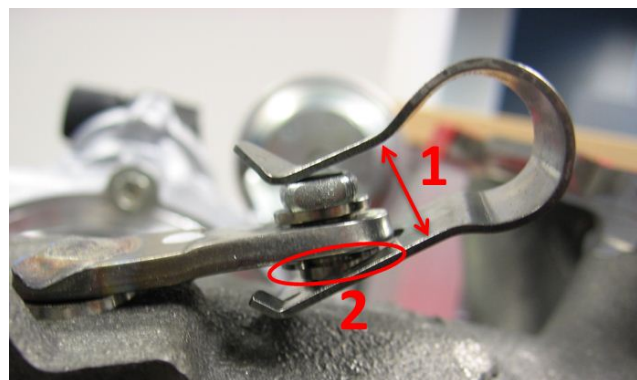
Figure 4. (1) Maximum opening of clip, (2) Position of original circlip

- The spring clip must not be overstretched. The maximum opening of the spring clip is 14 mm (Figure 4, 1).
- The spring clip must be replaced after every removal.

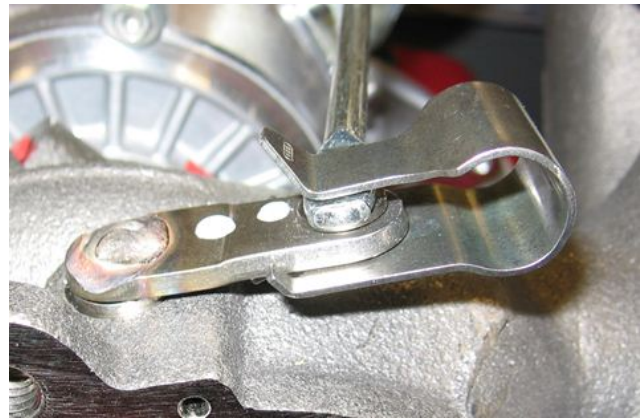
Figure 5. Correctly-fitted clip.

5. After fitting the spring clip, check for correct fit (Figure 5).

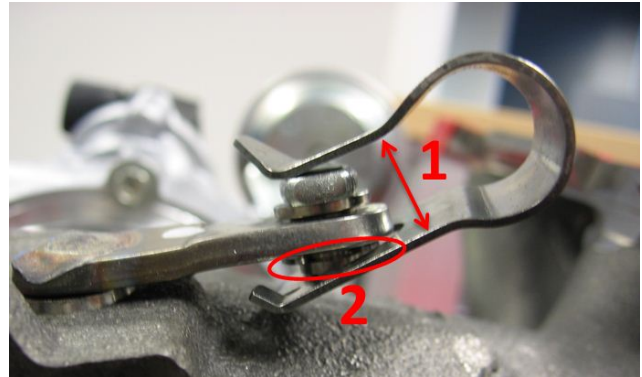
Figure 6. (1) Maximum opening of clip, (2) Position of original circlip

6. After fitting the spring clip, check the position of the original circlip (Figure 6, 2) and correct it if necessary.
