Dealer Operator/General Manager	Sales New Vehicles	Sales Used Vehicles	Business Manager (F&I)	Service	Parts & Accessories	Administration
Date: July 19, 2022		Source: Zero Motorcycles Customer Service Department

## Model Year 2022 Zero SR/F/S CCM Firmware Update Service Campaign

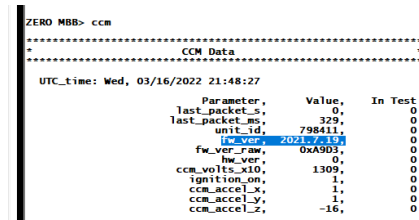
Figure 3, Verifying CCM firmware version

4. If the current firmware version is 2021.7.19, as shown above, then an additional update is not required.

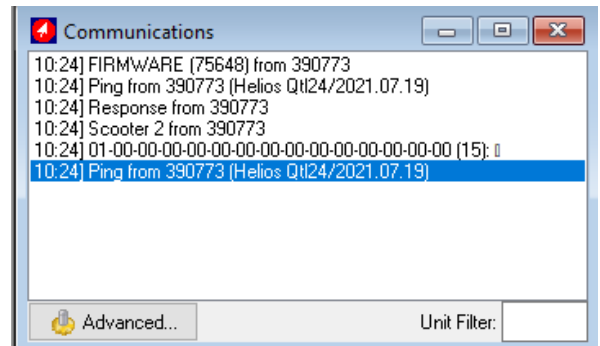
Figure 12, Verifying Ping Message

15. Once programming is complete, go back to the “Communications” tab and see if you get a ‘ping’ message as highlighted below. (Fig. 12)
