# Service Bulletin

Bulletin No.: 22-NA-015

**Subject:** Diagnostic Tips on GDS Graphing after Road-Test, for Shake and/or Shudder During Steady and/or Light Throttle Acceleration Between 25 and 50 MPH (40 and 80 KM/H) at Steady Speed, and Decel at approximately 15 MPH (24 KM/H).

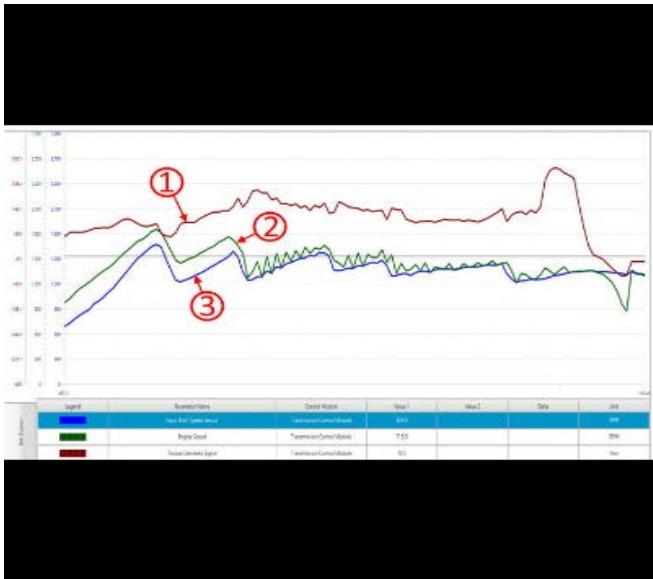
5975003

**Diagnostic Tips TCC Solenoid – Valve Body**

1. Torque
2. Engine Speed
3. Transmission ISS
  - The shudder condition is present both in Drive “D” or Manual “L9”.
  - Typically occurs at less than 15,000 miles (24,000 km)
  - Transmission ISS follows engine speed
  - Relatively consistent engine torque. <+/- 25 Nm

Engine torque remains relatively flat while engine speed rises and falls. The valve body should be replaced.

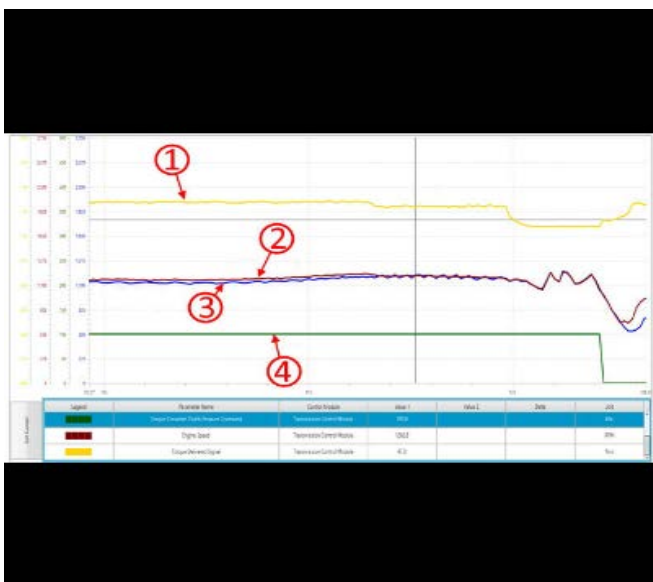
5975005

**Diagnostic Tip TCC Solenoid (Drift) – Valve Body**

3. Transmission ISS
4. TCC Pressure
  - Shudder condition is present in Drive “D” but NOT present in Manual “L9”
  - Throttle would typically be less than 10% and engine torque less than 100 Nm
  - TCC slip speed will be 0 or near 0
  - TCC pressure command will remain at 100 kPa

The valve body should be replaced.

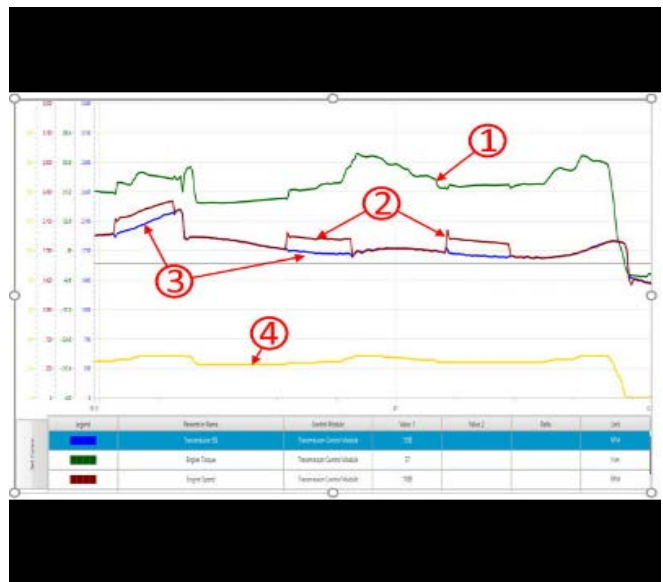
5975007

**Diagnostic Tip TCC Shudder – Torque Converter**

**Note:** A slight vibration that can only be felt when dynamic fuel management is active should be deemed normal characteristic and engine and transmission components should not be replaced.

1. Torque
2. Engine Speed
3. Transmission ISS
4. Pedal
  - TCC pressure control is steady
  - TCC slip is elevated
  - Engine RPM will increase at the shudder point while Transmission ISS remains steady
  - Engine torque remains relatively steady during the shudder event
  - Throttle angle remains steady during the shudder event

**Note:** Warranty claim reviews indicate that when the torque converter is replaced for shudder that vehicle often returns for additional engine or transmission repairs. In most cases the torque converter is not the cause of the shudder.

The torque converter should be replaced.

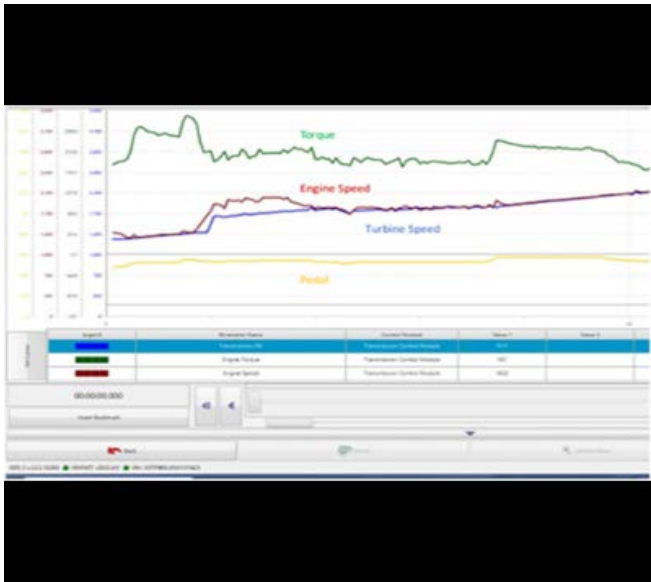
6124137

### Diagnostic Tip Engine Related Shudder - Fuel Injectors

1. Torque
2. Engine Speed
3. Transmission ISS
4. TPS
  - Engine RPM is erratic
  - Throttle is fairly steady/constant
  - Magnitude of RPM and TPS signal is relatively small
  - Engine RPM will not be in sinewave pattern. The issue is possibly related to one or more fuel injector.
