Service Bulletin

Bulletin No.: 22-NA-107

Subject: Service AWD Message in Driver Information Center (DIC) at Ignition On with DTC C056D Set

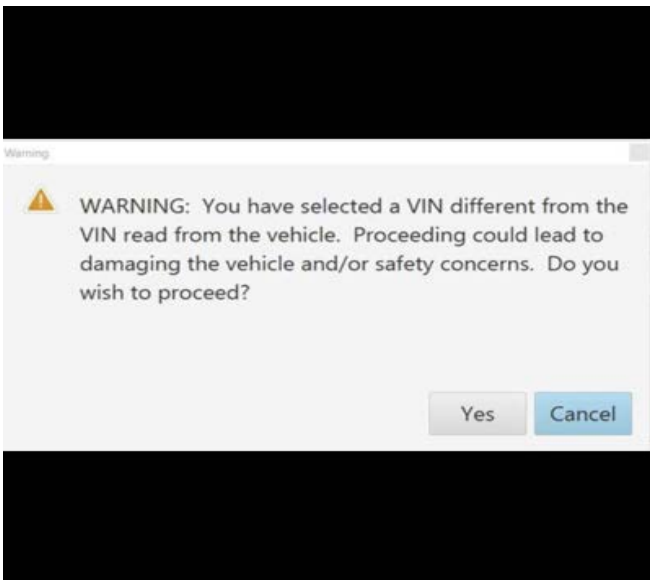
5877000

Important: If the vehicle VIN DOES NOT match, the message below will be shown.

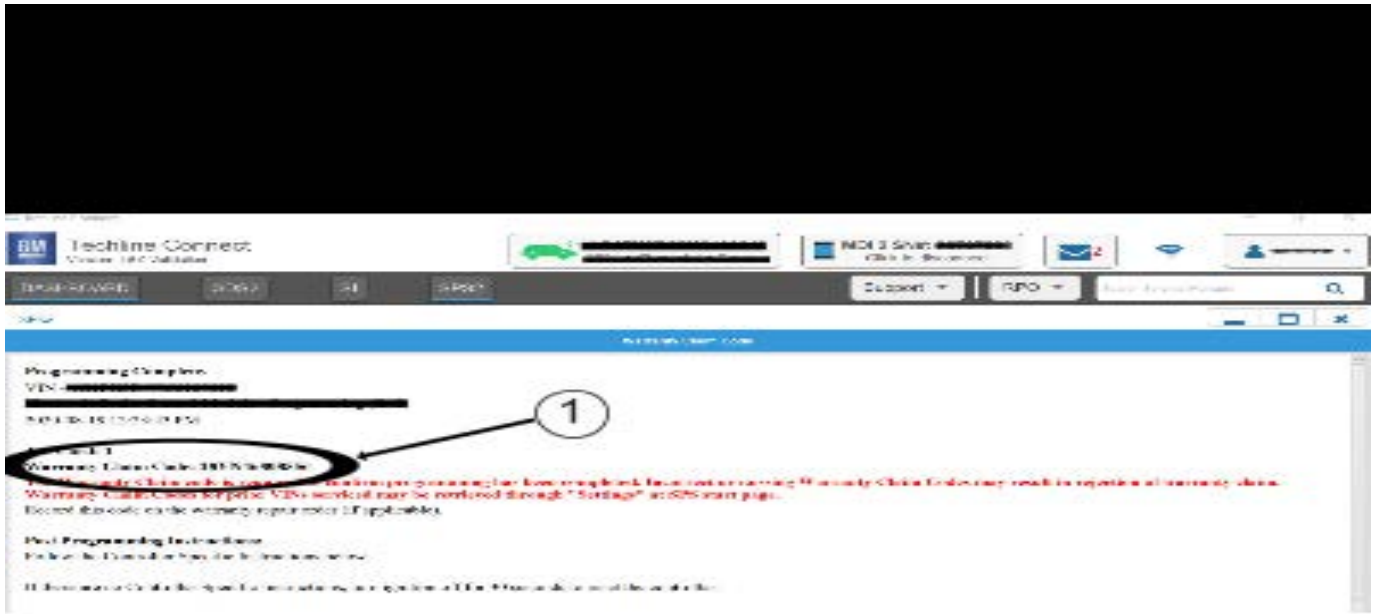
5644478

Note: The screenshot above is an example of module programming and may not be indicative of the specific module that is being programmed. Module selection and VIN information have been blacked out.

Important: To avoid warranty transaction rejections, you **MUST** record the warranty claim code provided on the Warranty Claim Code (WCC) screen shown above on the job card. Refer to callout 1 above for the location of the WCC on the screen.

1. Reprogram the Rear Differential Clutch Control Module. Refer to *K47 Rear Differential Clutch Control Module: Programming and Setup* in SI.

2. Record the Warranty Claim Code on the job card for warranty transaction submission.
