Service Bulletin

Bulletin No.: 21-NA-049

Subject: Diagnostic Aid – PicoScope Information and Setup for Transmission Related Concerns

Brand:	Model:	Model Year:		VIN:		Engine:	Transmission:
		from	to	from	to		
Chevrolet	Corvette	2020	2023	—	—	All	Automatic (M1M)

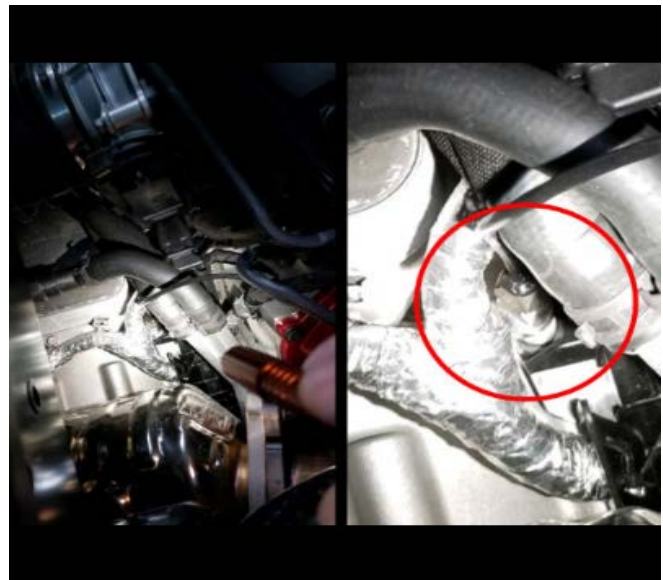
5751814

1. Place the PicoScope sensor on the bolt head shown in the image above. This is located on the right side of the transmission, near the transmission cooler. This bolt is used to secure a bracket for the wire harness. The sensor cable can be run into the passenger compartment with the engine compartment closed.

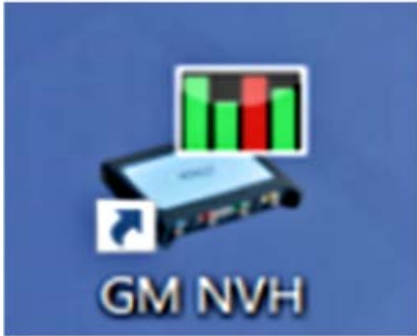
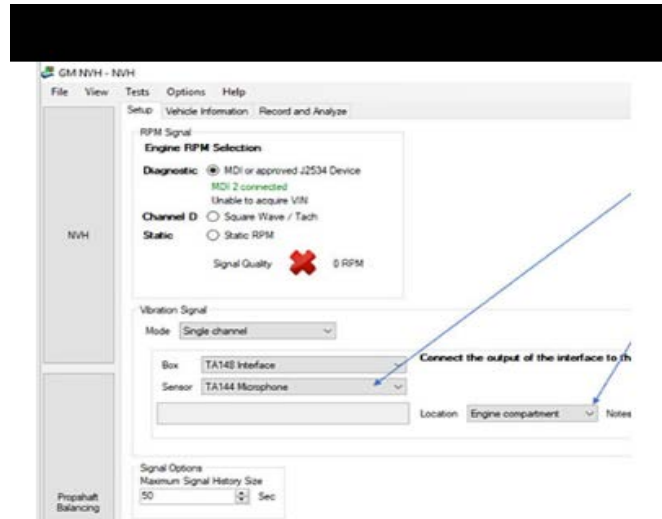
3. After completing the wizard, go back into the setup tab under Vibration Signal and select Single Channel. Select TA148 Interface in the “Box” dropdown and TA144 Microphone for the “Sensor” Drop down. Select the Location as Engine Compartment. Set the Diff Ratio to 3.55.

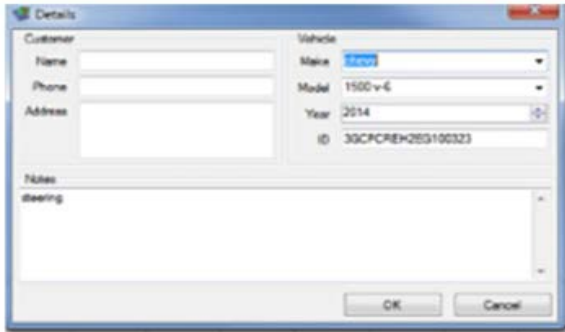
5751820

6. The next box allows you to save the vehicle information as well as customer information and notes in the Notes box. This could be sensor location, sensor direction and even road surface name, etc. Click Ok when you are done adding information.
7. If PICO scope data shows readings under 85 decibels, vehicle noise is deemed as a normal characteristic.
8. Create an e-mail to TACSNAPSHOT@gm.com in the U.S. and TACSNAPSHOTCANADA@gm.com in Canada and in the subject line Put Vibration, your BAC, and last 8 of the VIN.
