Service Bulletin

Bulletin No.: 22-NA-127

Subject: Radio Software Version V160 Update

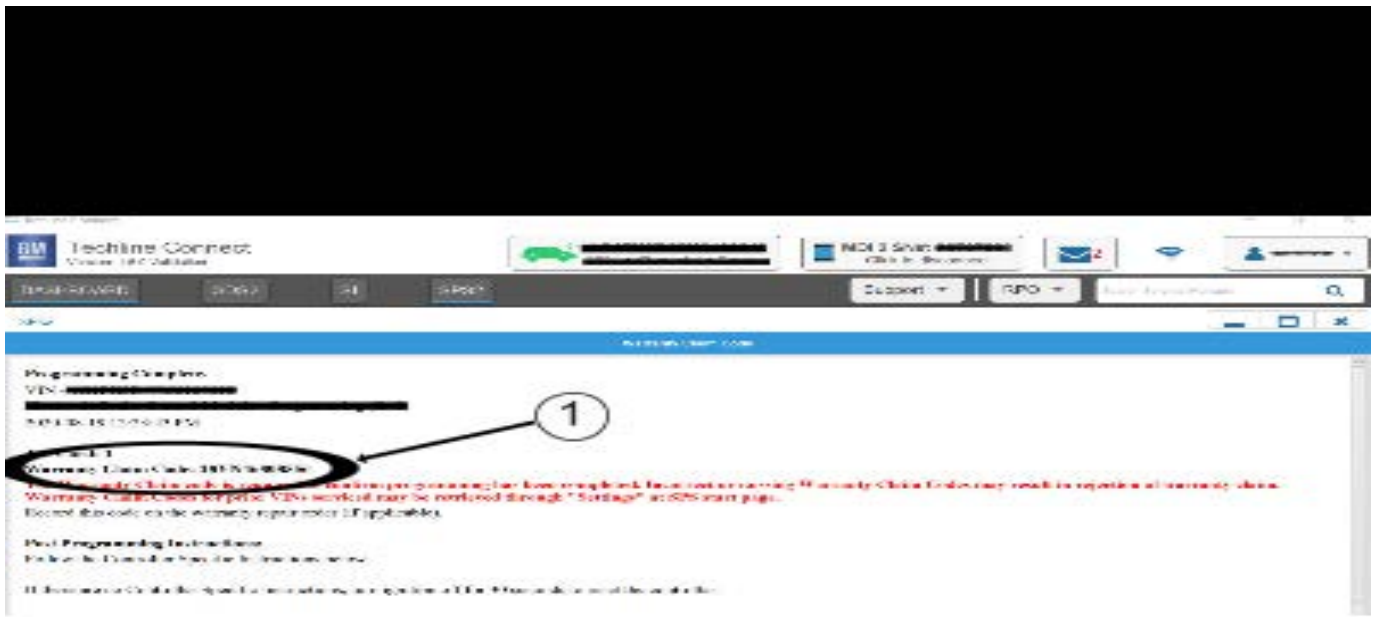
Note: The screenshot above is an example of module programming and may not be indicative of the specific module that is being programmed. Module selection and VIN information have been blacked out.

Important: To avoid warranty transaction rejections, you **MUST** record the warranty claim code provided on the Warranty Claim Code (WCC) screen shown above on the job card. Refer to callout 1 above for the location of the WCC on the screen.
