Location: Chassis

Topic: Information relating to the replacement and diagnosis of steering pumps

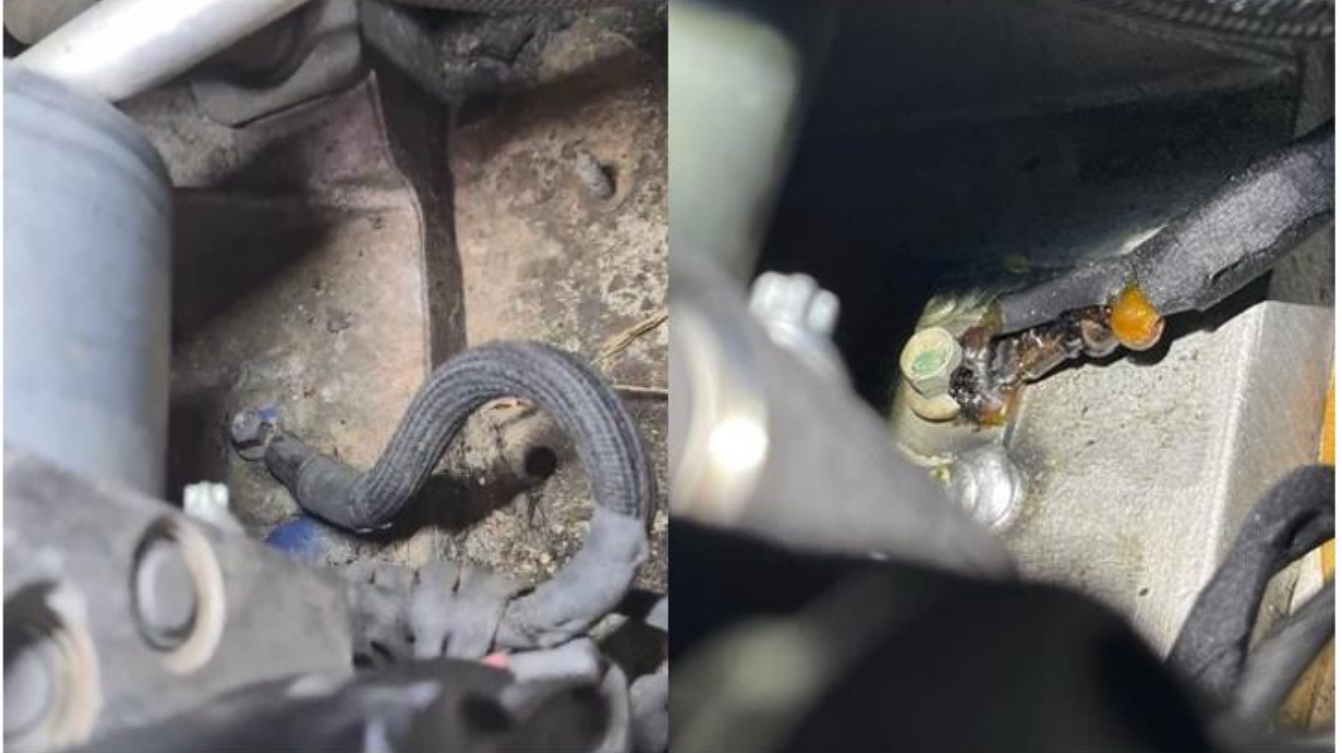
During the replacement or diagnosis of a suspected faulty steering pump (EHPAS), it is necessary to inspect the ground for the pump power supply circuit. Poor grounding of the steering pump can lead to intermittent warning messages or sporadic steering pump behaviour.

Please see **figure 1.2** for an example of poor grounding for the EPHAS circuit. For all models, Ground Point 5 located on the front subframe will need to be cleaned and inspected. The relevant wiring diagram must be consulted to locate Ground Point 5.

Figure 1.2 – Examples of poor grounding for Steering Pump

If damage to the harness is found, please proceed to submit a Technical Request.
