Technical product information

Topic	Clicking noises from the left and/or right front corner(s)
Market area	Bentley: worldwide (2WBE),Hongkong-Macau (5HK)
Brand	Bentley
Transaction No.	2052853/10
Level	EH
Status	Approval
Release date

Bentayga series

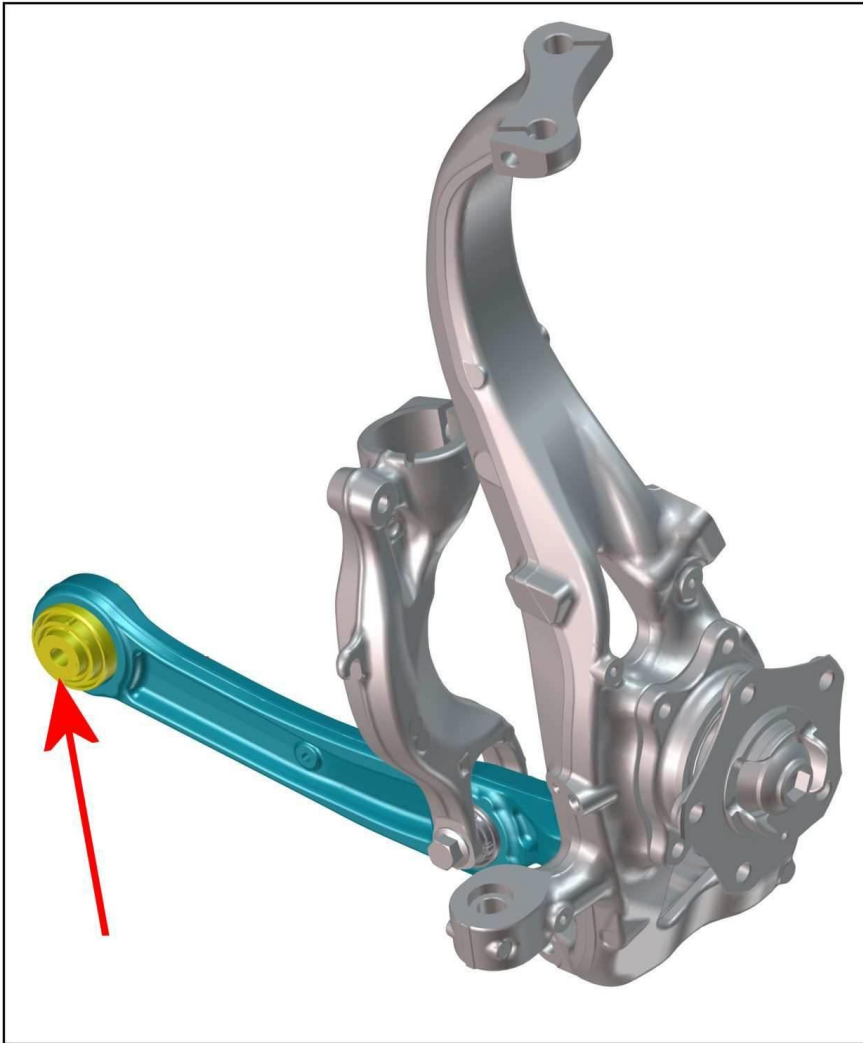
Figure 1

Single click from the front wheel corner(s) when the steering is moved from lock to lock whilst stationary

- If so then replace both front lower inner control arm bushes (Figure 1)

IMPORTANT: Please check the vehicle Repair History to confirm the inner bushes have not been previously replaced, if they have been replaced once before, You must then replace the complete arm, Do Not carry out the bush replacement procedure more than once (per lever)

IMPORTANT: Prior to starting this procedure ensure you have assembly lubricant part number G 052 566 A2 this must be used when fitting the new replacement bushes, the lubricant should only be used when the bushes are replaced as per the instructions within TPI 2052853/-

Each bush should have 5ml of lubricant applied prior to fitment within the bush, the grease should remain present throughout the fitting/pressing in procedure as the grease aids the fitting process and is also crucial once fitted to eliminate any further noise issues *Please Note that x1 – 100 ml tube will be sufficient for use on 20 bushes (10 vehicles) – Do not order x1 tube of lubricant per each individual vehicle complaint*

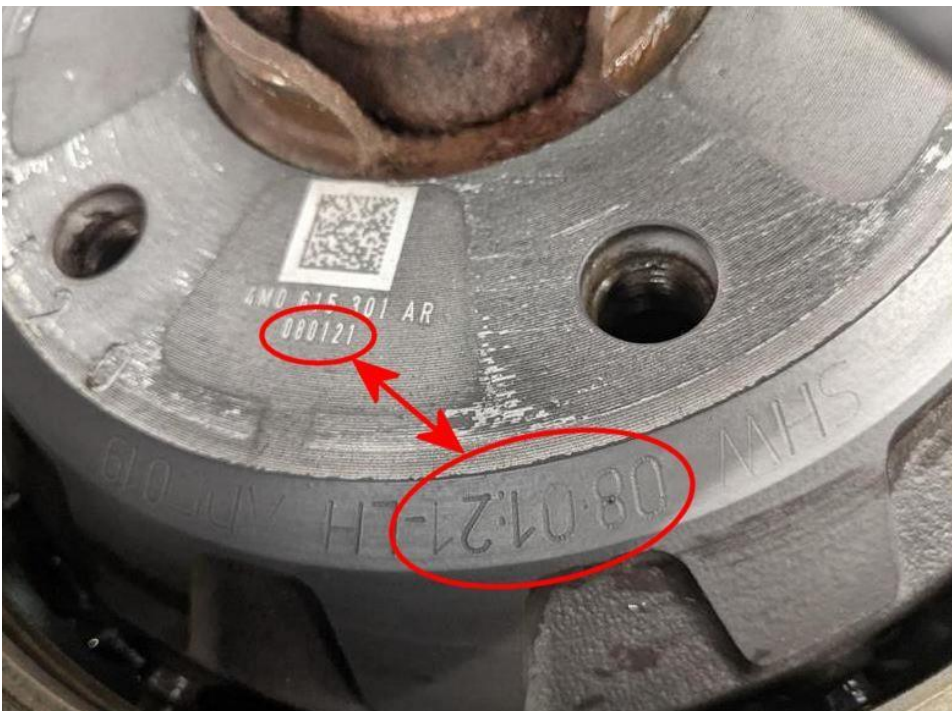
- Provide clear photographs of the mating surfaces between both front wheels, brake discs, hubs and photographs of the front brake disc date of manufacture stamp as shown in Figure 2

- Provide comments/feedback regarding any surface imperfections such as uneven wear, surface damage or fretting, or paint overspray
- If any of the above is present, ensure clear photographs are attached to a new or existing DISS query, and then replace the brake discs and wheel bolts
- If the fault remains the same, the operative should raise a new or existing DISS query and await feedback before conducting any other work
