TECHNICAL TOPICS

Clicking/Ticking Type Noise Whilst Turning

17- 22MY Discovery, 20-22MY Defender

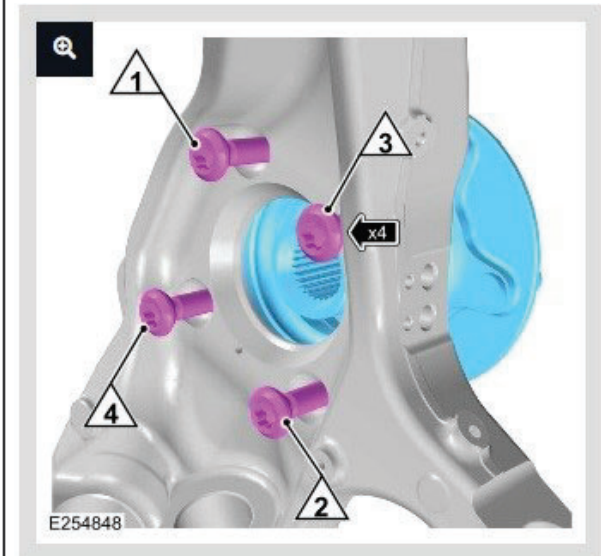
- A clicking/ticking type noise may be heard from the front hub area when turning to the left or to the right at full lock at low speeds. This may be caused by the front hub retaining bolts.

- SSM 75779 has been published to address this concern by replacing the front hub retaining bolts.
- Please refer to these SSMs should a customer express a concern. The SSM provides the part number and containment VINs.
- This affects models with 350mm or 365mm front brake discs only.
