Technical product information

Topic	"Drive System Fault" warning present within the DIP - Under full throttle conditions
Market area	Russische Föderation (5RU),Australia E04 Bentley rest Asia and Australia (6E04),China 796 VW Import Comp. Ltd (Vico), Beijing (6796),Germany E02 Bentley rest Europe (6E02),Japan E03 Bentley Japan (6E03),Korea, (South) E08 Bentley South Korea (6E08),United Arab Emirates E06 Bentley Middle East and Africa (6E06),United Kingdom E01 Bentley UK (6E01),United States E05 Bentley USA and rest America (6E05)
Brand	Bentley
Transaction No.	2067483/1
Level	EH
Status	Approval
Release date

New Continental GT(C) and New Flying Spur - V8 Kovomo

“Drive System Fault” warning present within the DIP - Under full throttle conditions

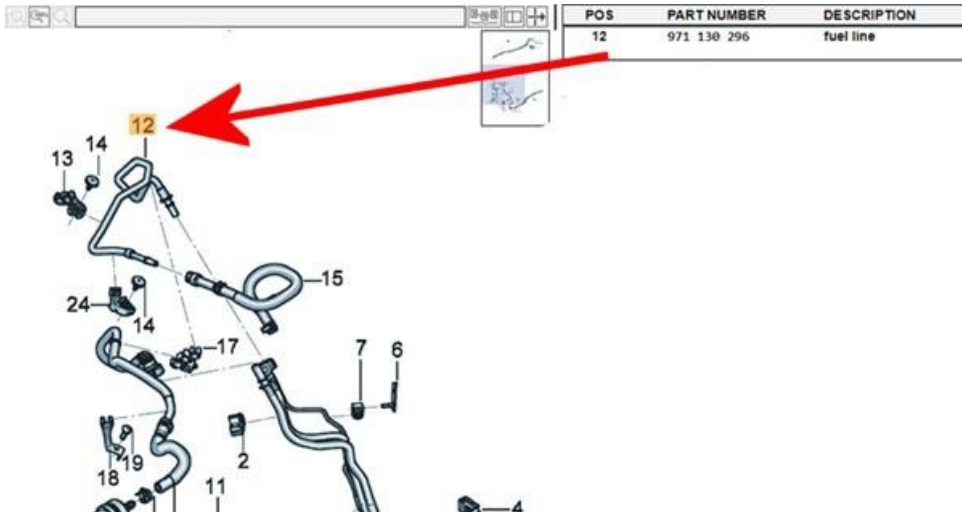
- 1) Referring to Rep.Gr 20 - Depressurise the fuel system
- 2) Referring to Figure 2 (Item 12) remove the fuel line shown

- In the event the fuel line is blocked/restricted - Replace the fuel line as shown in Figure 2 (item 12) ensuring all Rep.Gr guidelines are strictly adhered to

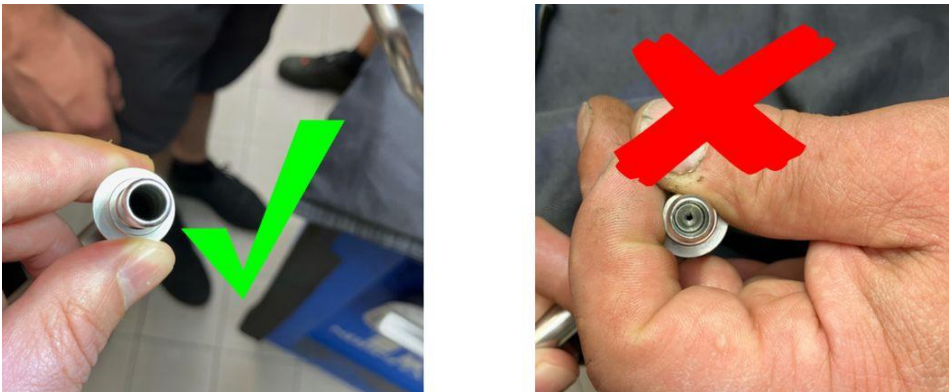
3) Referring to Figure 3 - Check to confirm if the fuel line is blocked/restricted

- In the event the fuel line is not blocked/restricted the operative should refer to Rep.Gr 20 and conduct the Low pressure fuel system - to test and provide feedback via a new or existing DISS query
