**NUMBER:** 23-036-15

Door Panel Armrest Pull Cup Loose And/Or Audio Induced Buzz/Rattle

2015 - 2016 (LA)

Dodge Challenger

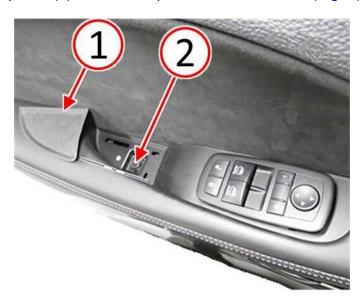
Fig. 1 Door Armrest Attachment Screw

The customer may describe an audio induced buzz/rattle from the door panel or a loose door armrest pull cup.

This condition may be caused by the door panel armrest pull cup attachment screw not tightened securely.

- 1. Remove the pull cup mat (1) from the door panel armrest handle (Fig. 1).
- 2. Verify that the pull cup screw (2) on both doors is tight or can be tightened securely (Fig. 1).
- 3. Is the screw on both doors tightened securely?
  - a. Yes>>> This Bulletin has been completed.
  - b. No>>> One or both screws cannot be tightened securely. Continue with the Repair Procedure Step #4.
- 4. Remove the screw(s) that will not tighten and obtain a NEW screw from the Parts Required section of this bulletin.
- 5. Install a NEW screw (2) in the door armrest handle pull cup and tighten the screw securely (Fig. 1).
- 6. Install the pull cup mat (1) in the door panel armrest handle (Fig. 1).
