- JEP (Jamestown Engine Plant) has received 35 BIS (Before In Service) reports of ECM's (Electronic Control Modules) with No Communication;
 - 1 reported by DTNA Cleveland
- RMEP (Rocky Mount Engine Plant) has received 15 BIS reports of ECM's with No Communication;
 - 9 reported by DTNA (4 at DTNA Santiago, 2 at DTNA Mount Holly, 2 at DTNA Cleveland, and 1 at FCCC Gaffney)
- There have been no failure reports from units at the supplier or at Cummins plants
- Cummins is investigating 1 reported failure from the field

ROOT CAUSE AND GOAL STATEMENT

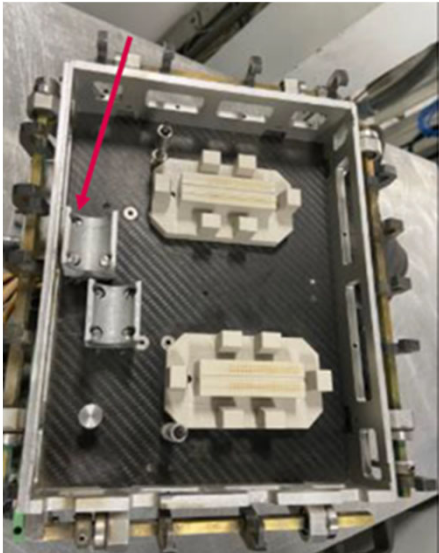
- Selective Solder Fixture had a screw loose. Screw was contacting the Lytic cap and applying excess force into the PCB (Printed Circuit Board). Vitesco can detect a direct short of capacitor ground post to V-Batt layer. However, when the capacitor post ground is pressed into the dielectric layer, there is no short to detect. Some scrubbing or movement of PCB & capacitor wears through the dielectric layer into the V-Batt layer resulting in high current draw and heat leading to L2002 reflow and ECM No communication.

Location of loose/raised screw in Selective Solder fixture

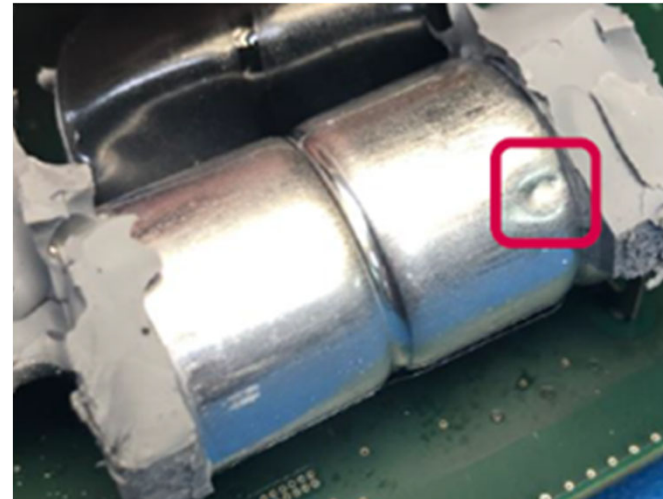
Damaged Lytic Cap

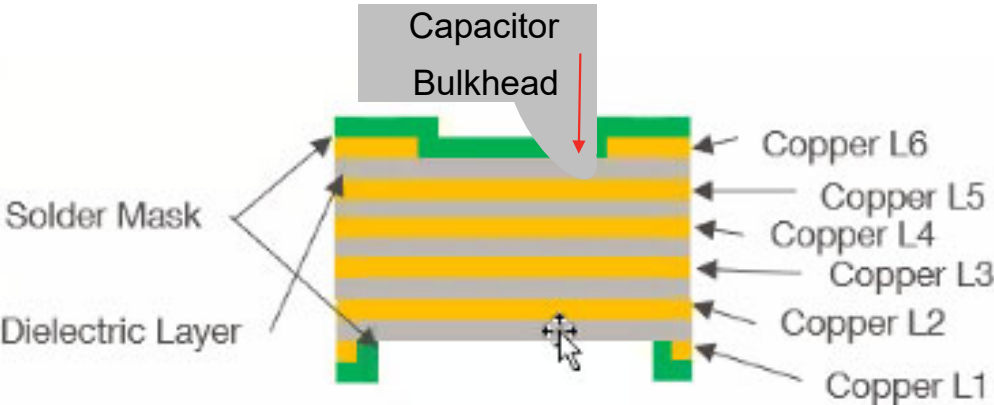
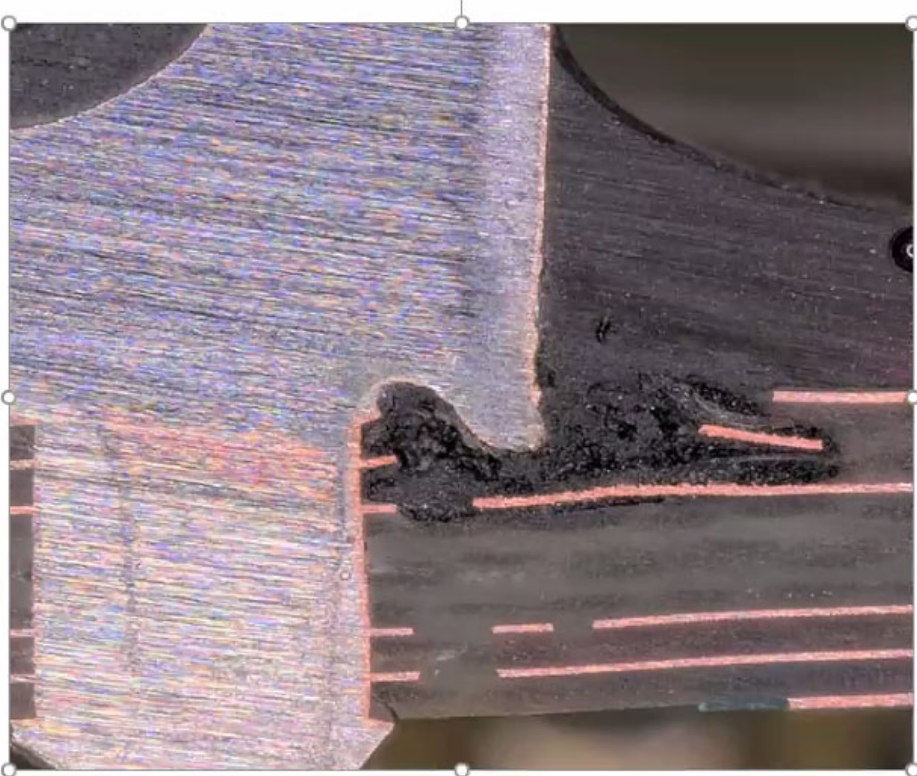
PC Board layers
