# Service Campaign Bulletin

Campaign No. 2022050016 June, 2022

SUBJECT: **Model 907 Model Year 2019-2020  
Retrofit Propeller Shaft Holder Bracket**

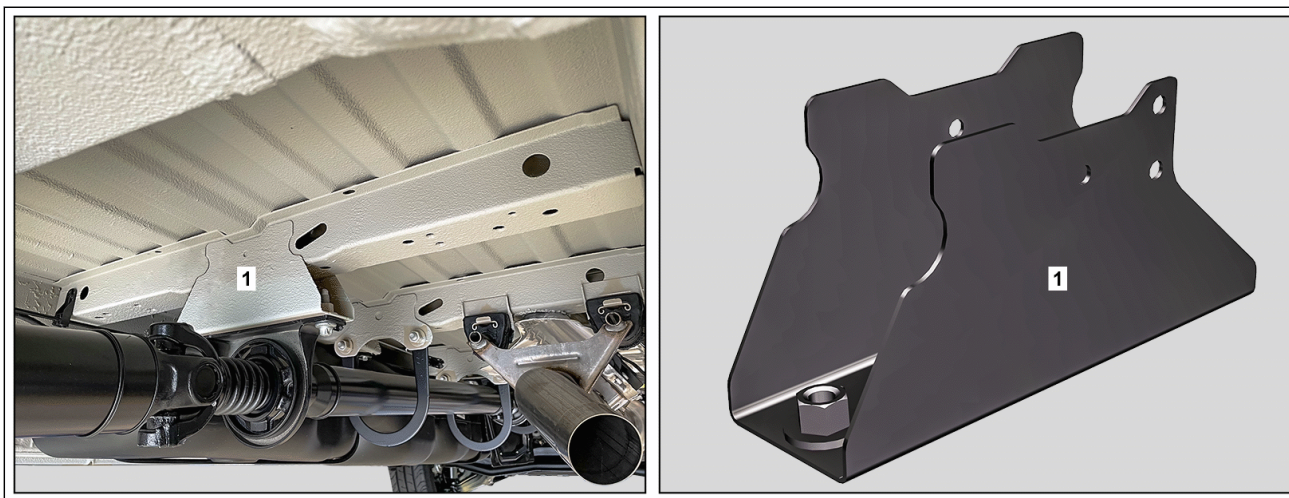
D41.10-A028-78

MBAG, the manufacturer of Mercedes-Benz Sprinter vehicles, determined that the holder brackets that are welded onto the cross member for the propeller shaft intermediate bearing may be missing on certain vehicles. As a result, the propeller shaft intermediate bearing may not have been installed at the specified position.

1 Bracket

<b>Install</b>		
5  WS	Retrofit holder (1) for propeller shaft.  000 588 02 84 00 Welder	Clip: Retrofit holder for propeller shaft on crossmember   <b>Commercially available devices/ tools</b> Clamping pliers (Standard) Rotary wire brush Drill bit 7 mm Wet and dry vacuum cleaner	<a href="#">Page 9</a>  <a href="#">Page 5</a>  WS60.00-P-0022K
6	Clean weld joints and sheet metal flange.	 <b>Commercially available devices/ tools</b> Rotary wire brush	
7	Remove welding protection blankets.	 <b>Commercially available devices/ tools</b> Welding protection blanket	
8	Clean repair area.	 <b>Commercially available devices/ tools</b> Wet and dry vacuum cleaner	
9 Notice	<b>Danger</b> <b>Risk of explosion</b> caused by paint vapors igniting. <b>Risk of poisoning</b> caused by inhaling paint vapors.  Prime repair area with primer filler. Notes on paintwork repairs	No smoking! No open fire! Use respiratory protection, protective clothing, gloves, safety glasses and protective skin cream. Ensure that the area is well ventilated.   Use only primer fillers approved by manufacturer. See guidelines for paint technology in the workshop portal.	AS98.00-Z-0002-01A  AH98.00-P-9408-02A
