TECHNICAL INSTRUCTIONS
FOR
SPECIAL SERVICE CAMPAIGN 22TC07
ENGINE ECU SOFTWARE UPDATE
CERTAIN
2020 MODEL YEAR COROLLA VEHICLES

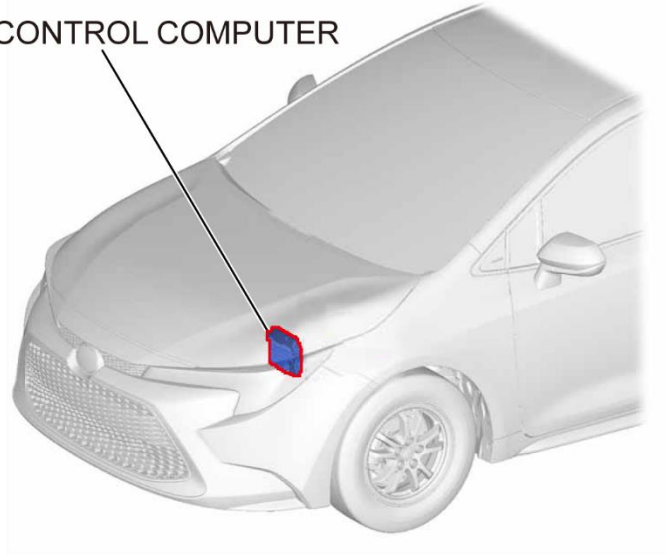
ENGINE CONTROL COMPUTER

Due to improper programming in the engine ECU, under certain conditions, the vehicle may stall at low speeds when accelerating from a stop. If this low-speed vehicle stall occurs, steering and braking are not impacted, and the vehicle can be restarted immediately.

Note: this condition may cause DTC P1603 to be present in DTC history. However, it will not cause the MIL to illuminate.
