**TECHNICAL INSTRUCTIONS  
FOR  
SPECIAL SERVICE CAMPAIGN 22TC08  
ENGINE ECU SOFTWARE UPDATE  
CERTAIN  
2022 MODEL YEAR TUNDRA VEHICLES**

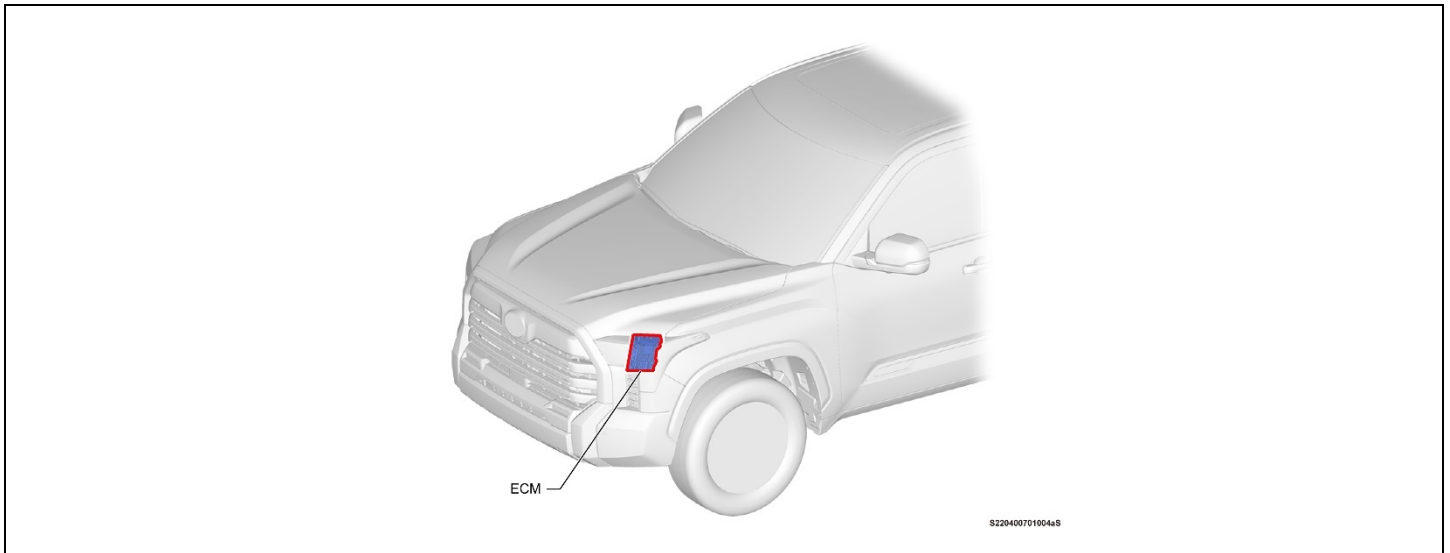
## IV. BACKGROUND

Due to certain programming in the engine ECU, in the event the accelerator pedal is forcefully depressed and immediately followed by aggressive braking, there is a possibility the vehicle may stall at low engine speed. If the vehicle stalls, steering, and braking are not impacted, and the vehicle can be restarted immediately
