Subject <b>2018-2022 Tacoma/4Runner Transfer Case Leak</b>		Market <b>USA</b>
Service Category <b>Drivetrain</b>	Section <b>Transfer/4wd/AwdAwd</b>	
Applicability <b>2018-2022 Tacoma/4Runner</b>

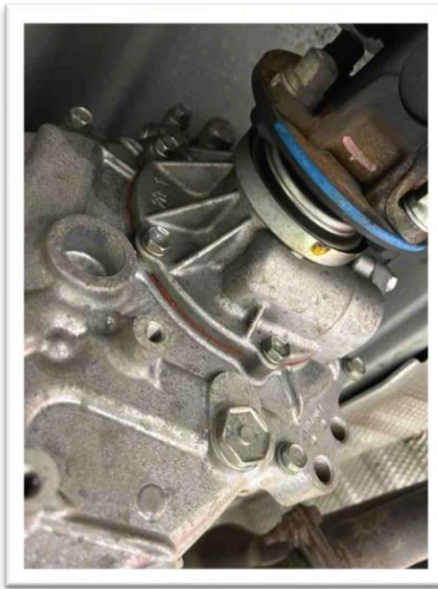
This condition is currently under investigation. Oil may be found leaking from the transfer case input or rear output shaft seal as seen in the example pictures below:

*Figure 1 Rear Output Shaft Seal Leak*

If you see this condition, please create a TAS case and contact TAS for instruction prior to diagnosing or repairing of the vehicle. If it is a weekend or holiday, continue with diagnosis and repair. Please save all parts and/or details and contact TAS on the next available workday.

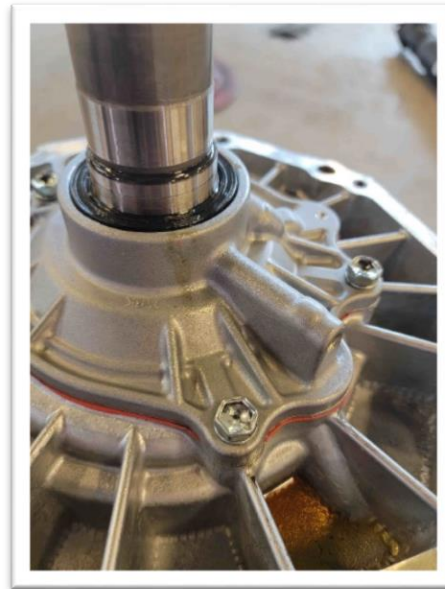
*Figure 2 Input Shaft Seal Leak*
