Technical Service Bulletin: TSB210187

Released Date: 31-Aug-2022

Fault Codes 3868, 4572 and 4677 Caused by Diesel Exhaust Fluid (DEF) Header Malfunction

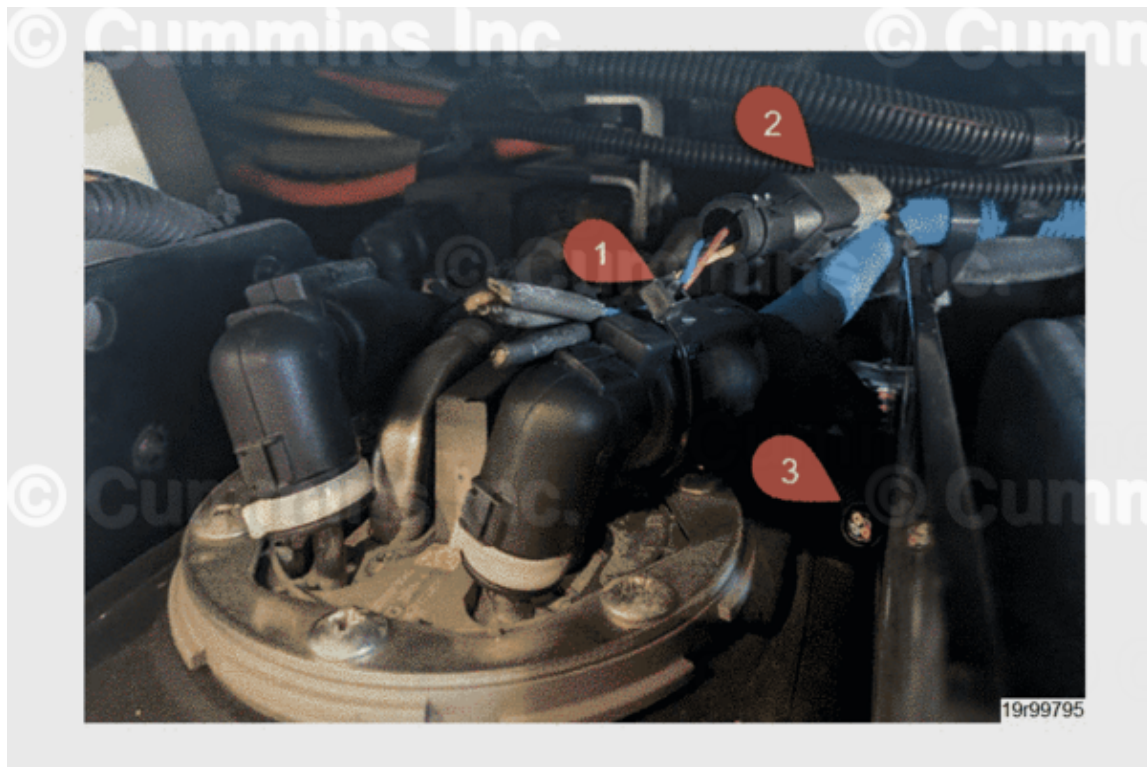
Figure 4, OEM Wiring Harness.

1. Zip tie securing the harness
2. Pigtail connected to chassis connector
3. Harness to DEF header left unsealed

8. Secure the wiring harness using a zip tie. See Figure 4 below.
