Preliminary Information

PIT5847F SES Light - Reduced Power - DIC Warning Messages - Reduced Steering Message - Stabilitrack Message

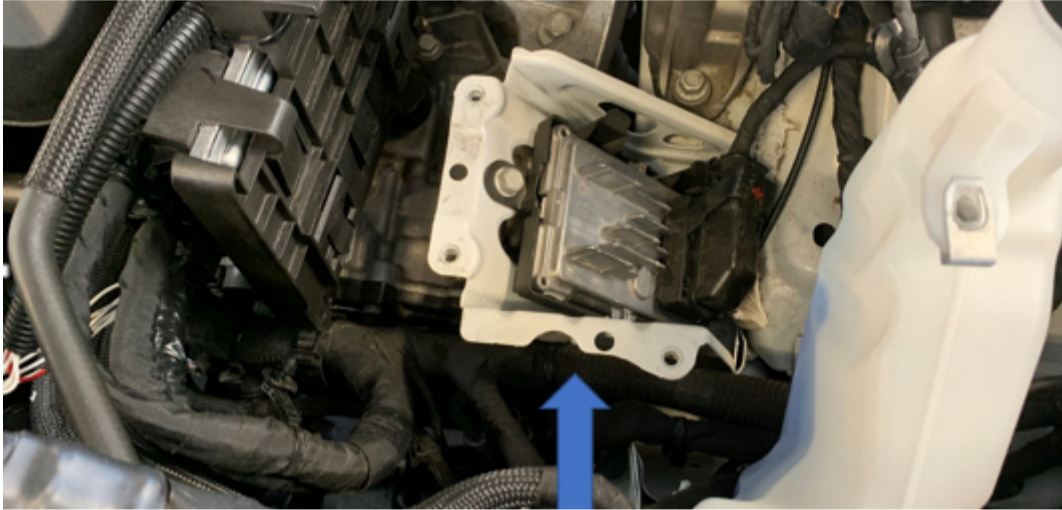
Battery and battery tray are removed to show the area of concern.

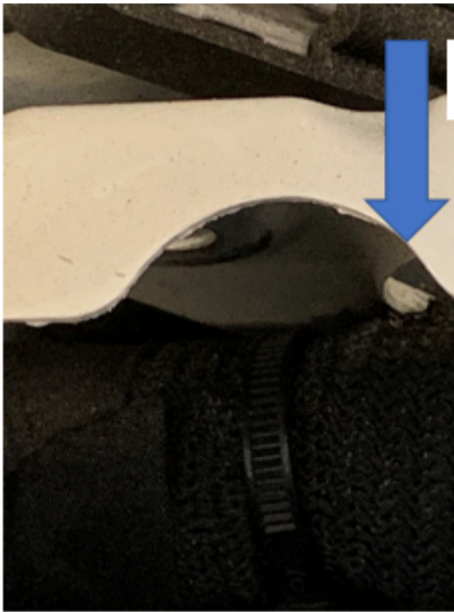
Close up of area where harness may chafe.

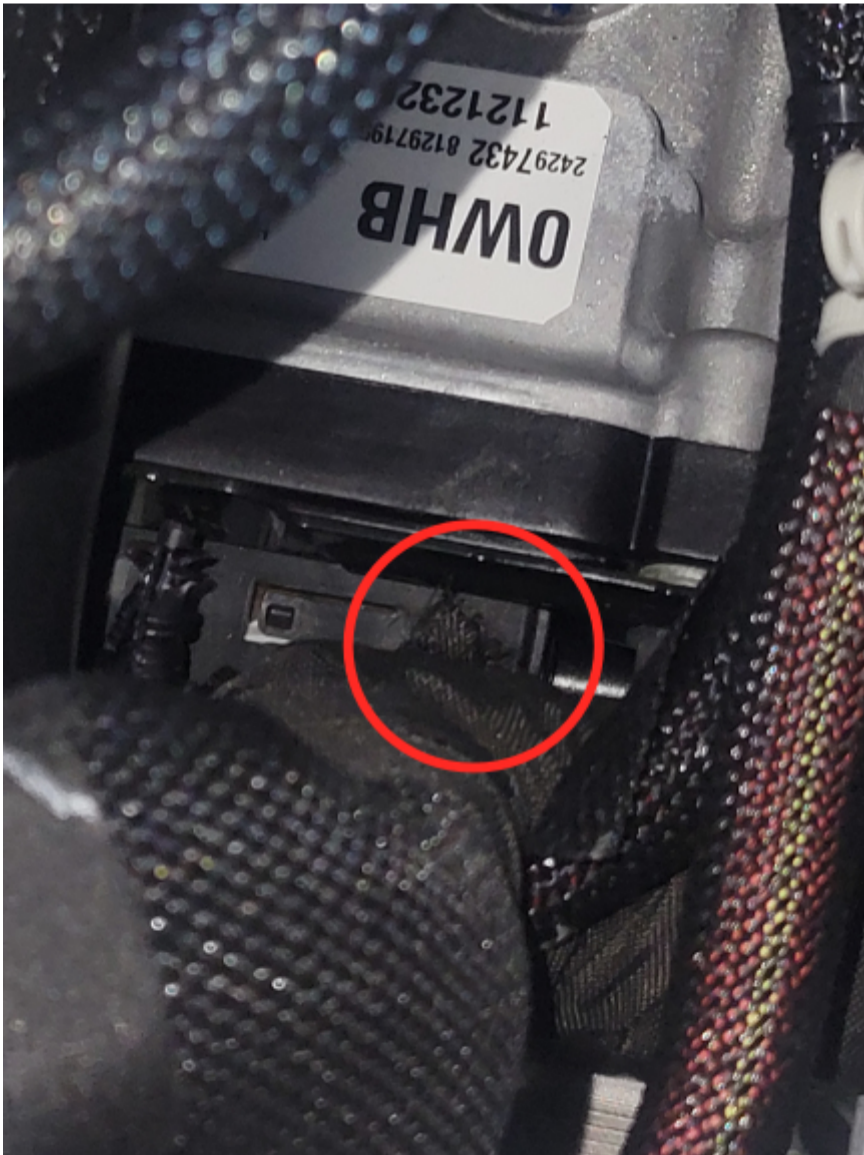
Close up of area where harness may rub.

If damage is found, repair the harness and secure it as necessary.
