Technical Service Bulletin:
TSB220192

Premature Battery Power loss: Fault Code 1117

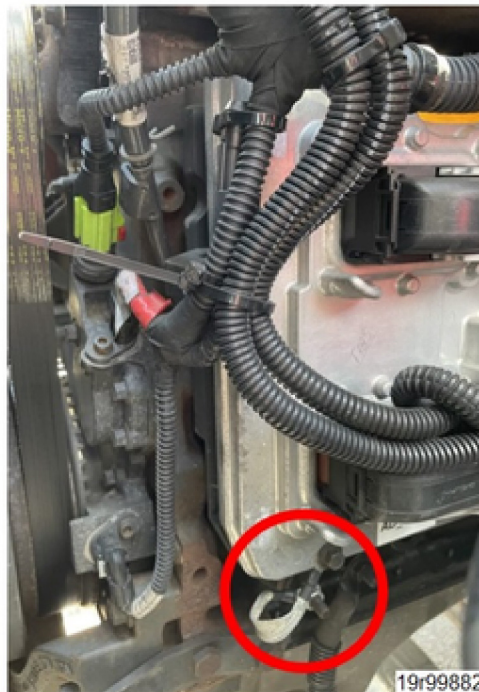
Figure 1, Grounding Strap.

Note : Some applications may have an ECM case ground strap. This grounds **only** the housing of the ECM and does **not** ground internal connections. This is **not** a connection that would lead to Fault Code 1117.

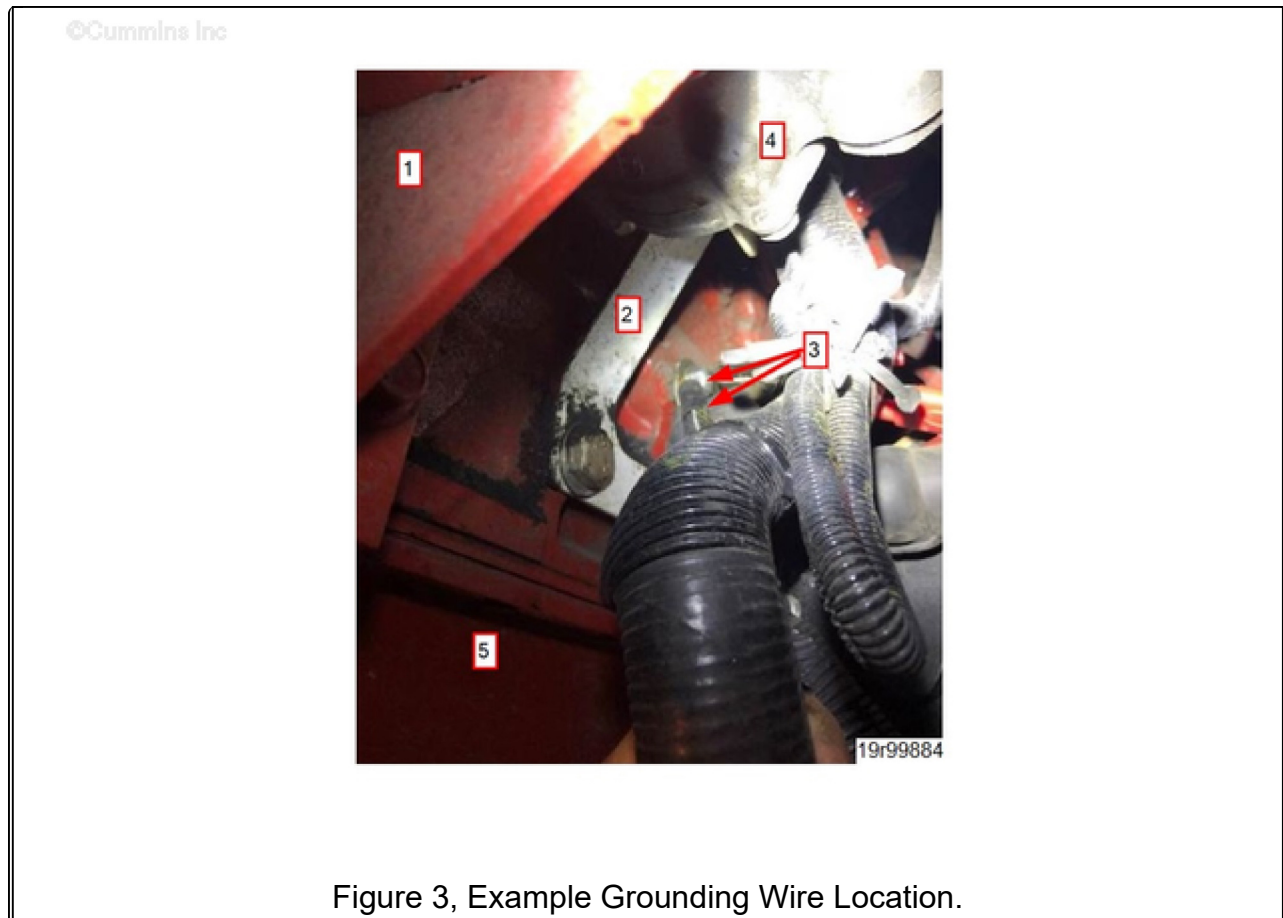
Figure 3 Items:

1. Fuel pump rear bracket.
2. OEM installed bracket.
3. Ground cable, stud, and nut.
4. Power steering pump.
5. Lubricating oil pan.

- Ground noise issues can cause ECM power ground loss if Cummins Inc. grounding best practices are **not** followed.

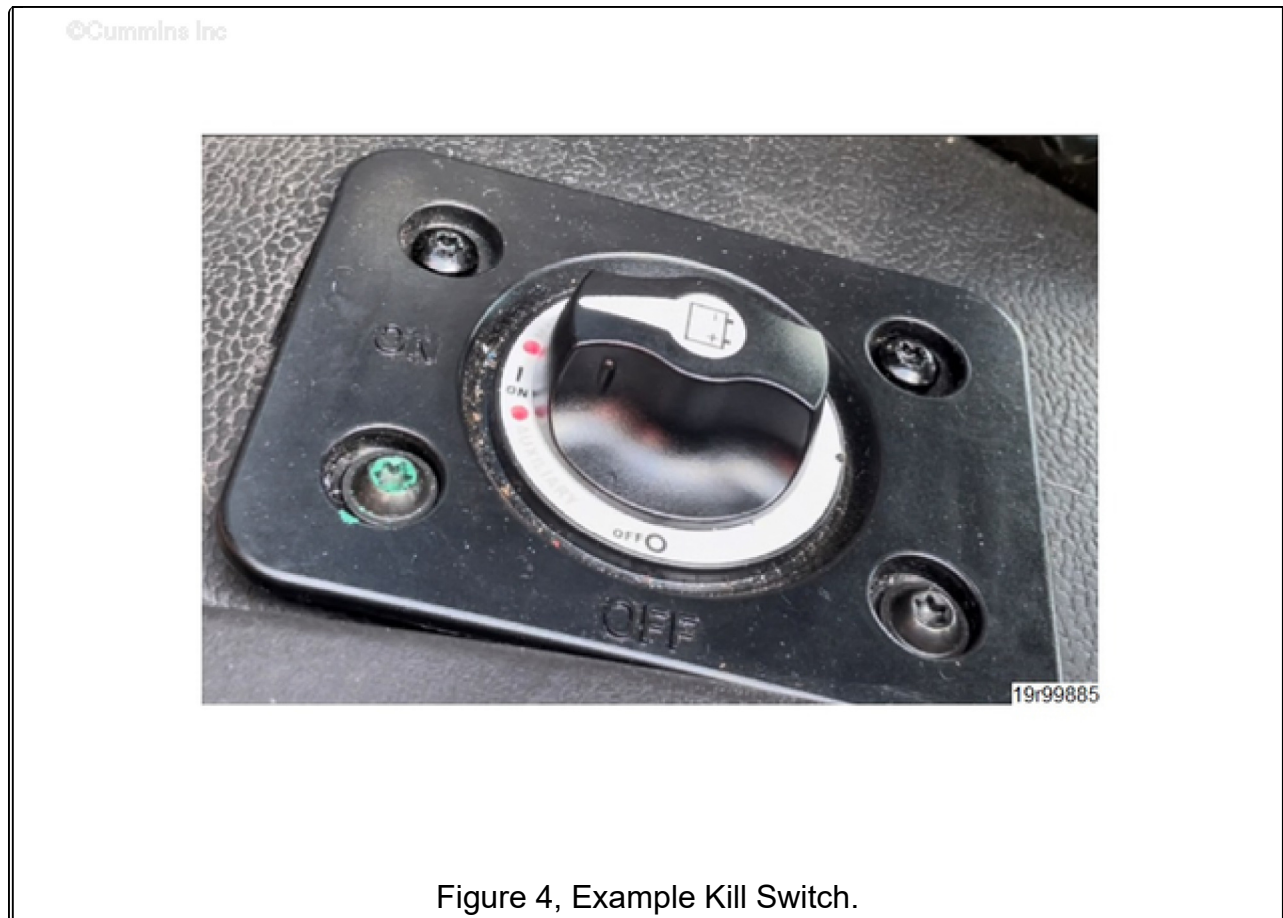
Figure 4, Example Kill Switch.

- a. Using an OEM Disconnect switch, sometimes referred to as a kill switch, E-Stop, etc., and/or **not** letting the ECM power down appropriately can cause a Fault Code 1117 indicating a premature power supply loss
 - The ECM continues to write data and work after engine key off and needs uninterrupted power for a set time to finish.

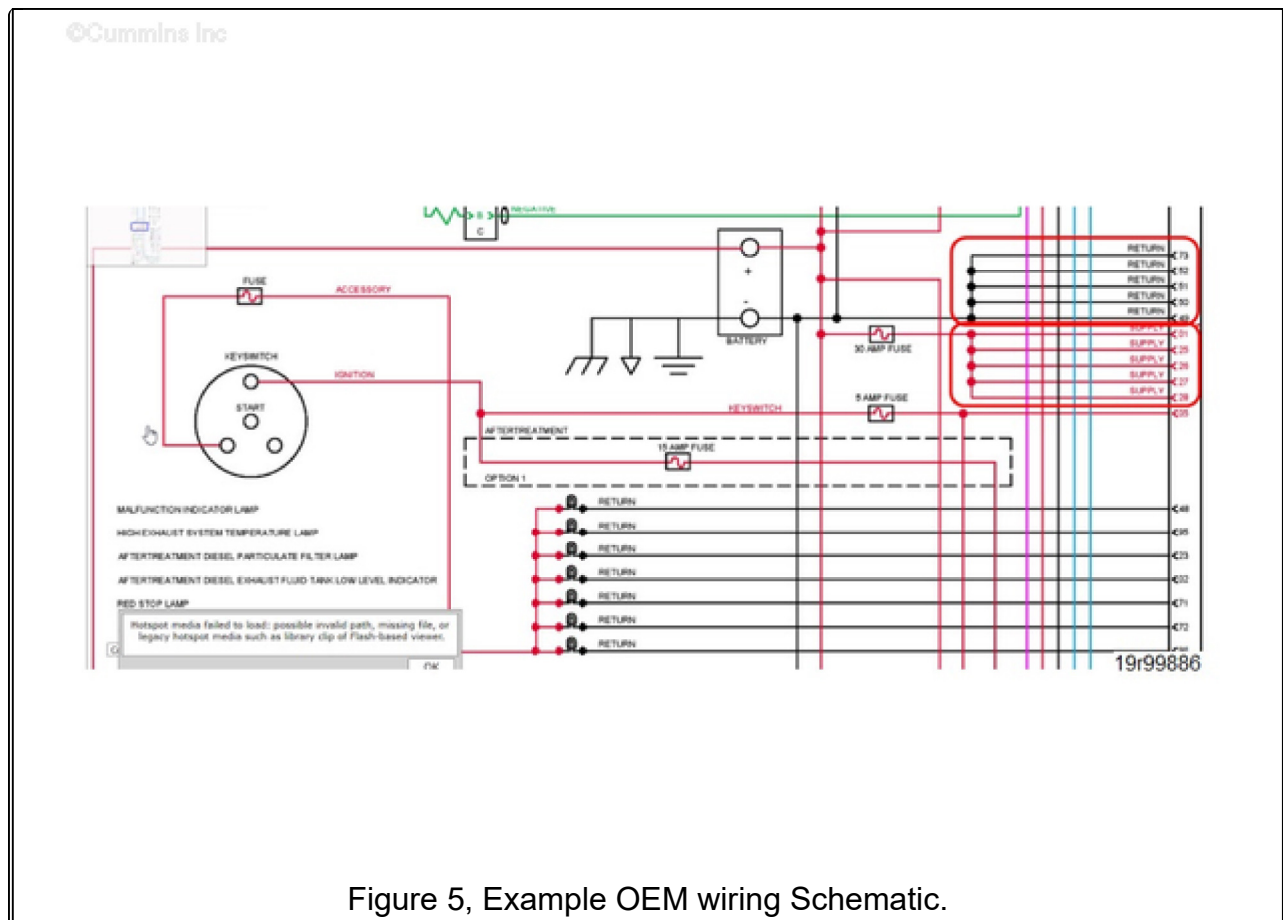
Figure 5, Example OEM wiring Schematic.

- Using a Power Distribution Module (PDM) can cause a premature power supply loss. Depending on application this may or may **not** be present. If present, A PDM is a module that can be used to control power on and off to a subset of the equipment or the whole engine.
- If the ECM Power wiring is connected through the starter to the battery a power supply loss could be detected by the ECM.

Note : CMI requires ECM power connected straight to battery from the ECM positive terminals on J2.

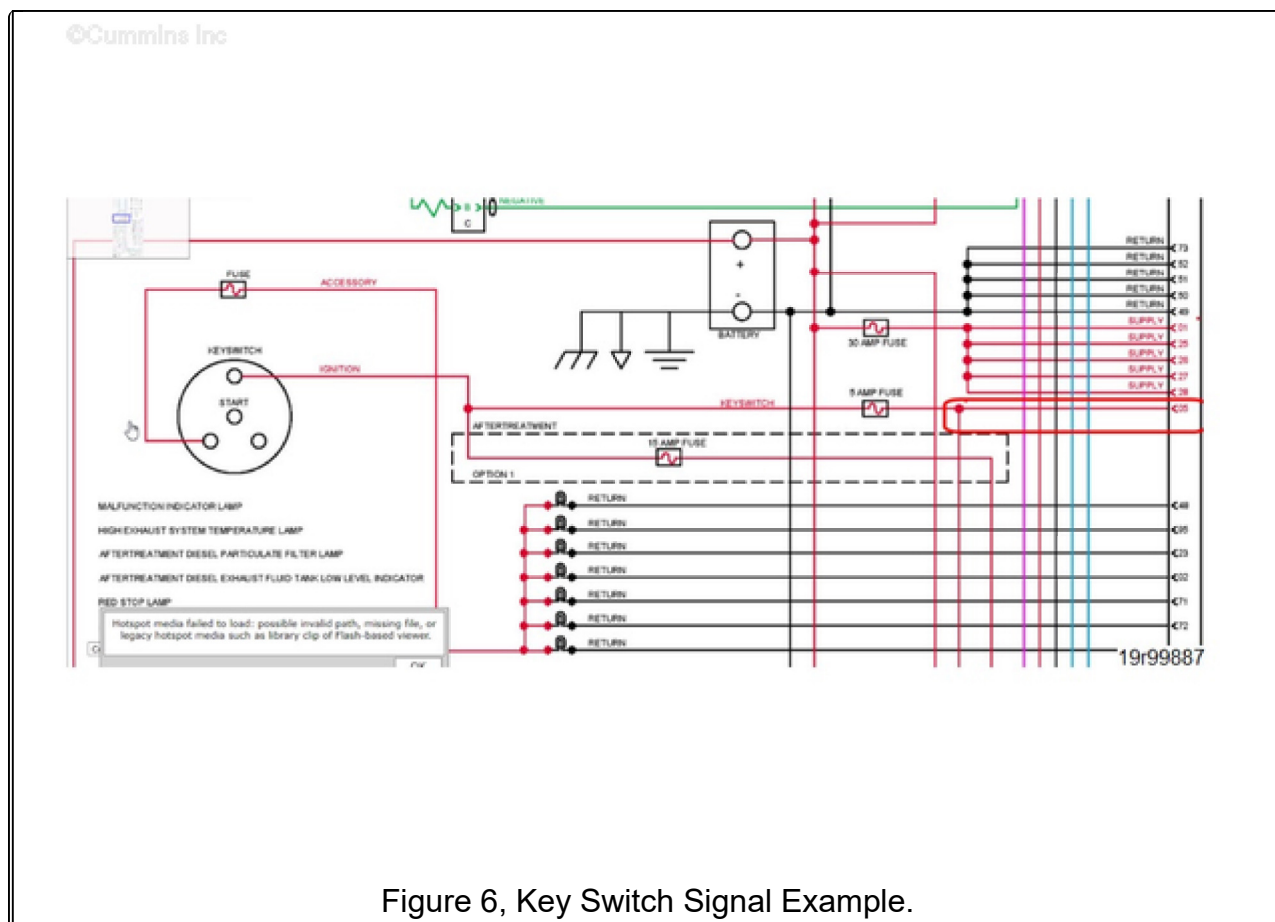
Figure 6, Key Switch Signal Example.

- Old or weak batteries weak batteries can cause a voltage drop at engine cranking events.
 - Indicators of a weak battery: long crank or hard start up; despite engine starting the voltage drop could cause Fault Code 1117.
- Loss of key switch signal or connection could cause voltage drops. Verify key switch hardware and or wiring is not loose. For the purpose of troubleshooting Fault Code 1117, the key switch of concern is the input signal from the OEM's physical key switch to the ECM J2 connector.
- Key switch signal should be uninterrupted without relays. Interruptions of the input signal could induce Fault Code 1117.

- If any connections are found to be incorrectly routed or in need of repair, contact OEM.
- For any malfunctions that are **not** covered under Cummins Inc. warranty, repair locations are to contact OEM for further repair direction.
