Technical product information

Topic	Water leaking from the mechanical water pump - Low coolant level warning displayed - W12 TSI
Market area	Russische Föderation (5RU),Australia E04 Bentley rest Asia and Australia (6E04),China 796 VW Import Comp. Ltd (Vico), Beijing (6796),Germany E02 Bentley rest Europe (6E02),Japan E03 Bentley Japan (6E03),Korea, (South) E08 Bentley South Korea (6E08),United Arab Emirates E06 Bentley Middle East and Africa (6E06),United Kingdom E01 Bentley UK (6E01),United States E05 Bentley USA and rest America (6E05)
Brand	Bentley
Transaction No.	2065919/3
Level	EH
Status	Approval
Release date

W12 Bentayga - New Continental GT/GTC - New Flying Spur

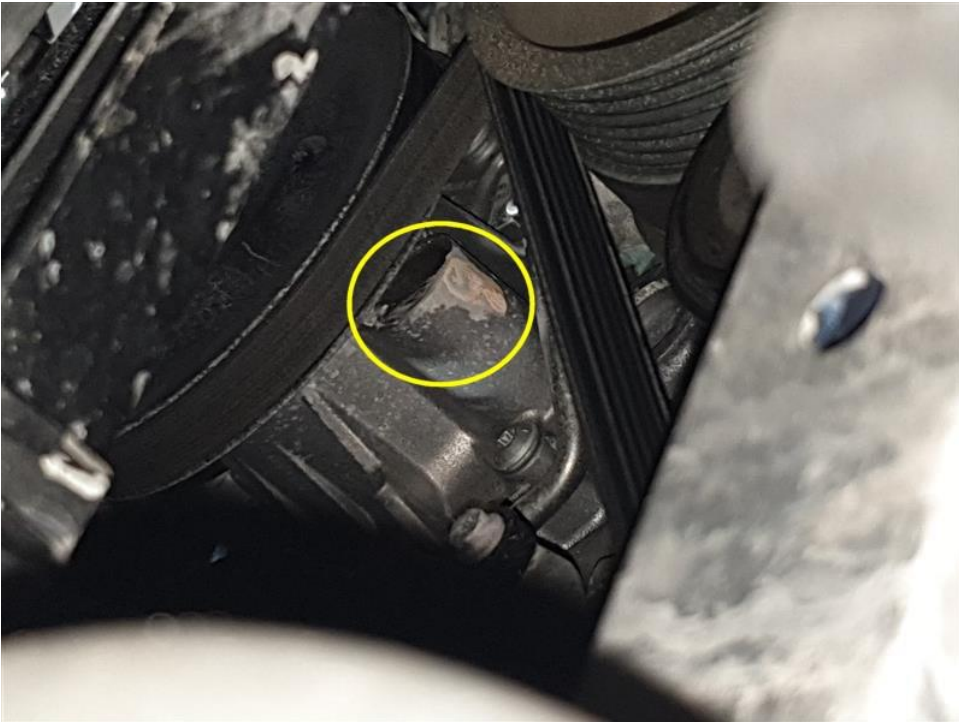
Figure 1

Refer to the video located within the Bentley Hub reference TPI 2065919/- this video shows an example of a coolant pump with no leak although there is a small coolant witness mark evident (Figure 1) in this scenario the coolant witness mark should be cleaned off (using a suitable cleaning agent) to the condition shown in Figure 2

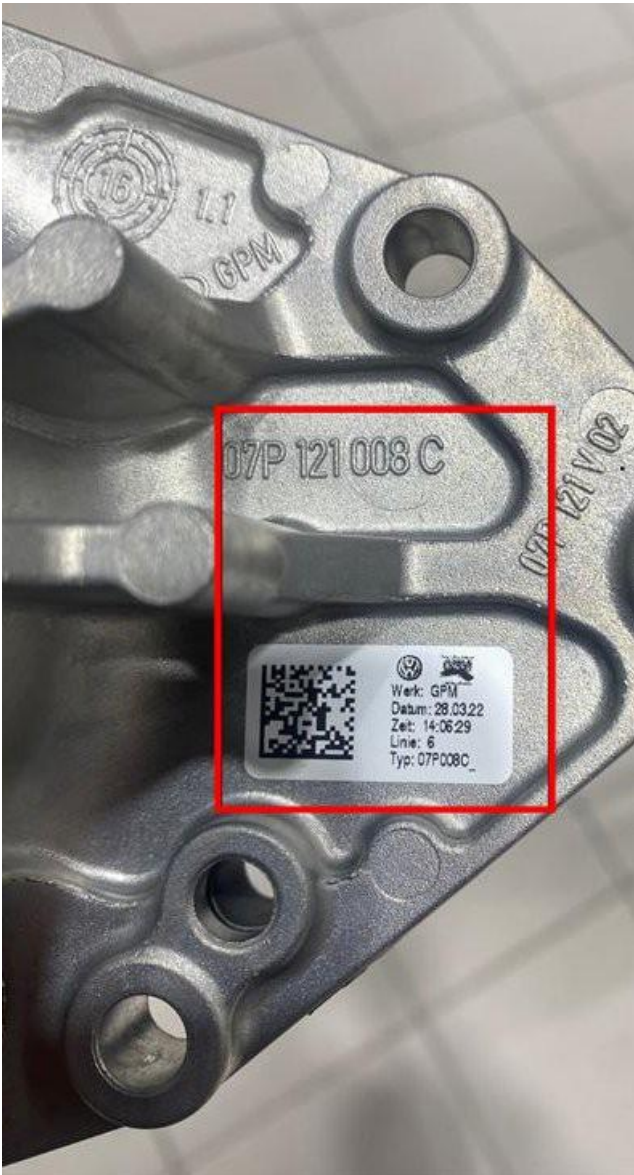
- The operative must raise a technical DISS query or respond via an already open DISS query ensuring the following is attached to the DISS query:
- Clear photo of the coolant level
- Clear photo of the mechanical coolant pump part number 07P 121 008C (Figure 3)
- Current ODISlog

NOTE: the photo shown in Figure 3 is of a C level coolant pump removed from the vehicle for photographic purposes only a borescope may have to be used for photos of the coolant pump fitted

- Record a clear video of the coolant leak whilst carrying out the pressure test
- Request permission to replace the mechanical coolant pump 07P 121 008C due to a leak from the mechanical coolant pump whilst conducting the pressure test

5) Once permission has been given via the technical DISS query, replace the mechanical coolant pump - Refer to Rep.Gr 19
