Technical product information

Bentayga

Incorrect display option for the 'Customizer button' within the MMI

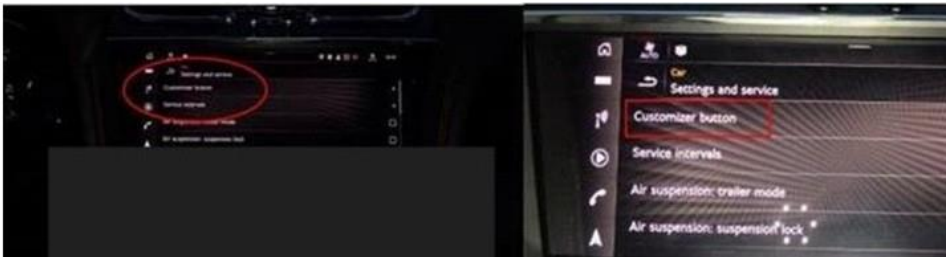
Figure 1

Incorrect menu item (Customizer button) displayed within the MMI.

The MMI incorrectly shows the "Customizer button" option (Figure 1)

In the event the issue is evident as described, the operative should conduct the instructions within the Measure section to update Diagnostic address 5F - control unit 1 for information electronics (J794)

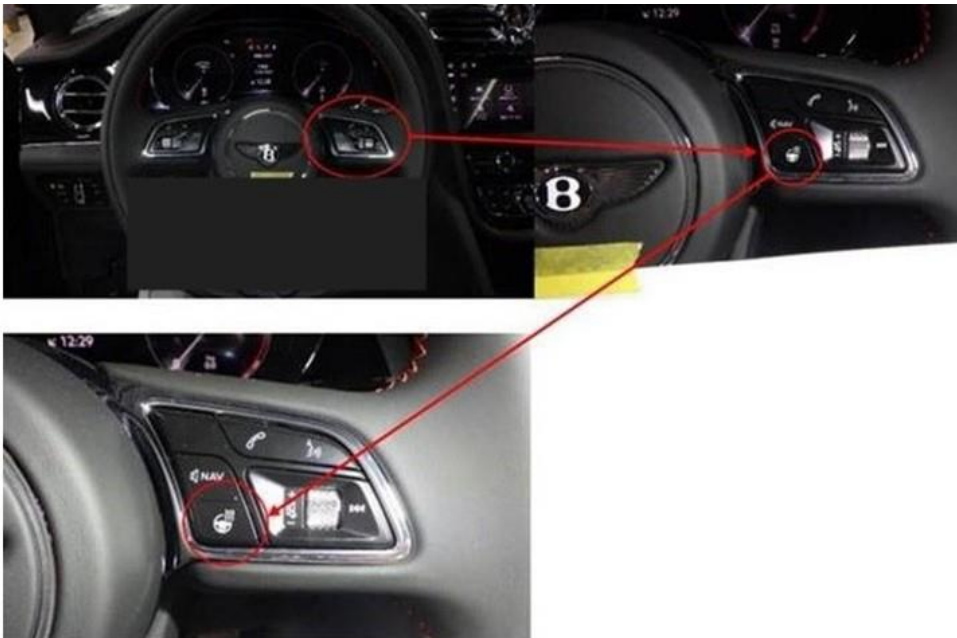
Important note: Only leather- wrapped steering wheels with multi-function - 3 spoke heated Mono-tone indented hide (With PR code 2PD) as shown in Figure 2 are affected
