**SIB 52 19 19**

**SECOND ROW 60/40 PASSENGERS SIDE SEAT INTERMITTENTLY WON'T LATCH**

This Service Information Bulletin (Revision 2) replaces SI B52 19 19 **dated August 2019**.

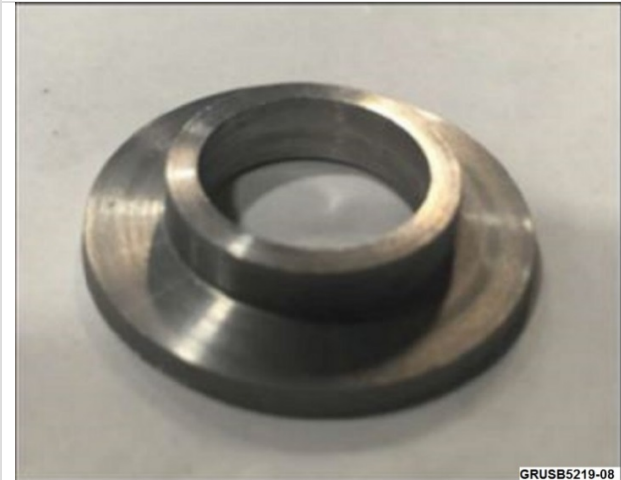
<p>As of CW40 production, one machined washer (shown) will be added to the bottom of the inner seat rail on the passenger's side (right rear) of the 60/40 split 2<sup>nd</sup> row seat.</p>
--	---

For vehicles with this specific complaint that were produced from June 24, 2019 thru October 1, 2019, a comparable correction is to add a single 2mm thick flat washer in this location.

- 2 mm thickness
- 15 mm inner diameter hole for the bolt fitment
- Outside diameter must be at least 30 mm
- Recommended basic surface coating for rust protection

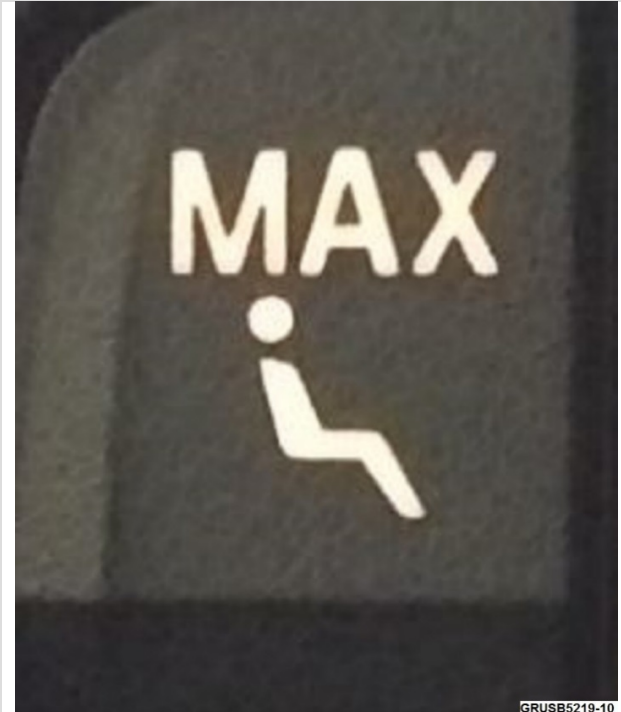
<p>A quick test to see if they are initialized (if equipped with third row power seats) is-</p> <ul style="list-style-type: none"> <li>• Access the rear switches in the D pillar area</li> <li>• Push the button for maximum cargo space</li> </ul>

<ul style="list-style-type: none"> <li>• Alternatively, push this button for maximum seating.</li> <li>• Intended result: All 2<sup>nd</sup> and 3<sup>rd</sup> row seats should move</li> </ul>

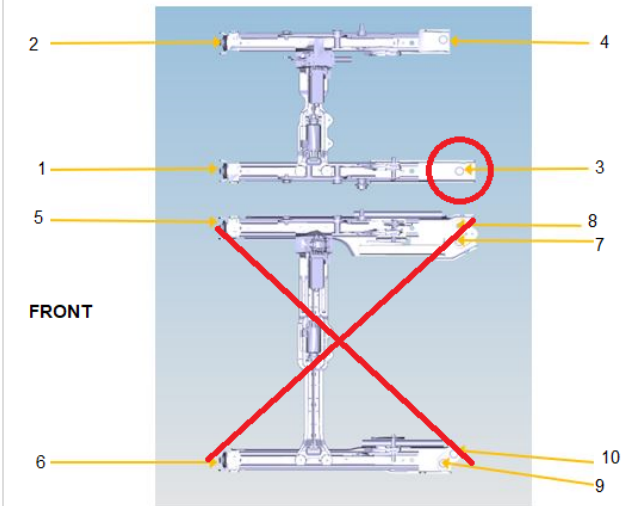
Note: Only install the 1 washer at the specified location 2 (circled).

- Locations 5 thru 10 pertain to the 60% 2<sup>nd</sup> row seat which is not affected by this repair.

5. Install 1 flat 2 mm thick washer under rear of inner rail of the 40% structure.

Washer is installed between the floor of vehicle and the rear of the inner seat rail.

- Only install a washer at the specified location
- Seat must **\*NOT\*** be in Easy Entry position during the fastener torquing
- Seat must **\*NOT\*** be fully forward when torquing the fasteners
