SIB 61 03 22

SERVICE ACTION: CHECK WIRING HARNESS CONNECTORS

2022-09-20

Model	Model Description	Production Date
K50	R 1250 GS	Apr. 21 – May 23, 2022
K51	R 1250 GS Adventure	Apr. 29 – May 23, 2022

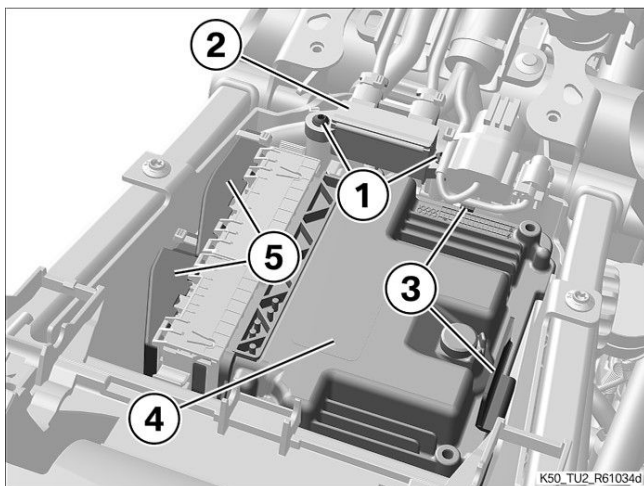
Wiring harnesses installed during assembly with individual pins, in both the large and small connections to the engine control unit (DME), were not manufactured correctly. This may cause faults in the engine control unit and subsequent engine run in emergency mode.

Engine control unit (DME) (4)

Connectors (5)

Both DME connectors for the main wiring harness and for the engine wiring harness will be checked.

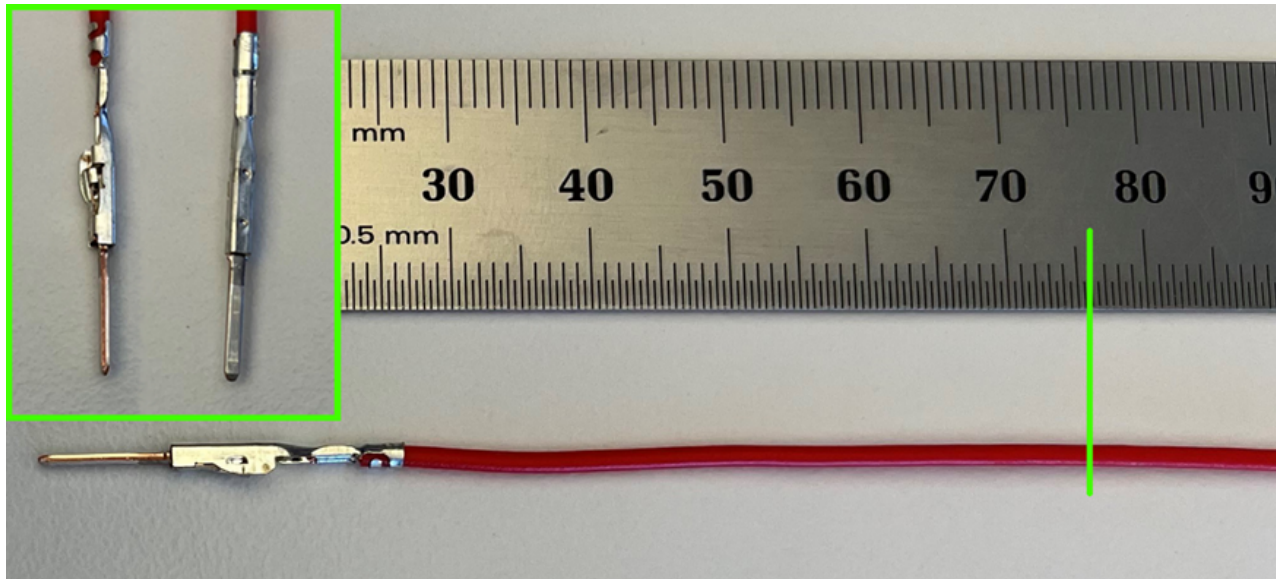
Hold the provided test pin with 2 fingers on the cable **approximately 3 inches (76 mm)** from the end of the pin. Make sure the **blade of the pin lines up with the Female side terminal** and gently put the test pin into terminal to verify the condition of the terminal.

A **Good** terminal is when inserting the test pin into the terminal the pin stops and will not enter into the terminal without forcing it past the resistance/stop felt.

A **Defective** terminal is when inserting the test pin into the terminal without using any force to move past the natural resistance/stop of the terminal to the pin connection. Once a defective terminal/s is detected, it needs to be marked on the attached "Pin Record Sheet"..

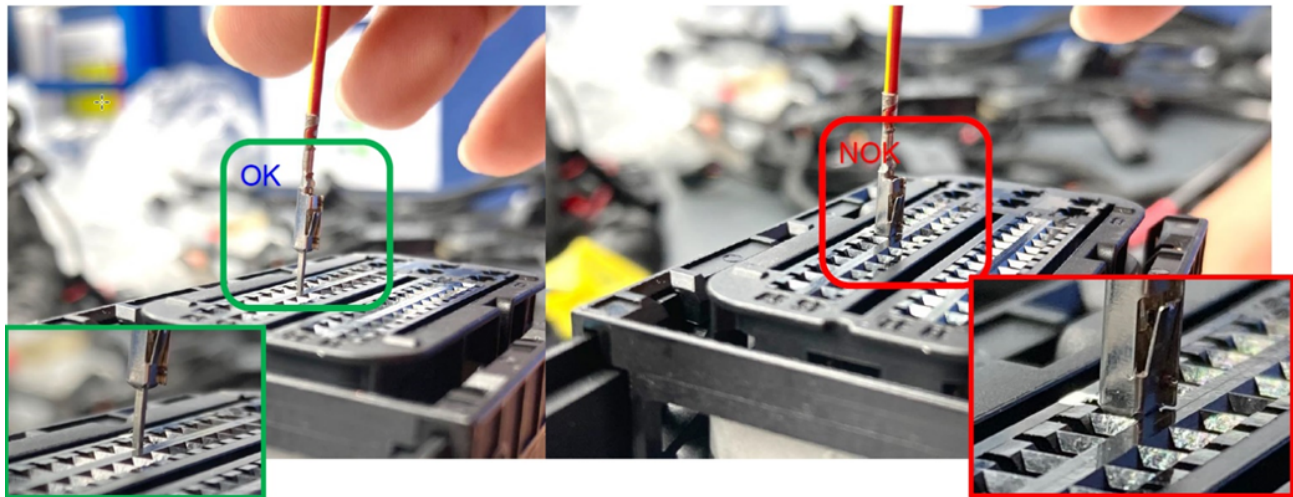
Do not use force!

Do not push the pin inside! If you feel any resistance STOP!

If a defective terminal (**NOT OK (NOK)**) is detected, please contact the Technical Support Via TSARA case with the Pin Record Sheet Attached to determine the required repair method.

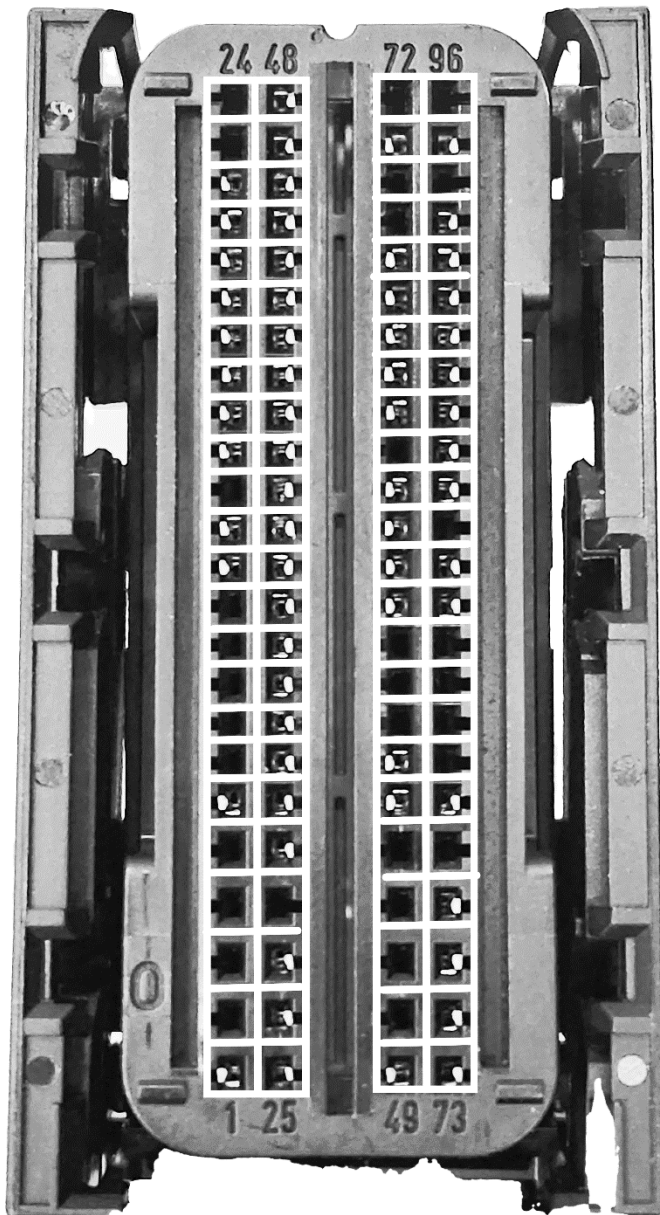
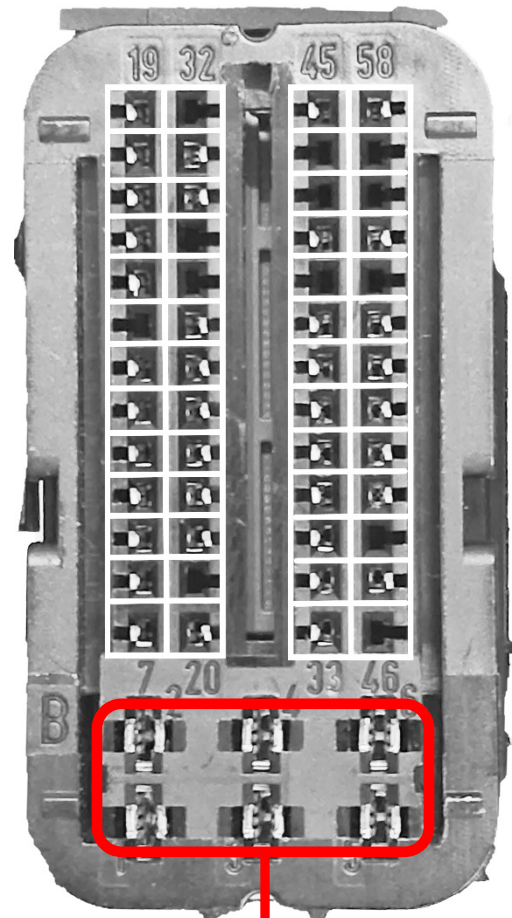
Use a permanent marker to fill in any pin that does not pass the pin testing procedure.

**Do not test
these big pins**

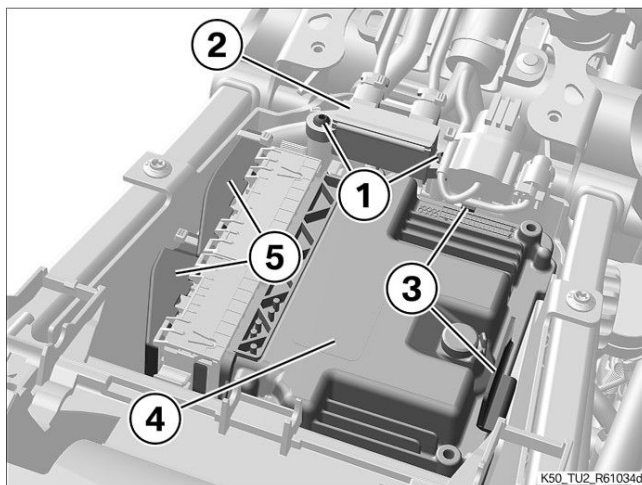
Wiring harnesses installed during assembly with individual pins, in both the large and small connections to the engine control unit (DME), were not manufactured correctly. This may cause faults in the engine control unit and subsequent engine run in emergency mode.

Engine control unit (DME) (4)

Connectors (5)

Both DME connectors for the main wiring harness and for the engine wiring harness will be checked.

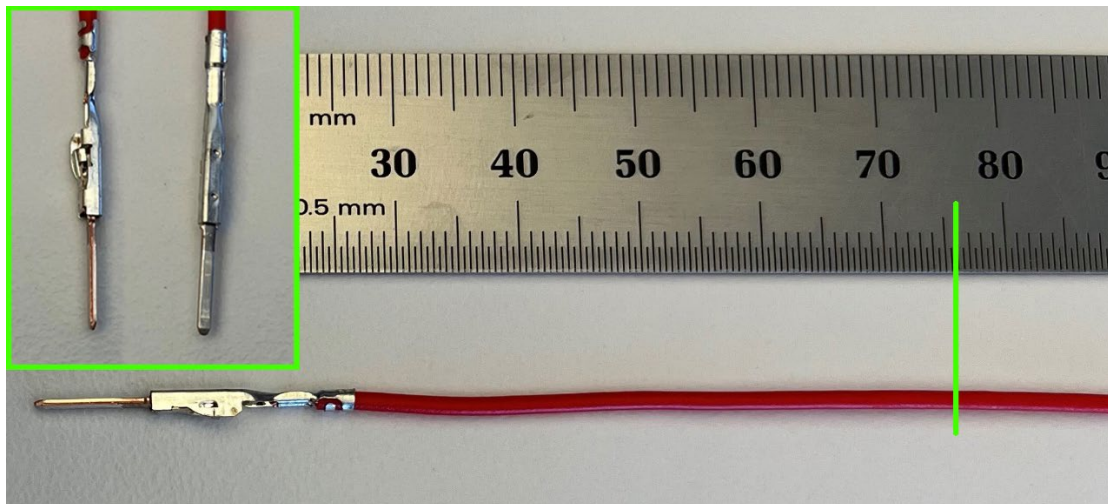
Hold the provided test pin with 2 fingers on the cable **approximately 3 inches (76 mm)** from the end of the pin. Make sure the **blade of the pin lines up with the Female side terminal** and gently put the test pin into terminal to verify the condition of the terminal.

A **Good** terminal is when inserting the test pin into the terminal the pin stops and will not enter into the terminal without forcing it past the resistance/stop felt.

A **Defective** terminal is when inserting the test pin into the terminal without using any force to move past the natural resistance/stop of the terminal to the pin connection. Once a defective terminal/s is detected, it needs to be marked on the attached “Pin Record Sheet”..

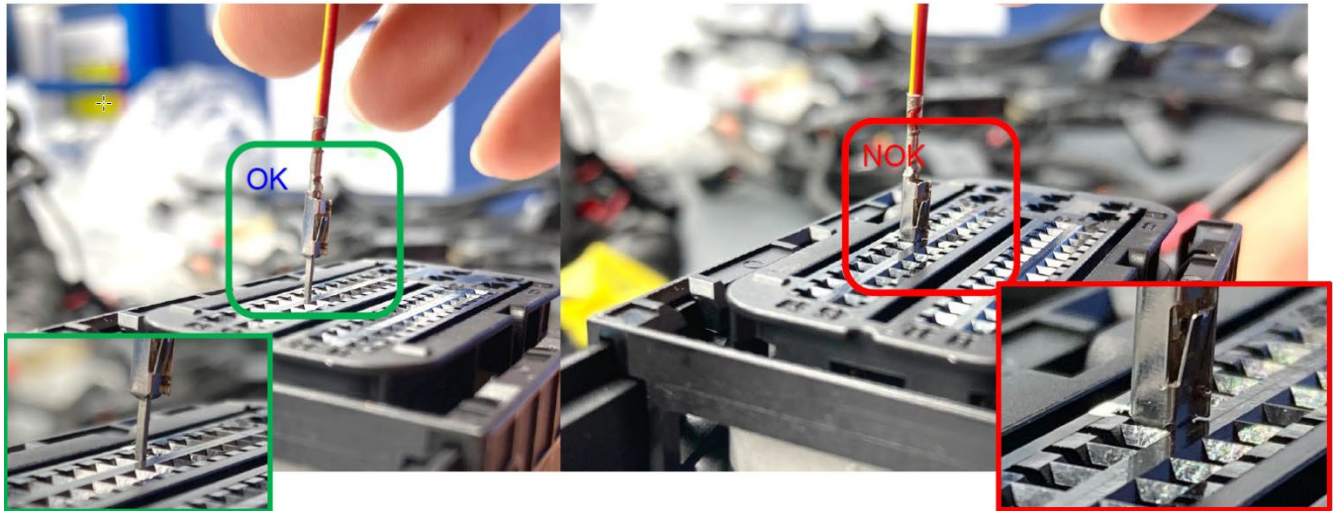
Do not use force!

Do not push the pin inside! If you feel any resistance STOP!

If a defective terminal (**NOT OK (NOK)**) is detected, please contact the Technical Support Via TSARA case with the Pin Record Sheet Attached to determine the required repair method.
