TECHNICAL SERVICE BULLETIN

22-2380

6.7L - Chassis Cab/Dual Rear Wheel (DRW) Pickup Only - Oil Consumption Under Extended Idle Conditions

27 October 2022

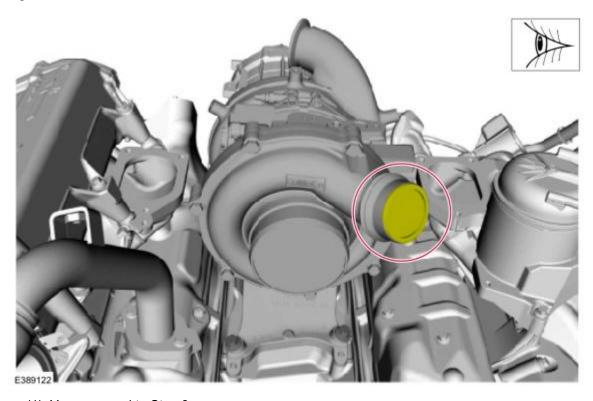
- **1.** Remove the charge air pipe that connects the turbocharger compressor outlet to the charge air cooler. Refer to Workshop Manual (WSM), Section 303-12.
- 2. Inspect the turbocharger compressor outlet. Is there oil on the compressor outlet of the turbocharger? (Figure 1) Figure 1

- (1). Yes proceed to Step 3.
- (2). No turbocharger inspection is complete, proceed to Step 12.
- 3. Clean any oil from the compressor outlet and charge air cooler.
- **4.** Remove the air cleaner outlet pipe that connects the air box to the turbocharger. Refer to WSM, Section 303-12.
- **5.** Look through the lower intake manifold tube and inspect the turbocharger compressor wheel for damage. (Figure 2)

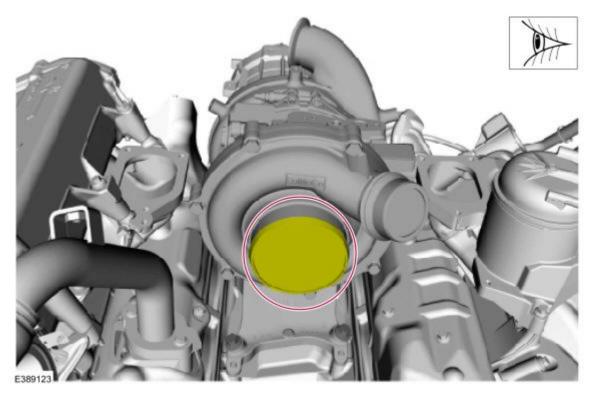
Figure 2

NOTE: Do not attempt to wiggle or push up and down on the compressor wheel. Evidence of oil in the compressor outlet, outlet hose or charge air cooler (CAC) is not a reason for turbocharger replacement. Correcting the crankcase pressure will prevent oil from being pushed past the turbocharger rings (seals) and into the turbo housing, outlet hose, exhaust system, and CAC.

- 6. Is the turbocharger compressor wheel damaged?
 - (1). Yes replace the turbocharger. Refer to WSM, Section 303-04. Turbocharger repair is complete, proceed to Step 12.
 - (2). No proceed to Step 7.
- 7. Reinstall the air cleaner outlet pipe, refer to WSM section 303-12.
- 8. Drive the vehicle until the engine reaches normal operating temperature.
- 9. Perform a manual regeneration.
