TECHNICAL SERVICE BULLETIN

Water Leak From The A-Pillars, Overhead Console/Upfitter Switches And/Or Sun Visors

22-2403

Ford 2021-2022 Bronco

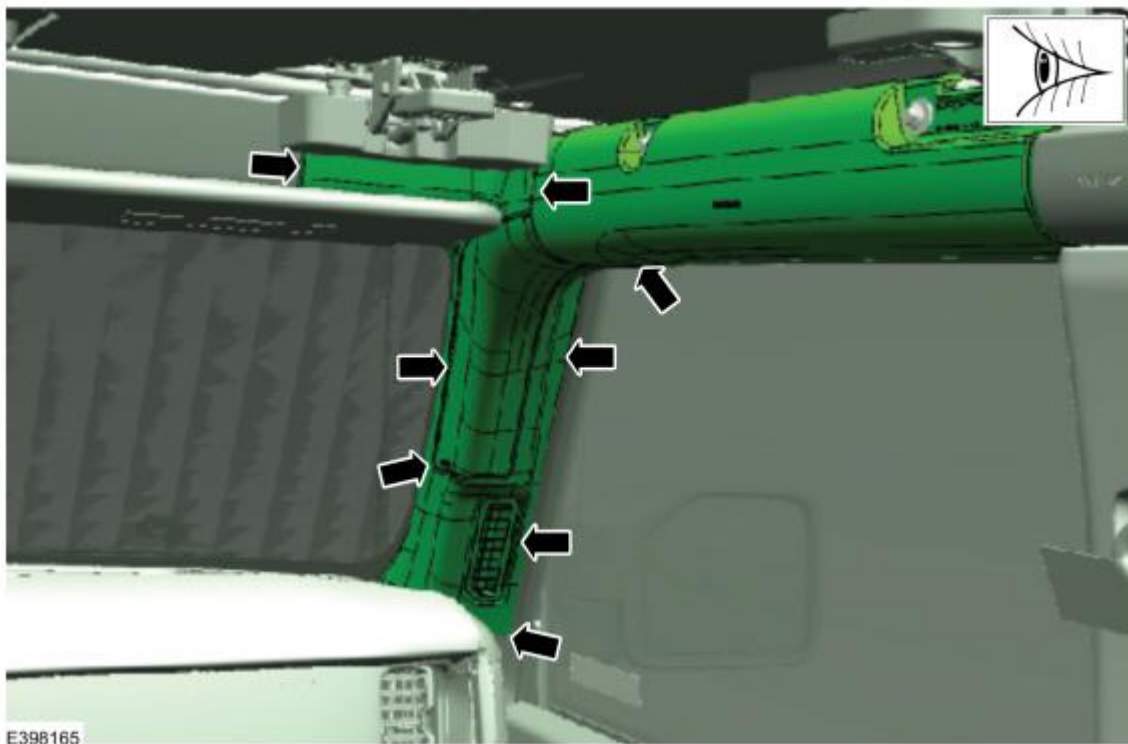
1. Does the vehicle exhibit a water leak from any of the locations shown in Figure 1 and Figure 2?

Figure 1 - Right side A-pillar shown, left side similar

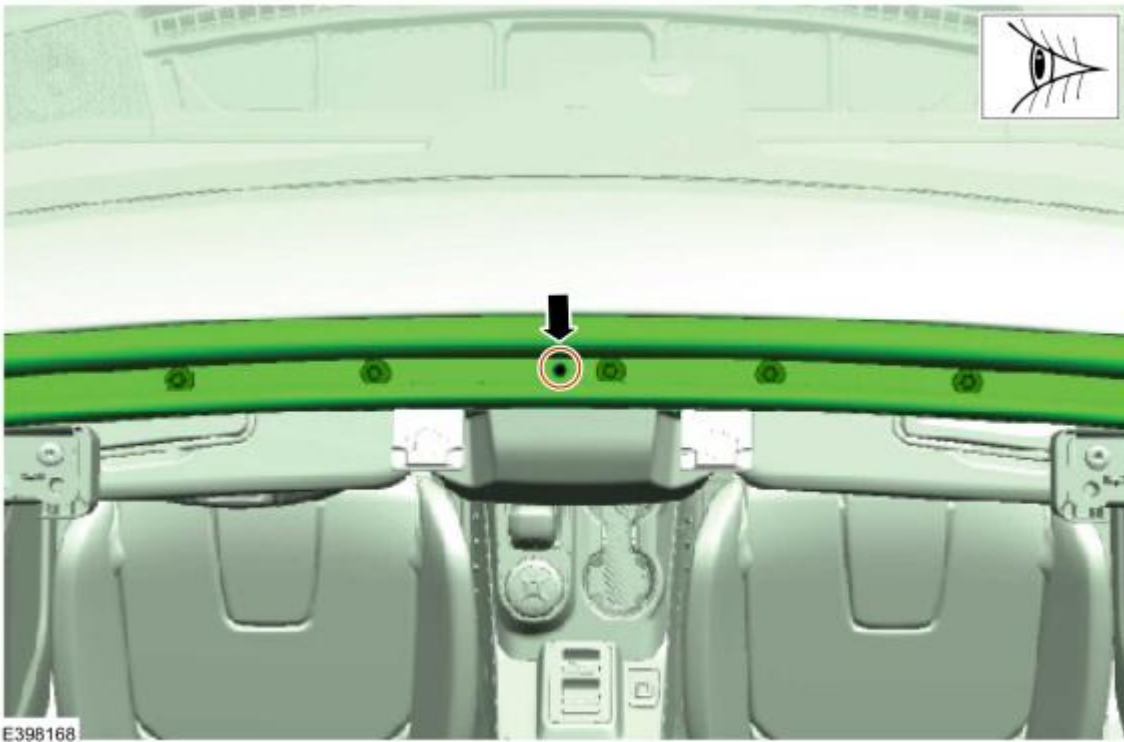
Figure 4

5. Inspect the header seal locator pin which can be found to the left of the middle header seal bolt. Is the locator pin missing, broken and/or damaged? (Figure 4)

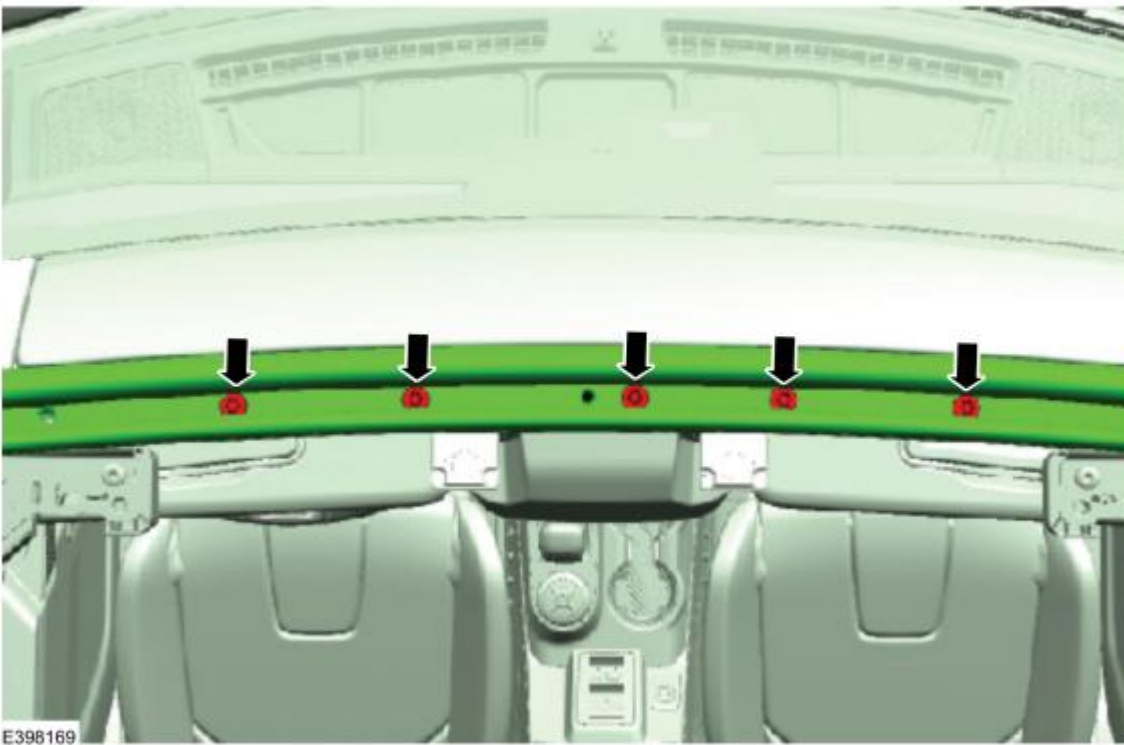
Figure 5

6. Inspect the five fasteners that secure the header seal to the body. Make sure these are tightened to 9 Nm (80 lb-in). The nuts that receive these bolts are not welded to the body will free spin with the bolt if they are loose. If a bolt spins freely during this check, temporarily remove the windshield header trim panel to gain access. Refer to Workshop Manual (WSM), Section 501-05. (Figure 5)

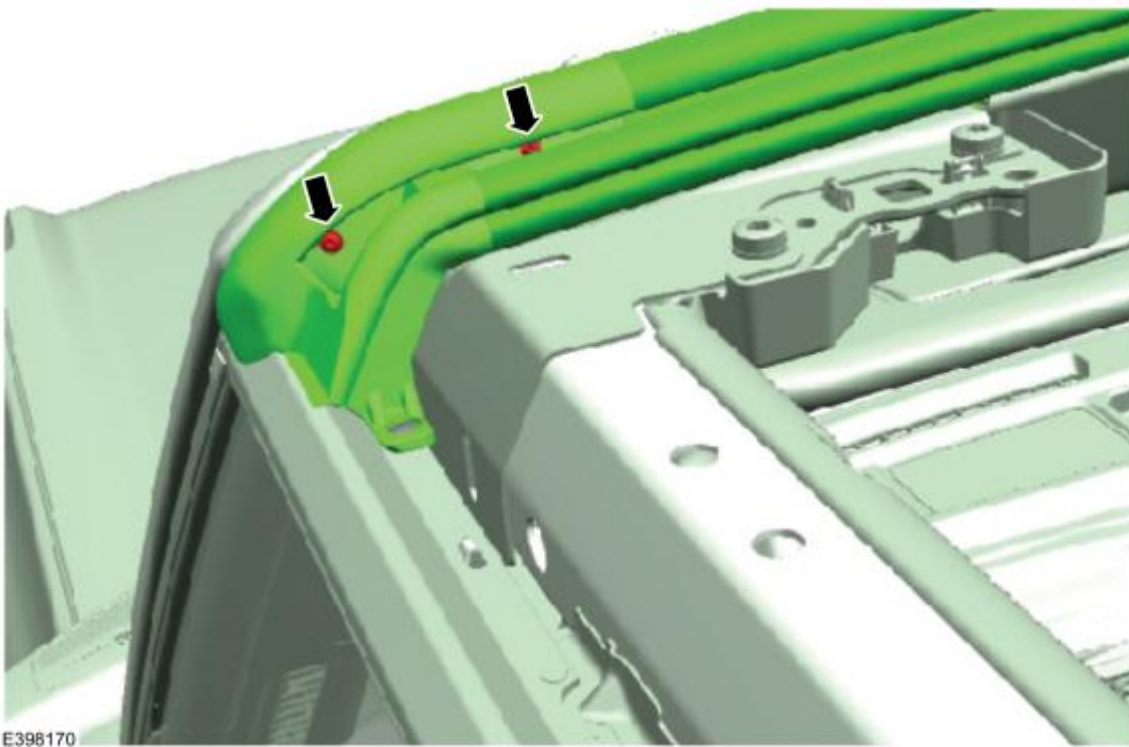
7. Inspect the 2 small bolts on both corners of the header seal. Make sure these are tightened to 3 Nm (26 lb-in). (Figure 6)

Figure 6 - Left side shown, right side similar

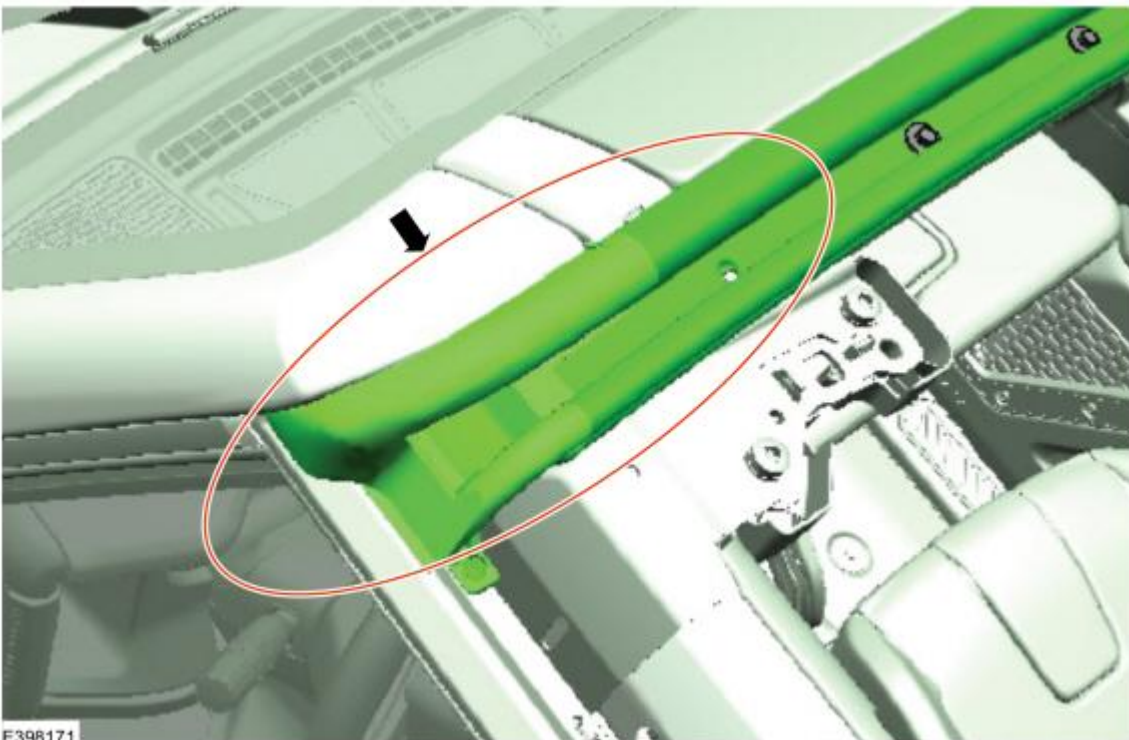
Figure 7 - Left side shown, right side similar

8. By hand, firmly massage the header seal in the areas shown in Figure 7. The header seal has butyl located throughout this area. Firmly pressing down while massaging the header seal will make sure the butyl is properly adhered to the body creating a water-tight seal which is required to prevent leaks.

24. By hand, firmly massage the header seal in the areas shown in Figure 7 and any other areas where strip-calk was added. The header seal has adhesive located throughout these areas. Firmly pressing down while massaging the header seal will make sure the butyl is properly adhered to the body creating a water-tight seal.

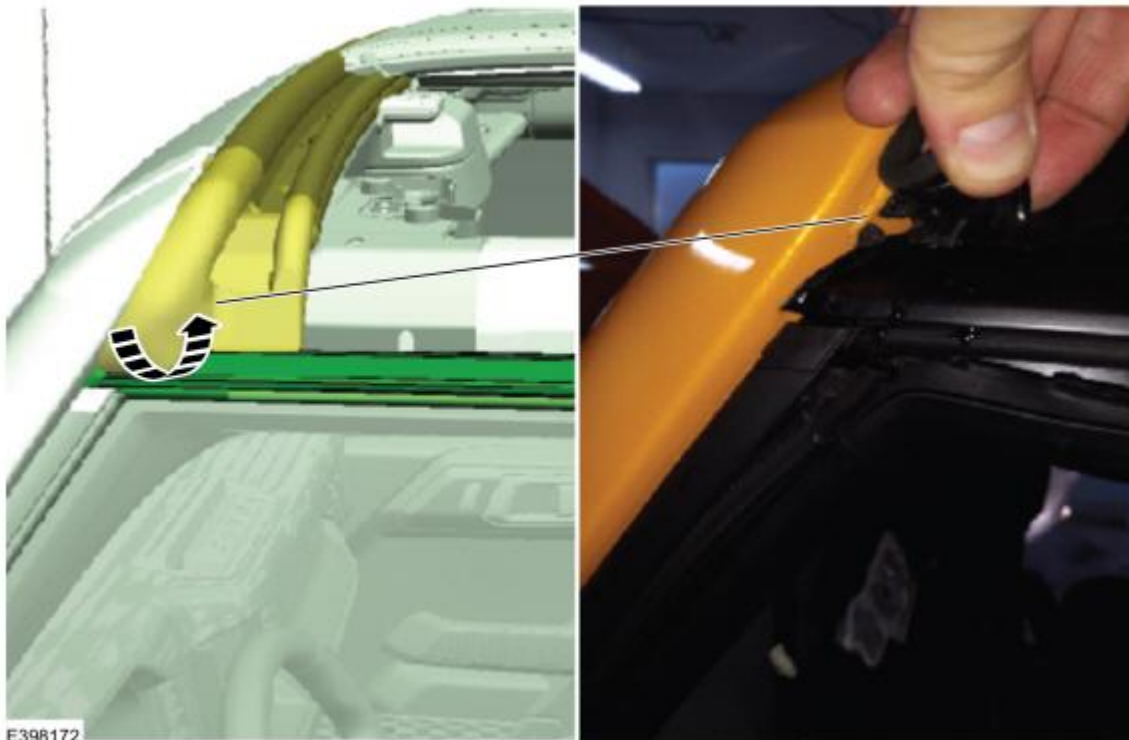
Figure 8 - Left side shown, right side similar

9. Reseal the header seal edge to the body. (Figure 8)

- (1). Gain access to the front header seal edge by gently pulling back on the corner.
- (2). Inspect for the presence of a clear plastic circular sticker attached to the body. The sticker may only be partially visible. If this sticker is present, use needle nose pliers to completely remove it.
- (3). Insert a marble-sized ball of 3M™ Strip-Calk into the gap between the rubber header seal and the body. Return the header seal corner flap to its natural position then Firmly massage the seal in this area (pushing on the

seal, onto the body) to be sure it is formed correctly, creating a water-tight seal. When complete, there should not be any visible strip-calk outside of the seal.

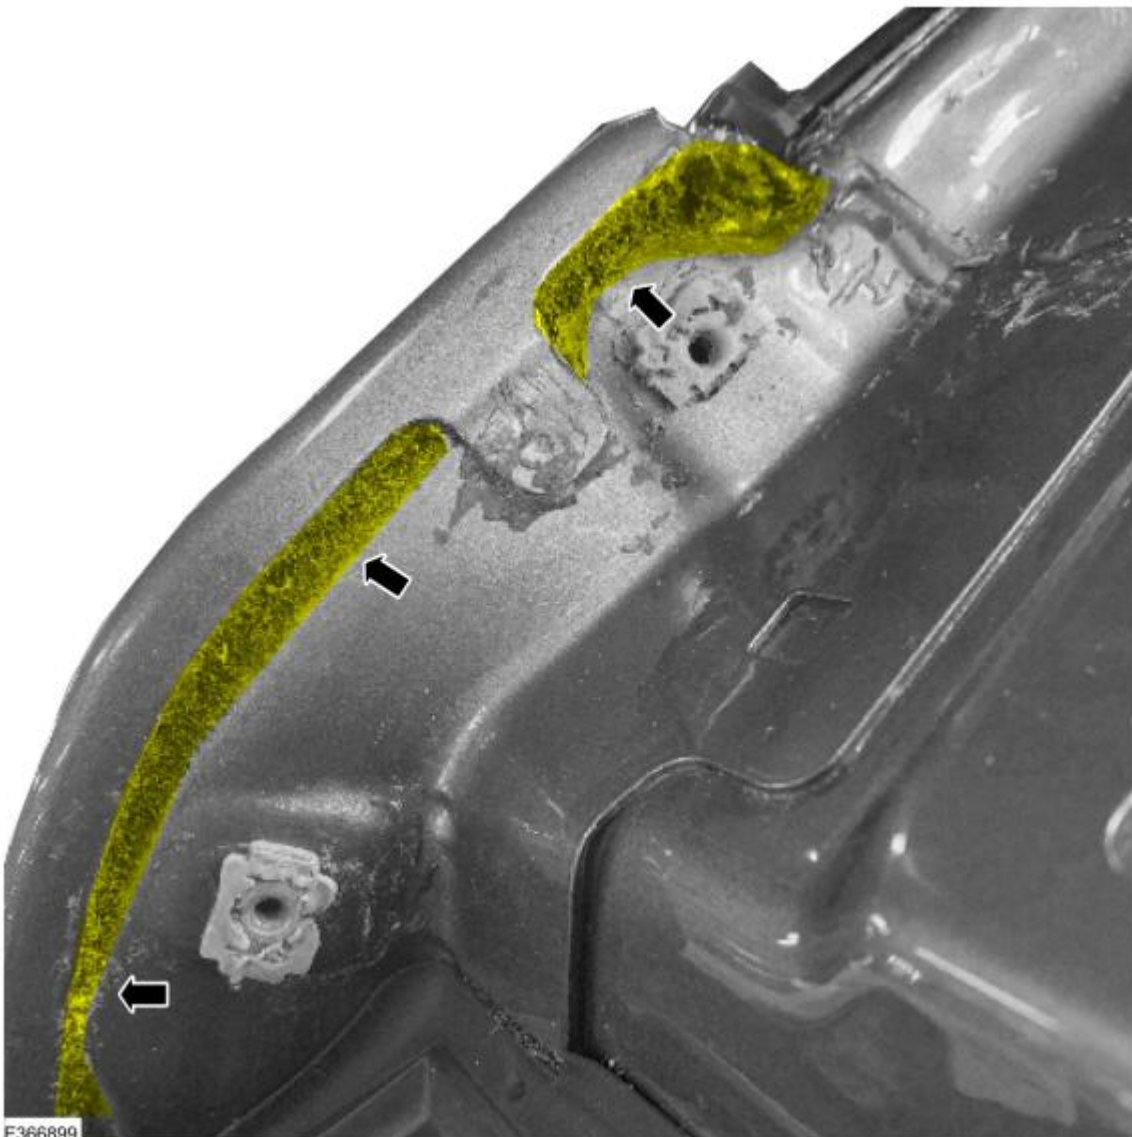
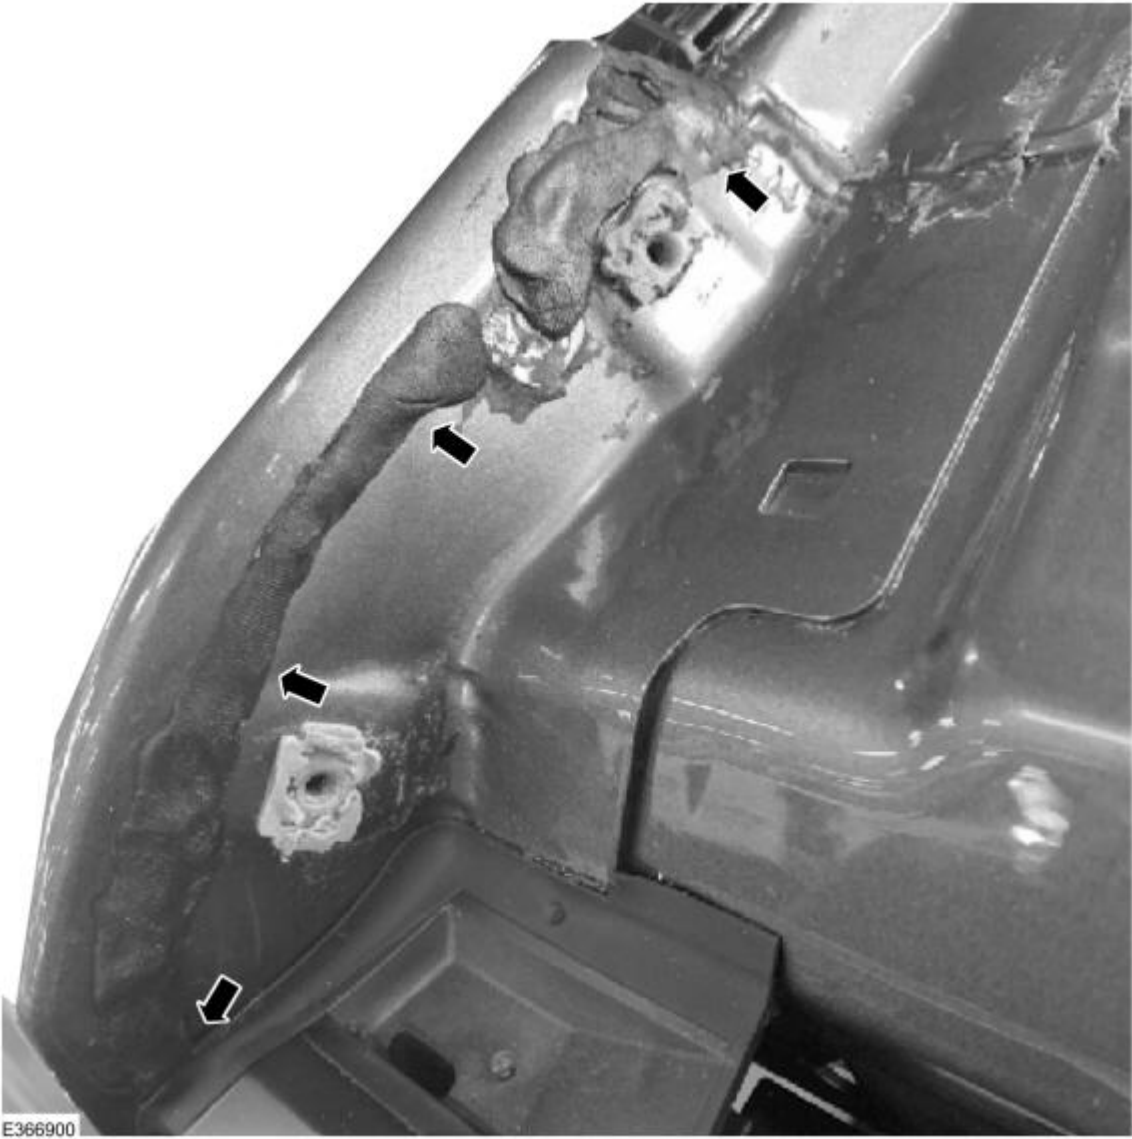
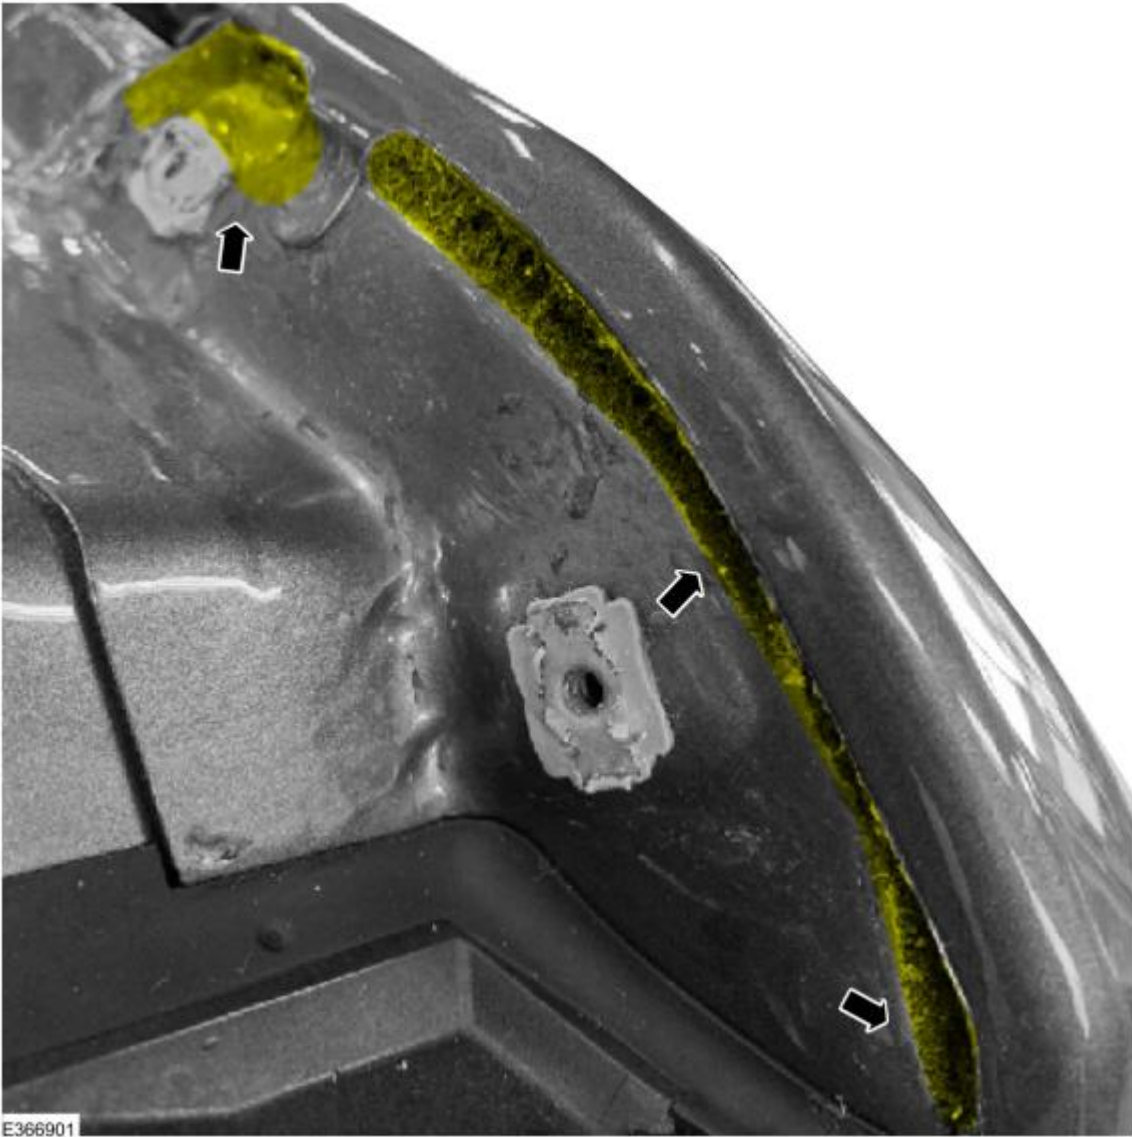
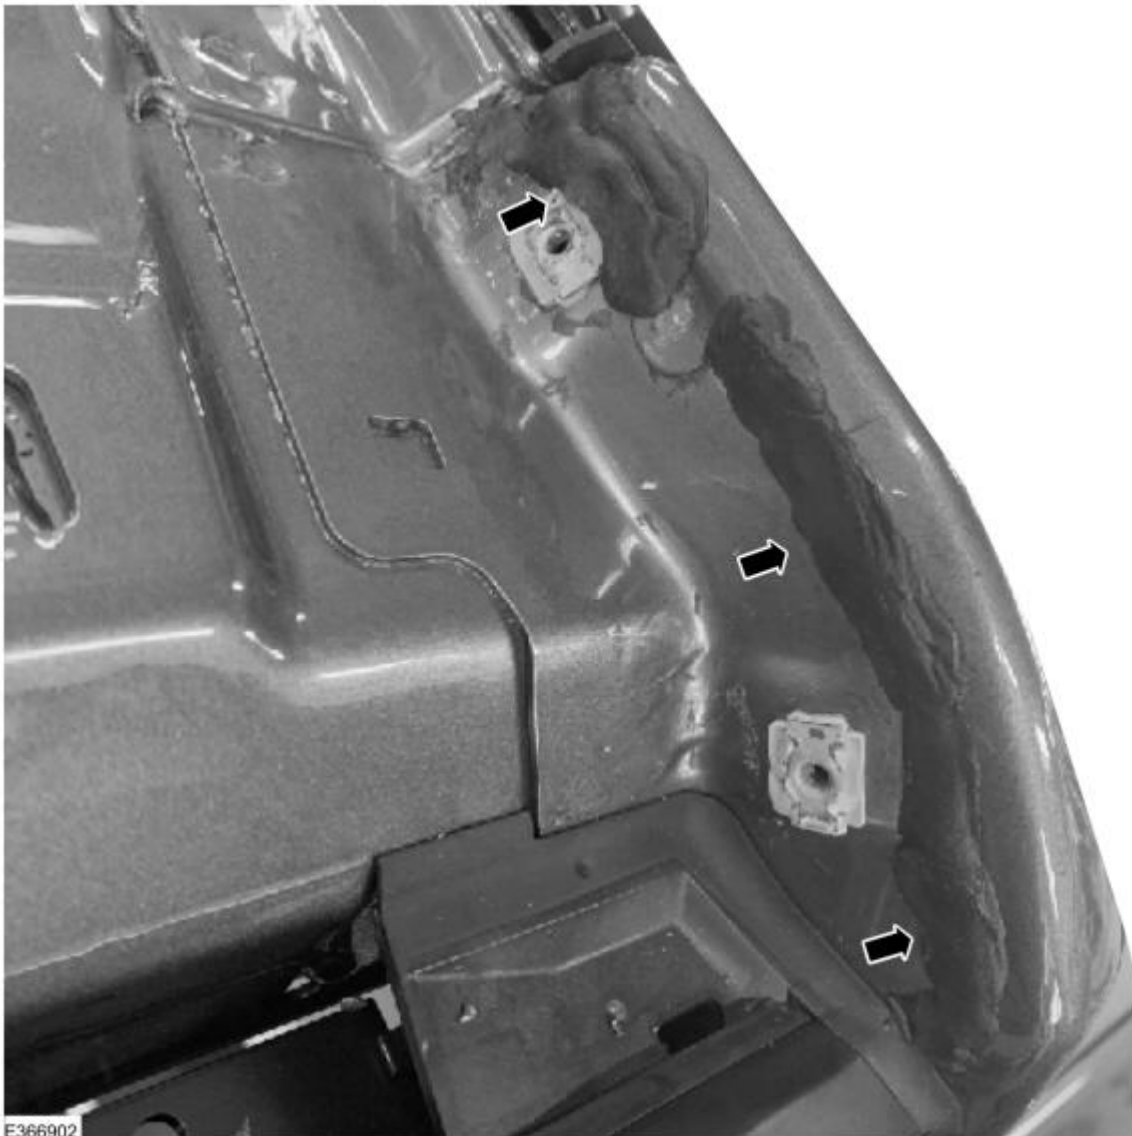
Figure 14 - Left side shown before application

Figure 15 - Left side shown, after application

Figure 16 - Right side shown, before application

Figure 17 - Right side shown, after application

19. Apply 3M™ Strip-Calk to the exposed body seams starting at the roof rack trim cover area and ending at the corner seal where the body seam ends. Do not leave a gap between the edge of the caulk and the corner seal. (Figures 14-17)
