Technical Service Bulletin

13 Starter/generator drive belt is noisy or came off, DTC P2BA300 may be stored in the ECM

20 22 50 2061461/5 October 27, 2022. Supersedes Technical Service Bulletin Group 13 number 21-15 dated July 14, 2021, for reasons listed below.

Model(s)	Year	VIN Range	Vehicle-Specific Equipment
A6	2019 – 2021	All	2.0 TFSI
A4, A4 allroad, A5 Cabriolet, A5 Sportback, Q5, and Q5 Sportback	2021

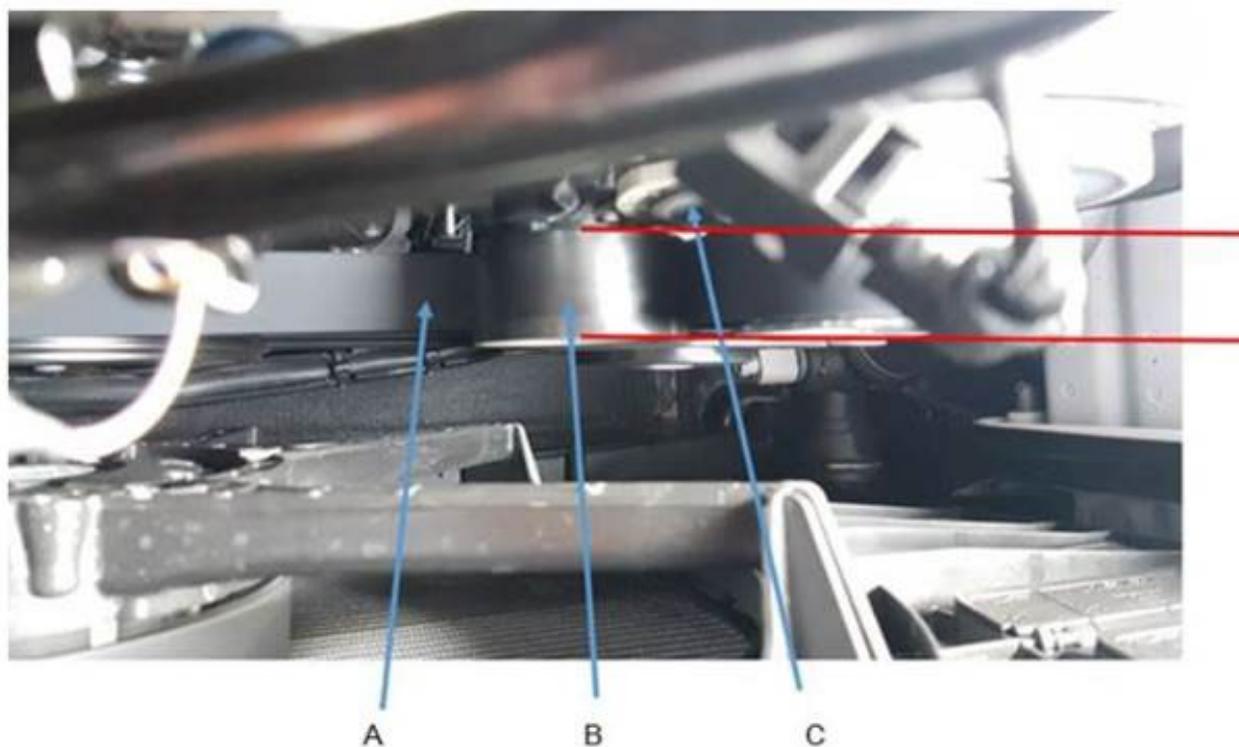
Deviation on the rollers of the belt tensioner.

1. Run the engine at idle speed.
2. The belt must not protrude forward or backward over the roller edge of the tensioner (Figure 2, red marks).

Figure 2. Check to ensure that the poly V-belt is not protruding in either direction.

1. Replace the belt tensioner and poly V-belt. **If a new belt tensioner has already been installed, do not replace it again.**

Check for correct belt running alignment after poly V-belt and tensioner replacement as follows:
