Service Bulletin

Bulletin No.: 22-NA-028

Subject: Whining/Whirring, Whistle, Squeaking, Groaning/Growling Noise Coming from Front Wheel/Engine Area

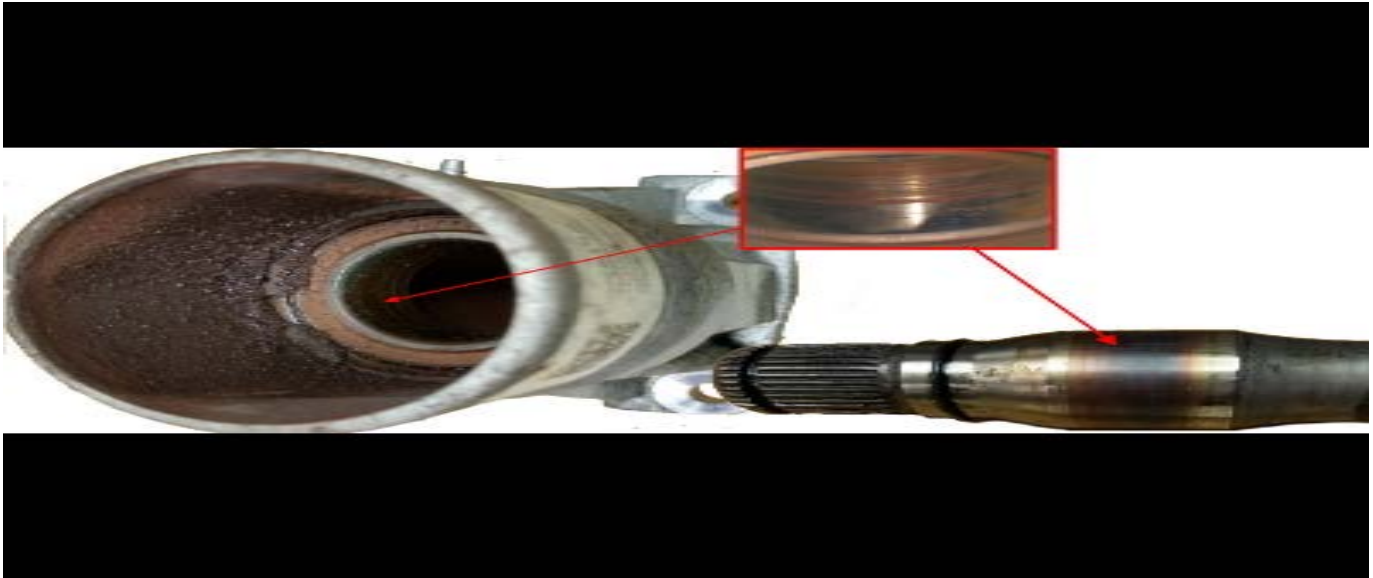
5875997

Note: Fretting worn IDS shaft and bracket must be discarded and replaced with new parts.
