GLOBAL SAFETY FIELD INVESTIGATIONS
DCS6310
URGENT - DISTRIBUTE IMMEDIATELY

Subject: N222367650 - Service Update
Transfer Case Fasteners Incorrect Torque

Models: 2022 Chevrolet Silverado 2500HD/3500HD
2022 GMC Sierra 2500HD/3500HD

N222367650 Transfer Case Fasteners Incorrect Torque

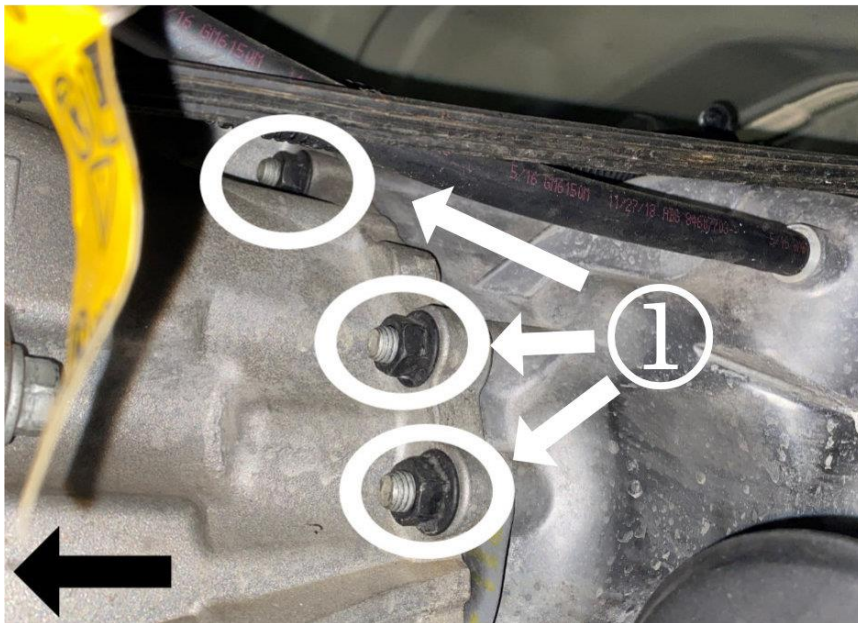
6148306

Condition	Certain 2022 model year Chevrolet Silverado 2500HD/3500HD and GMC Sierra 2500HD/3500HD vehicles may have a condition in which the transfer case fastener was incorrectly torqued at the assembly plant.
Correction	Dealers will torque the transfer case fasteners to the proper specification.

10. Locate the 3 nuts (1) located on the top and driver's side of the transfer case, replace any that are missing.

11. Inspect the surrounding areas for any signs of cracks or damage.

- If no damage is found, proceed to step 12.
- If damage is found, replace necessary components under warranty, proceed to step 12.

12. Tighten the 3 nuts (1) to 58 Nm (43 lb ft).
