ABS Sensor Mounting Bracket Contact with Tone Wheel S462, S522 Rear Axles

M-593-001

(September 2007)

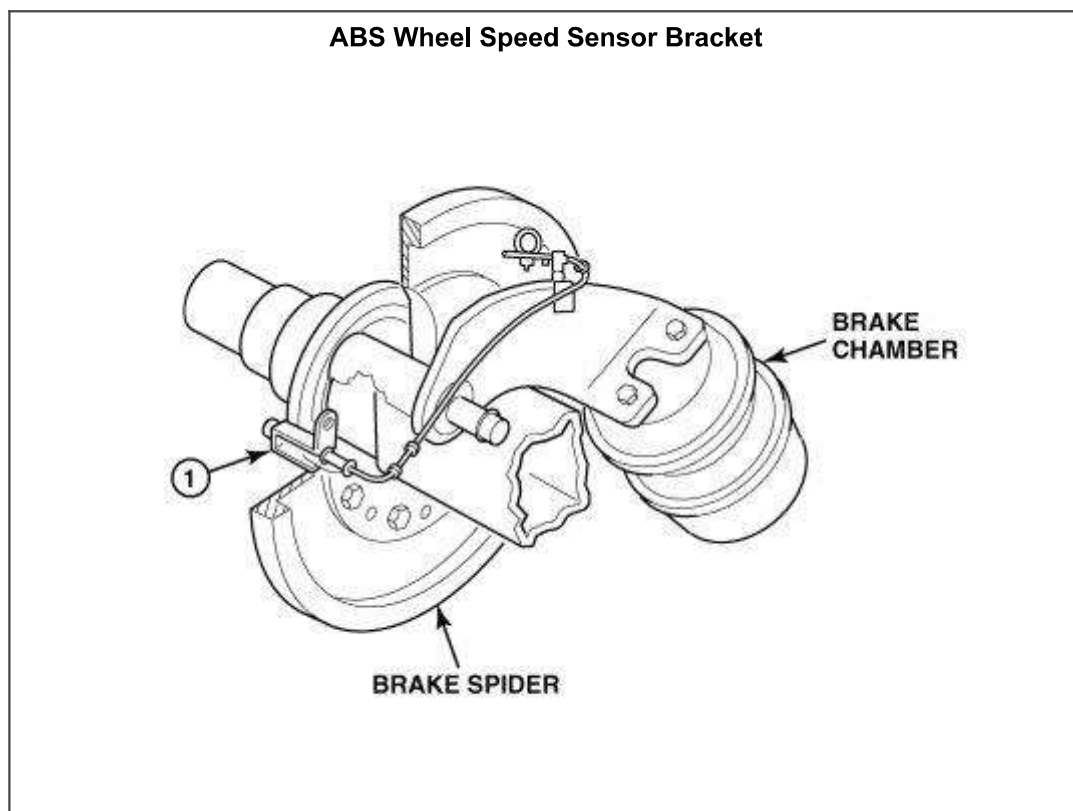
Parts

Effective August 29, 2007, a different ABS wheel speed sensor mounting bracket (part No.11MN45M) was implemented into production on all chassis equipped with an S462 or S522 rear axle. This change was made to eliminate an interference condition between the mounting bracket and tone wheel. Should contact between the wheel speed sensor mounting bracket and tone wheel occur, an ABS fault (MID 136, SID/FMI 003/000, 003/008,004/000, 004/008, 005/000 or 005/008, "Sensor Air Gap too Large," or "Air Gap too Large or Sensor Shorted") will be logged. If this condition is encountered on a chassis manufactured prior to August 29, 2007, replace the existing sensor bracket (part number 11MN43M) with bracket part number 11MN45M.

Key	Part number	Description	Replaces
1	11MN45M	Bracket, ABS wheel speed sensor mounting	11MN43M

Note: If contact between the wheel speed sensor mounting bracket and tone wheel has occurred, inspect the tone wheel for damage and replace as required.
