# Service Bulletin

Bulletin No.: 22-NA-216

**Subject:** Information on Concern of an Engine Thermostat Tick Noise and/or Running Hot

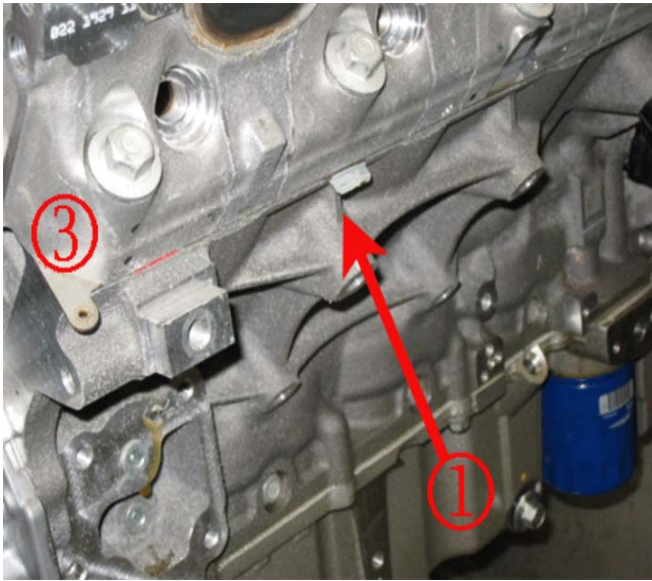
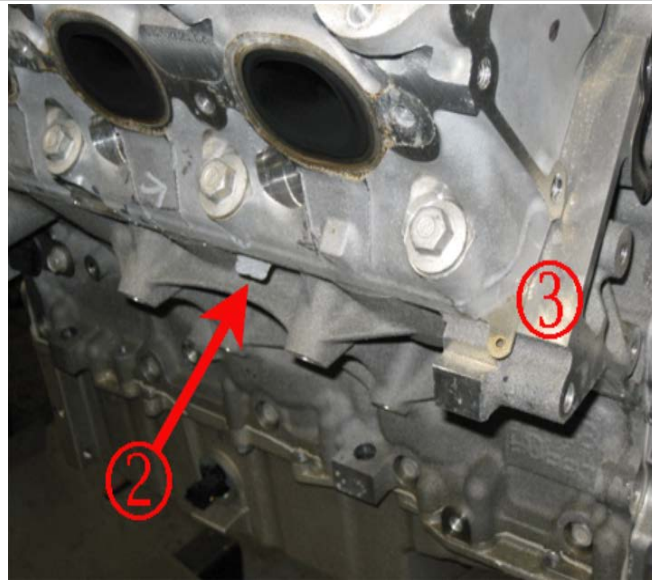
3960232

| <b>Cause</b> | This condition may be caused by the cylinder head gasket being installed incorrectly after a service procedure requiring the cylinder head to be removed and replaced. |

- #1 is Bank 1 tab near cylinder 3
- #2 is Bank 2 tab near cylinder 4
- #3 is the front of the engine

If the head gasket locating tabs are found to be closer to cylinders 5 or 6, this indicates the head gaskets were installed incorrectly, restricting the engine coolant flow.

Replace the head gasket for this concern.
