# Service Alert

<b>Subject:</b>  CONNECTED VEHICLE SYMPTOM TROUBLESHOOTING	Service Alert No.: SA-017/22
	Last Issued : 10/10/2022

2019-2023 Mazda3  
2020-2023 CX-30  
2021-2023 CX-5  
2021-2023 CX-9  
2022 MX-30  
2023 CX-50

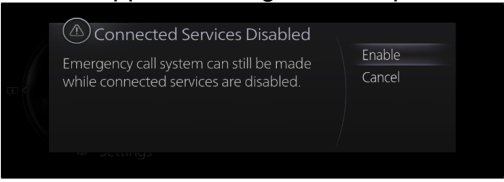
<p>CX-5, CX-50, CX-9, MX-30 Mazda3, CX-30 built July 1, 2021 and later</p> <p>Connected Services Disabled message appears at engine start up</p>

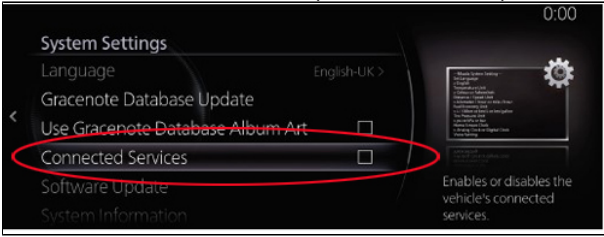
<p>Connected Services disabled (box unchecked)</p>
