SERVICE PROGRAM BULLETIN

APPLICABILITY: 2023 MY Legacy
2023 MY Outback

NUMBER: WRI-22

SUBJECT: Telematics DCM Replacement

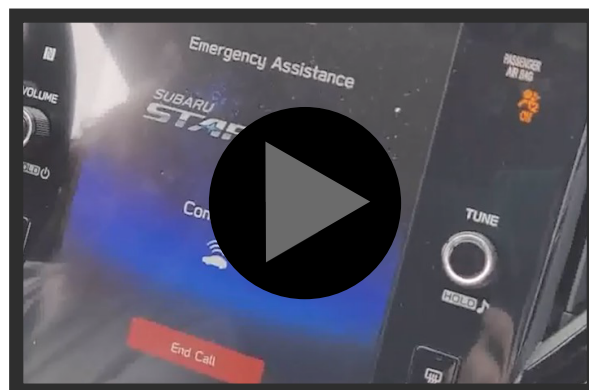
[iButton Failure](#)

Vehicles unable to perform a successful call will require DCM replacement. If this behavior is duplicated, proceed to the DCM replacement procedure outlined in this bulletin. If this behavior continues after DCM replacement has been performed, further diagnostics will be required.

The link below provides an **EXAMPLE** of an unsuccessful STARLINK® call attempt.

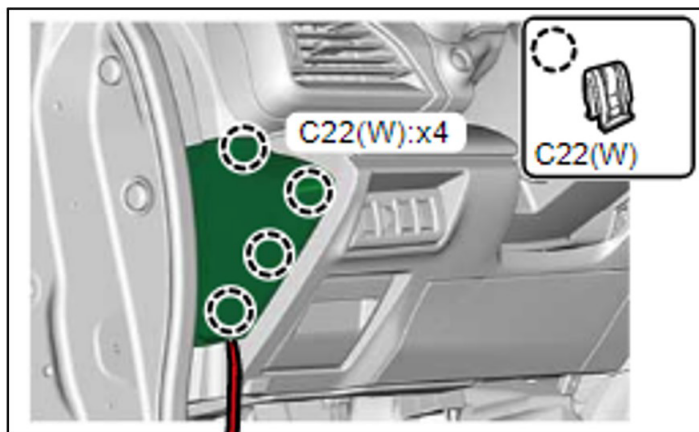
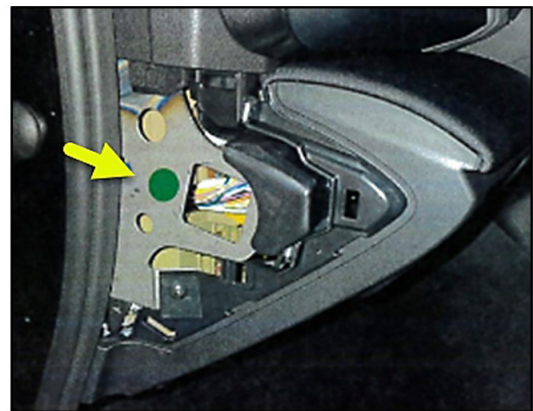
NOTE: If a **GREEN** sticker is present, STOP. This vehicle has the latest DCM, and is not affected by the WRI-22 service program.

STEP 3: Release the four mounting clips securing the driver side instrument panel side cover. Once released, remove the cover.

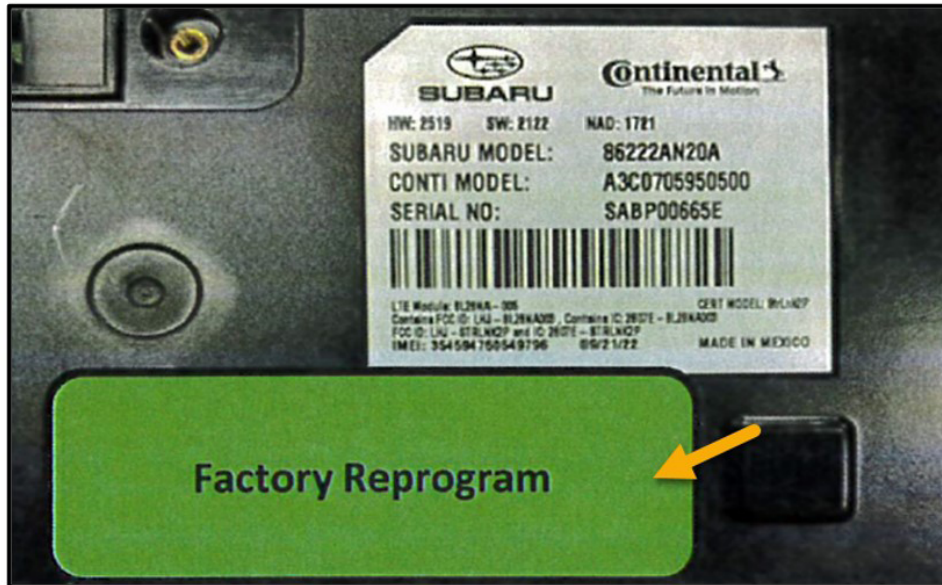
NOTE: If a **GREEN** sticker is present, STOP. This vehicle has the latest DCM, and is not affected by the WRI-22 service program.

- **STEP 15:** Remove and properly recycle the back-up battery from the original DCM.

STEP 16: Replace the DCM. Reinstall all parts in the reverse order of removal.
