SERVICE BULLETIN

APPLICABILITY: 2020-22MY Legacy and Outback Models **NUMBER:** 15-261-20R
SUBJECT: Reprogramming File Availability for Optimization of Gen 4 Denso CP1 Infotainment Systems **DATE:** 03/10/20
REVISED: 10/31/22

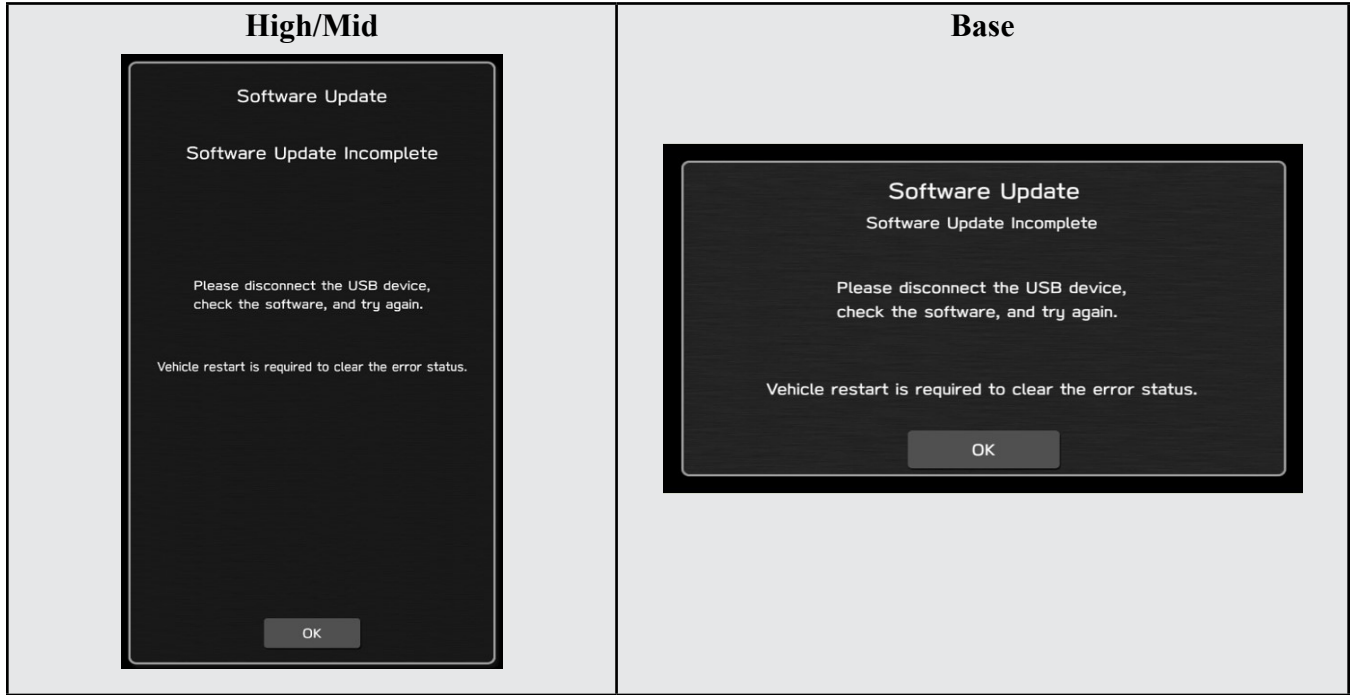
- If the first attempt of update fails with the message below, follow the steps described below 1-2 to 1-8 before retrying the software update.

1-1. Select OK in the screen below

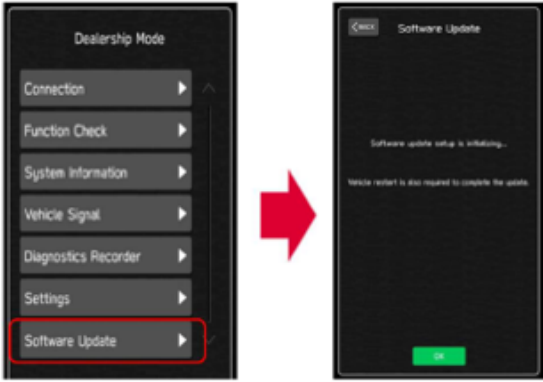
<p>Insert USB</p> <p>Tap OK</p> <p>Confirmation screen</p> <p>Error screen</p>
<p>13</p>	<p>When “Software Update” is selected in the Dealership Mode, the following initialization process does not end more than 20 minutes. *</p>

<p>Note* In case this USB update failure occurs, retry updating according to the instructions in “Appendix A”</p>
<p>14</p>	<p>When the FOTA pop-up (new software availability notification) is displayed while the CarPlay is being used, the display comes back to CarPlay screen even if the customer tries to get into the FOTA screen.</p>

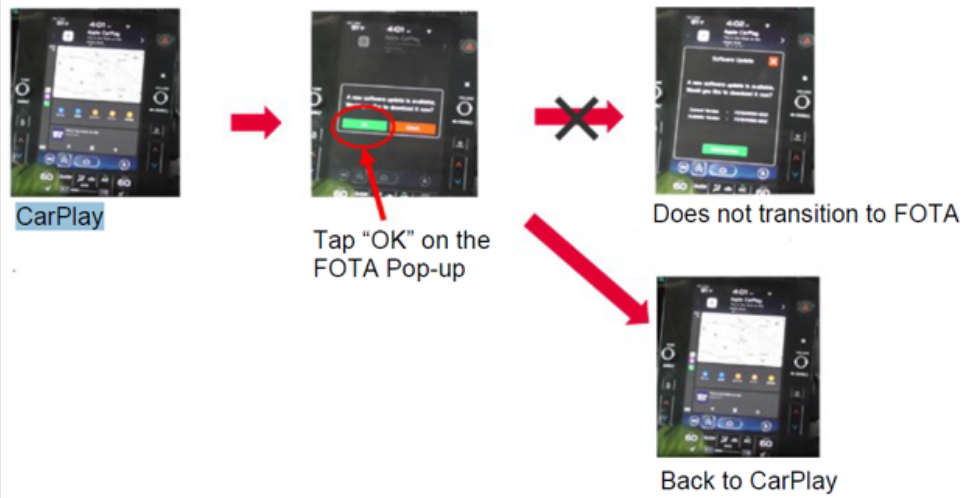
<p>CarPlay</p> <p>Tap “OK” on the FOTA Pop-up</p> <p>Does not transition to FOTA</p> <p>Back to CarPlay</p>

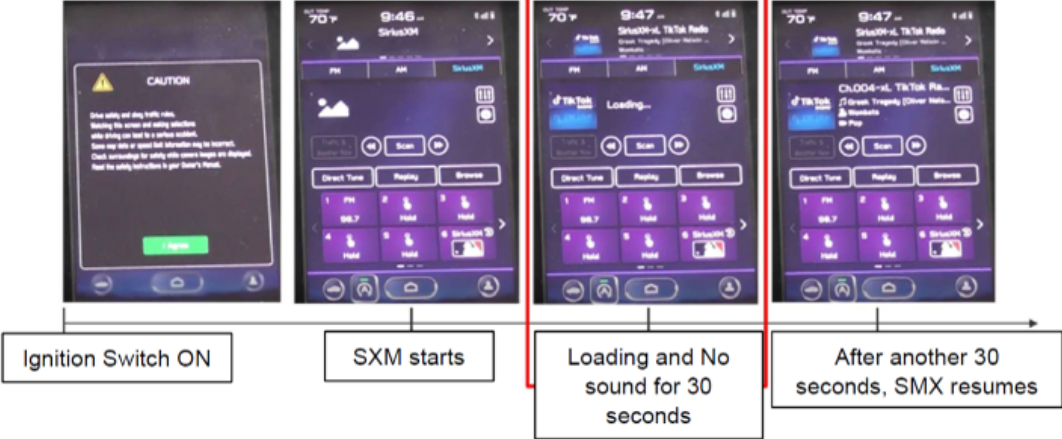
27	<p>About 30 seconds after starting the SXM the operation is paused with loading screen and resume after another 30 seconds. This symptom occurs when the SXM screen had been selected as audio source at the previous ignition off timing.</p>

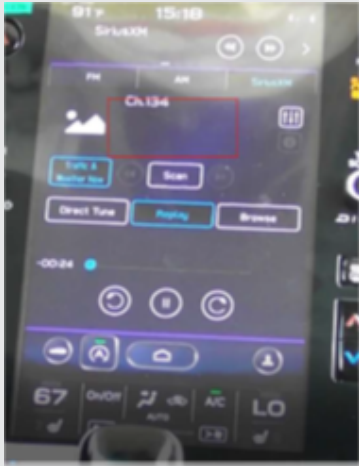
30	<p>The team logo is not displayed on Sports Flash screen when the SXM screen had been selected as audio source at the previous ignition off timing.</p>

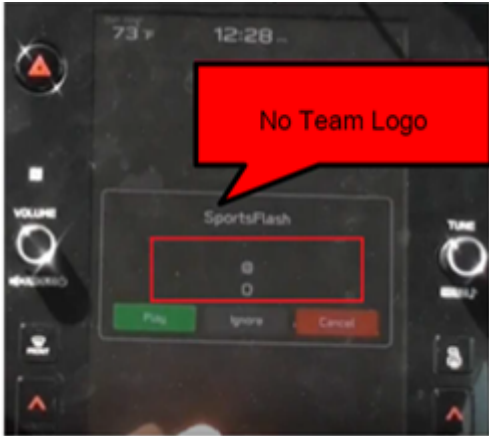
31	<p>The team logo is not displayed on Sports Flash screen when the SXM screen had been selected as audio source at the previous ignition off timing.</p>

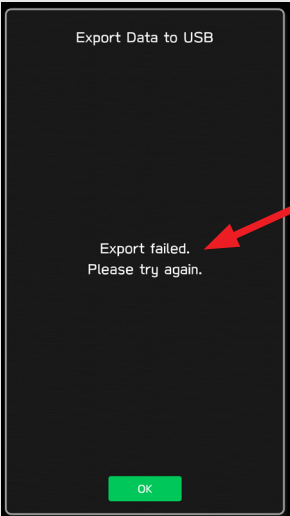
4	<p>Diagnostics Recorder Data cannot be exported to the USB memory device. When the diagnostic log data is being downloaded (by selecting: Dealership Menu > Diagnostics Recorder > Export Data to USB), it fails after the progress bar reaches almost 90% with an error message of Export failed. Please try again.</p>
