## Soft Top Does Not Close Completely or is Intermittent in Operation

Topic number	LI77.33-P-075246
Version	3
Function group	77.33 - Vario roof, soft top - mechanical system
Date	10/31/22
Validity	Model series 232
Reason for change	Revised repair instructions based on new findings

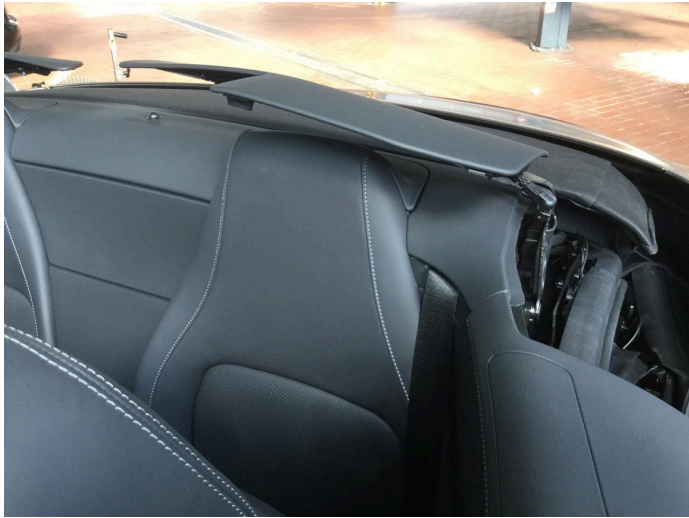
Attachments	
File	Description
<a href="#">Bild 1.jpg</a>	Picture 1

Soft top does not close – Soft top mechanical components/linkage outlet flaps ("GAK") move into the intermediate position (picture 1) and then cancel the closing process.

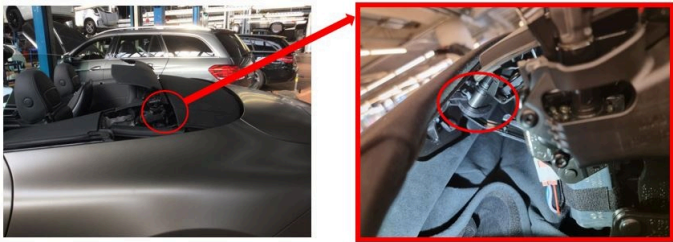
Picture 2
<a href="#">Bild3.jpg</a>

Steps to identify the cause are processed below. To begin with, however, the locking hooks should be checked in the position in which the closing process is aborted by means of a visual check (see picture 2 and Locking Clip Check attachment). For this, check the locking hooks on both sides. This is the most common fault cause and can shorten the analysis process. If one of the two hooks has not opened, proceed with step C.2. (Only step A must then additionally be observed). If both hooks have opened, proceed to step A.
