Rear Quarter Glass Finisher Abrasion Marks Below Tailgate Spoiler

23MY New Range Rover Sport (L461)

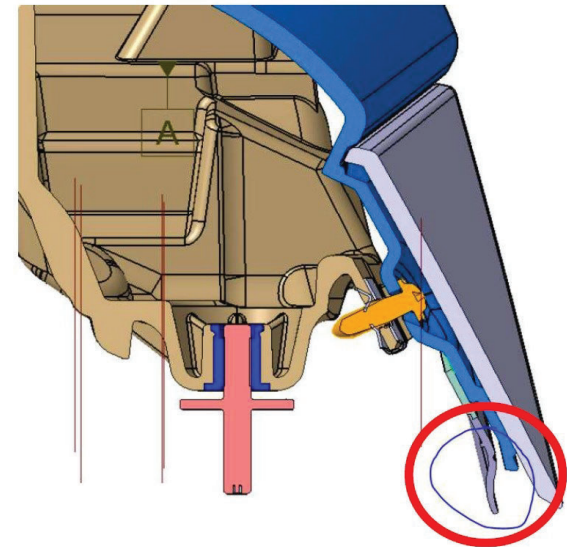
- A customer may report abrasion marks (scuffing) on the quarter glass finisher when the tailgate is open.

- This may be caused by the rear spoiler winglet seals contacting the finisher when the tailgate is closed.

- SSM 75864 has been published to address this concern by removing the winglet seals.
- The abrasion marks on the finisher should easily be removed with suitable polish.
