Service Bulletin

Bulletin No.: 22-NA-085

Subject: Radio Software Version 135120 (IOR) – Multiple Updates

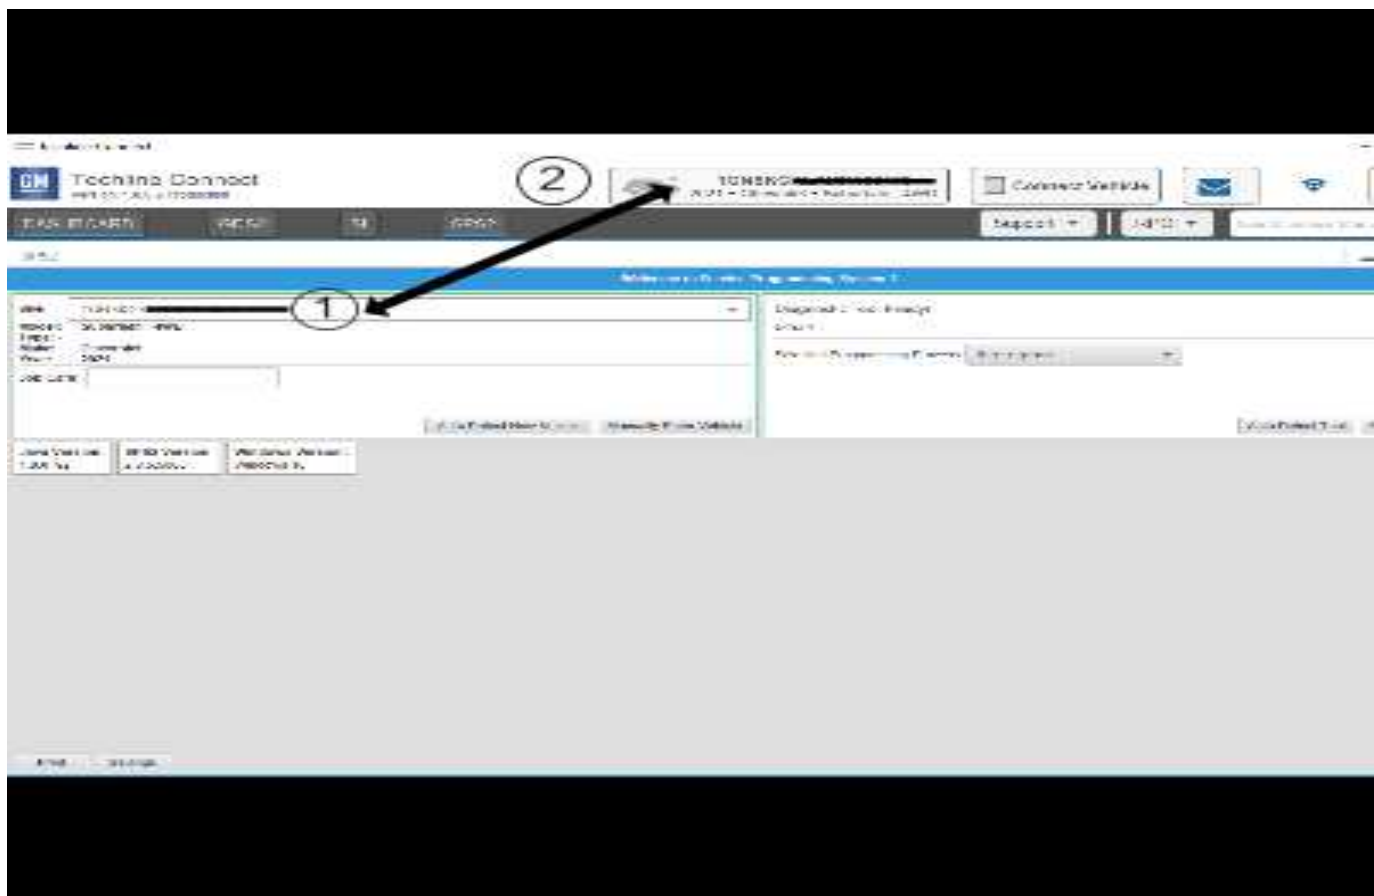
Caution: Be sure the VIN selected in the drop down menu (1) is the same as the vehicle connected (2) before beginning programming.
