VOLUNTARY SERVICE CAMPAIGN

Classification: BT22-020	Reference: NTB22-095	Date: October 27, 2022
-----------------------------	-------------------------	---------------------------

VOLUNTARY SERVICE CAMPAIGN 2002-2006 ALTIMA AND 2004-2008 MAXIMA FLOOR PAN

CAMPAIGN ID #: PC926
APPLIED VEHICLES: 2002-2006 Altima (L31)
2004-2008 Maxima (A34)

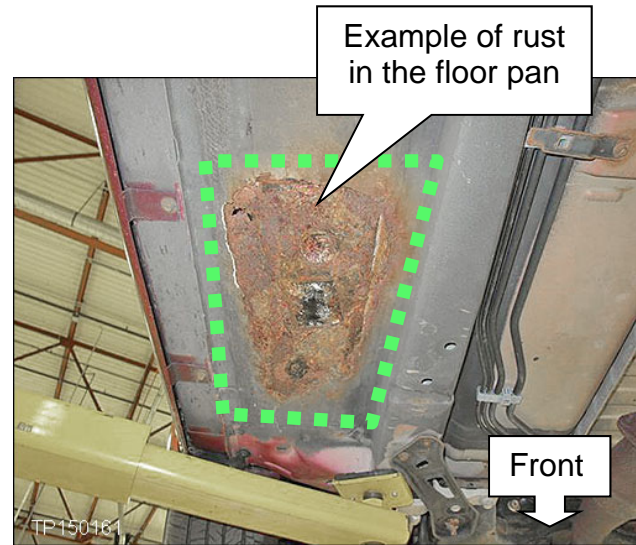
Figure 5

2. Inspect for rust on the driver (LH) side and passenger (RH) side floor pans, as shown in Figure 5.
 - If rust is found in only one floor pan, continue to step 3 on page 5 and install a Repair Plate only on the affected floor pan of the vehicle.
 - If rust is found in both floor pans, continue to step 3 on page 5 and install a Repair Plate on both floor pans of the vehicle.
 - If rust is NOT found in either floor pan area, the inspection is complete. Skip to **CLAIMS INFORMATION** on the last page.

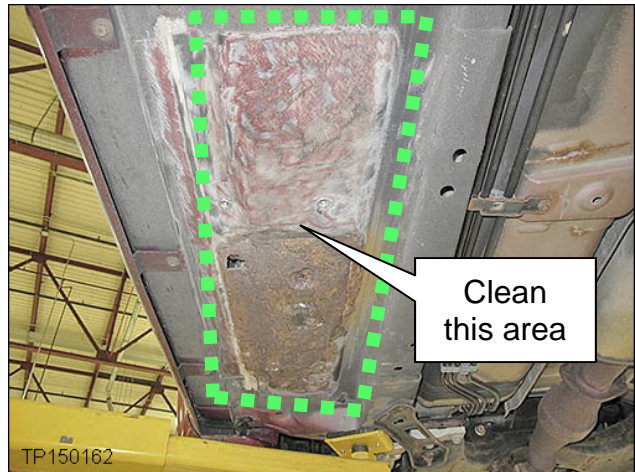
Figure 8

HINT: In some cases the floor pan may be bulged. If so, use a rubber mallet to tap the floor pan back to a level/flat position.

9. Clean all of the undercoating and loose rust off of the floor pan in the area shown in Figure 8.
 - Use a grinder with a “cup type” twisted wire brush attachment (or equivalent).
 - Use low pressure compressed air to blow off dust and debris.
