# Customer Satisfaction Program

## N212354521 Heated Vented Seats Retrofit - Front Seats Only

**Release Date:** November 2022

**Revision:** 03

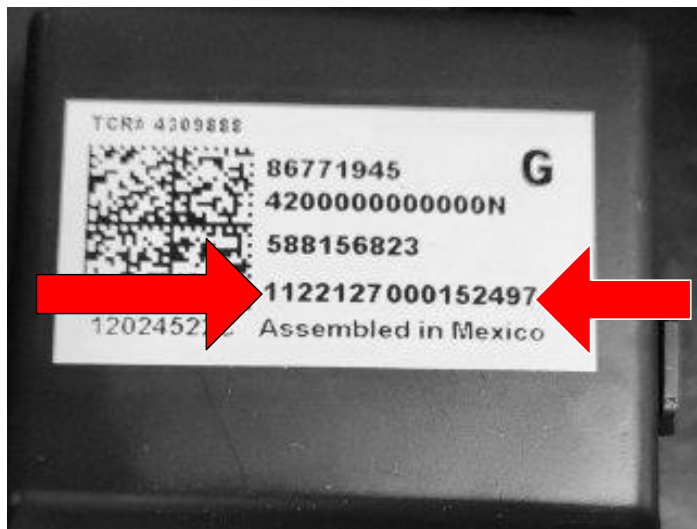
6098078

**Record the serial number on the seat heater vent control module label.**
