N222380840 Incorrect TCM Calibrations in Service Reprogramming

Release Date: November 2022 Revision: 00

Model Year			
Make	Model	From	То	RPO	Description
Chevrolet	3500/4500 Medium Duty (LCF)	2021	2022	L8T	6.6L Engine

Condition	General Motors has decided to conduct a Voluntary Emissions Recall on certain 2021-2022 Chevrolet
	3500/4500 Medium Duty Low Cab Forward vehicles with a 6.6L engine (RPO L8T). The Transmission
	Control Module (TCM) in these vehicles may have been service reprogrammed with incorrect
	calibrations. If this occurred, the transmission shift quality and timing could be degraded.
Correction	Dealers are to reprogram the TCM.

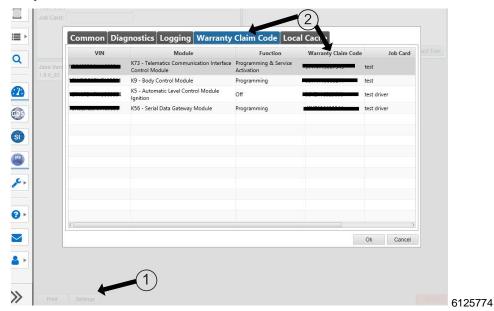
Warranty Claim Code Information Retrieval

If the Warranty Claim Code was not recorded on the Job Card, the code can be retrieved in the SPS2 system as follows:

- 1. Open TLC on the computer used to program the vehicle.
- 2. Select and start SPS2.
- 3. Select Settings (1).
- 4. Select the Warranty Claim Code tab (2).

The VIN, Warranty Claim Code and Date/Time will be listed on a roster of recent programming events. If the code is retrievable, dealers should resubmit the transaction making sure to include the code in the SPS Warranty Claim Code field.

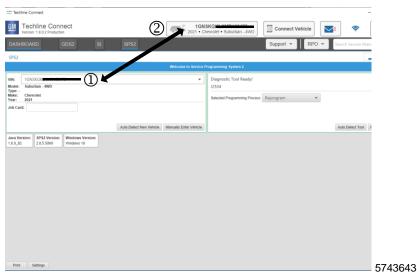
Caution: Be sure the VIN selected in the drop down menu (1) is the same as the vehicle connected (2) before beginning programming.

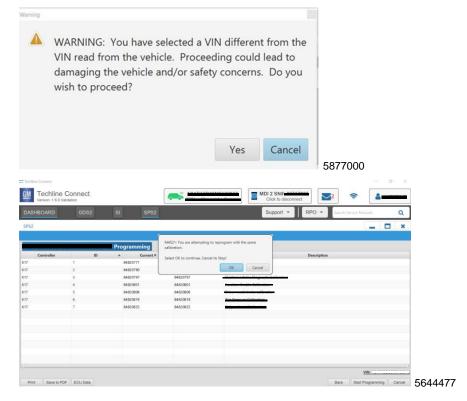
Important: If the vehicle VIN DOES NOT match, the message below will be shown.

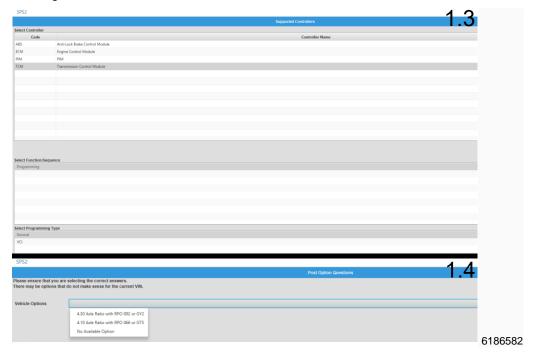
- 1.3. Select the TCM programming function in SPS as shown.
- 1.4. Select your vehicle options by RPO in the next step.
- 1.5. Follow the on-screen instructions to complete the programming event.

Note: The screenshot above is an example of module programming and may not be indicative of the specific module that is being programmed. Module selection and VIN information have been blacked out.

Important: To avoid warranty transaction rejections, you MUST record the warranty claim code provided on the Warranty Claim Code (WCC) screen shown above on the job card. Refer to callout 1 above for the location of the WCC on the screen.

- 1. Reprogram the Transmission Control Module. Refer to Service Programming System SPS in SI, with additional instructions provided below.
 - 1.1. Install the special tool: EL-49642 SPS Programming Support Tool.
 - 1.2. Ignition » On.
