TECHNICAL BULLETIN
JTB00314NAS1
14 NOV 2013

Headlamp Inner Lens Stain

F-TYPE (X152)

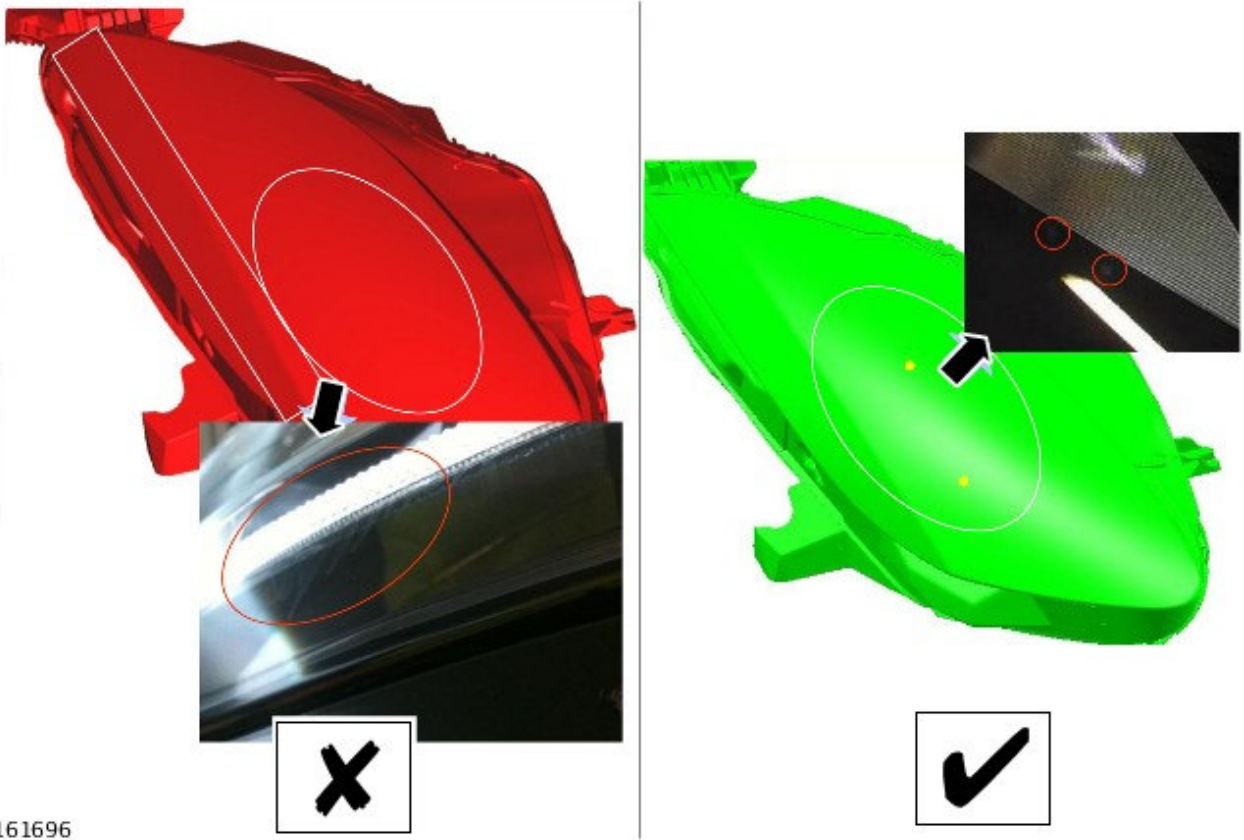
E161696

**NOTE: The 'X' shows 'drips' and/or 'staining'. This condition in either the oval or rectangle areas of the lamp is unacceptable and the headlamps must be changed.**

**NOTE: The 'tick' shows 'spotting'. This condition in the oval area of the lamp is acceptable and the headlamps must not be changed.**

Install a new right and left headlamp assembly (see TOPIx Workshop Manual, Section 417-01).
