Technical Service Bulletin

96 Warning message in DIS: "Key not In vehicle" or "Remote key not recognized"

96 14 89 2039108/1 December 3, 2014.

Model(s)	Year	VIN Range	Vehicle-Specific Equipment
Q3	2015	All	Not Applicable

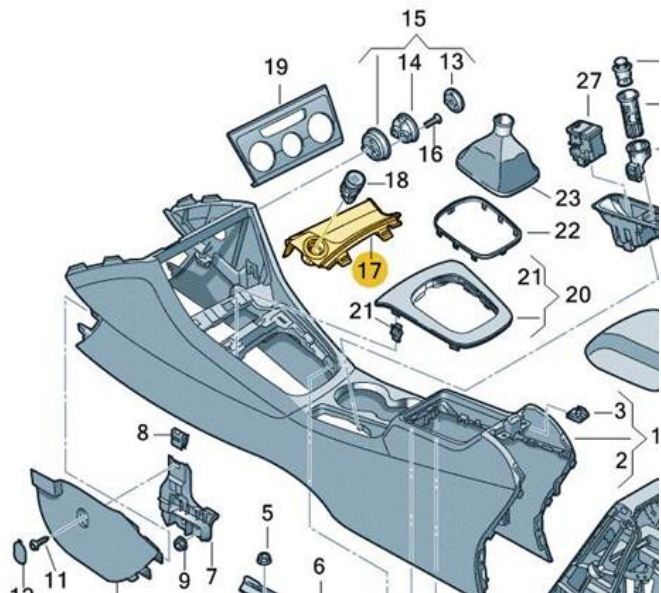
Figure 1. The front storage compartment in the center console (Number 17).

1. Remove the front storage compartment according to the Elsa Repair Manual (Figure 1).

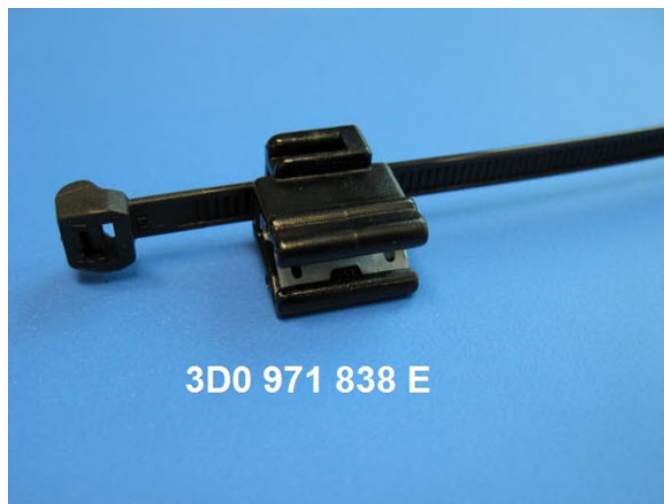
Figure 2. Zip tie with holder.

- Using a zip tie with holder (3D0 971 838 E) (Figure 2), turn the zip tie by 90° (Figure 3).

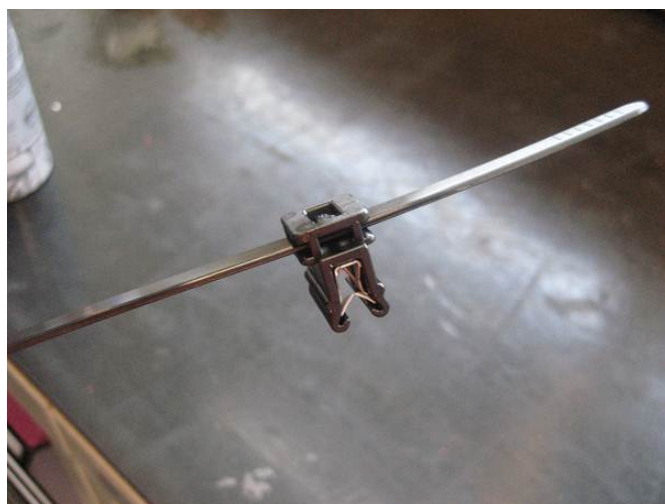
Figure 3. Zip tie turned by 90°.

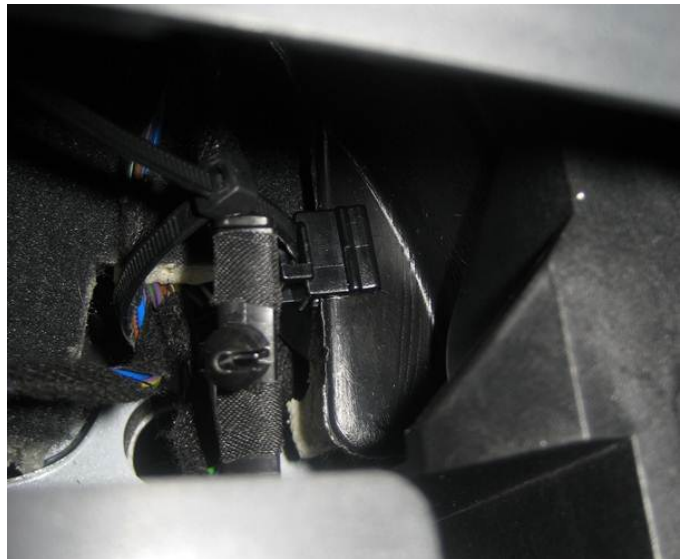
Figure 4. The zip tie with holder is installed but not tightened.

6. Attach the zip tie with holder as shown (Figure 4). Do not tighten the zip tie.

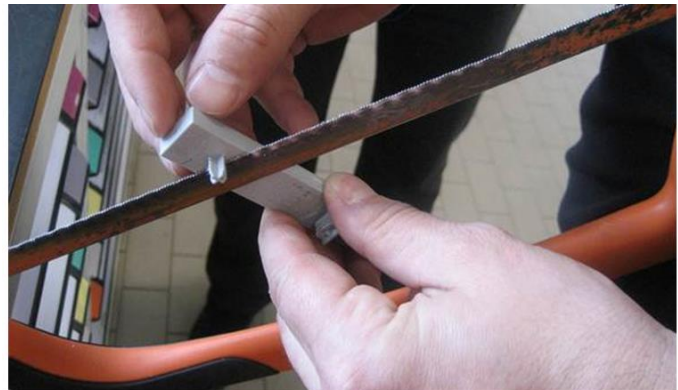
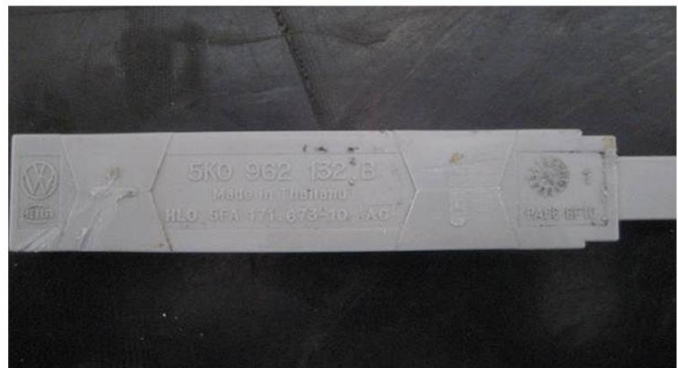
Figure 5. Removing the plastic locating pins from Aerial 1 (top image), and Aerial 1 with locating pins removed (bottom image).

7. Remove the two plastic locating pins on Aerial 1 so that no cables can chafe any components (Figure 5).

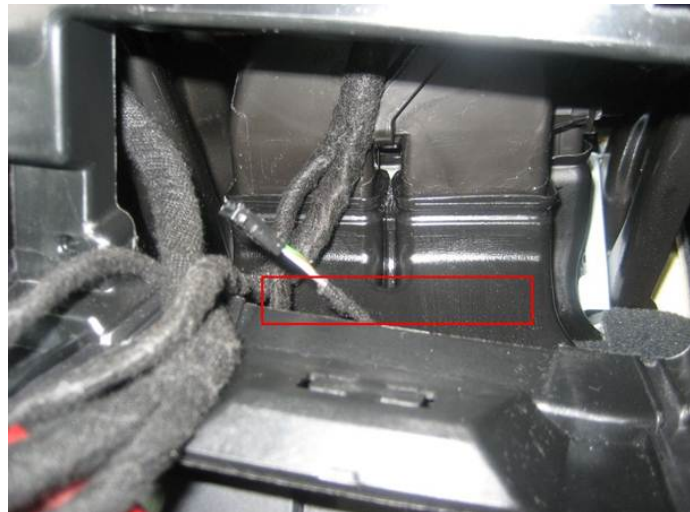
Figure 7. Mounting surface on HVAC ducting to be cleaned.

9. Prepare the mounting surface by cleaning the marked area with cleaning solution (D 009 401 04) (Figure 7).

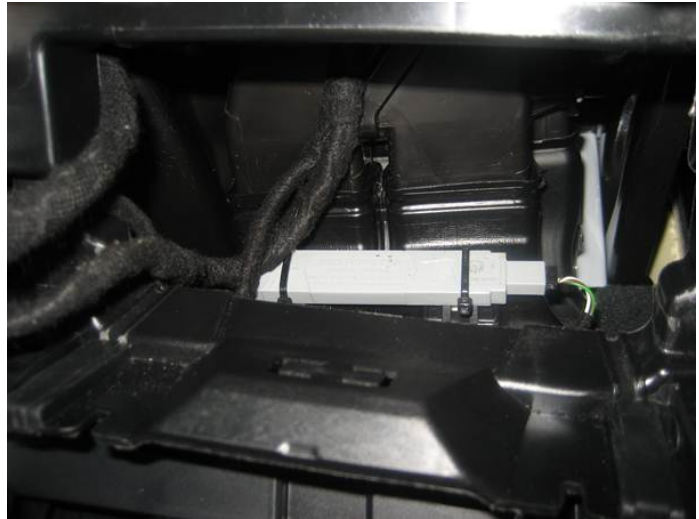
Figure 8. Aerial 1 mounted on HVAC ducting.

10. Once the area is dry, attach Aerial 1 to the HVAC ducting (Figure 8).

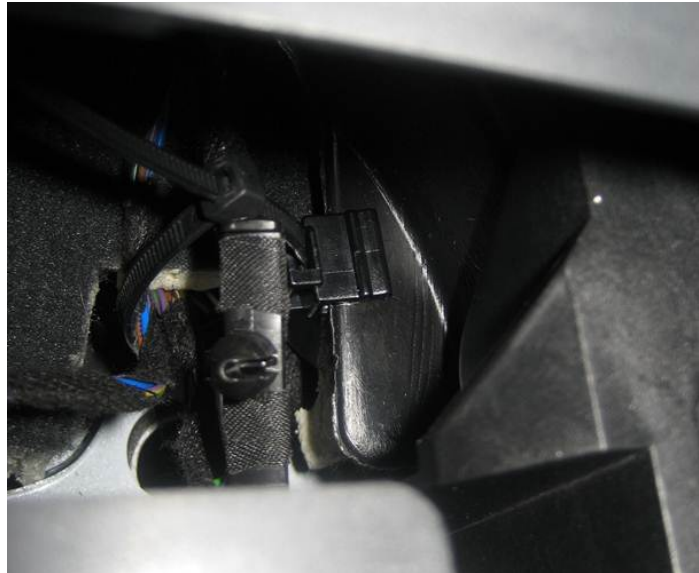
Figure 9. Zip tie needs tightening.

11. Tighten the zip tie and cut off any excess material (Figure 9). Rotate so that the sharp edge of the zip tie will not interfere with any cables in the area.
