Technical product information

Topic	Rotating screen alignment - Minimum standards could not be achieved
Market area	Russische Föderation (5RU),Australia E04 Bentley rest Asia and Australia (6E04),China 796 VW Import Comp. Ltd (Vico), Beijing (6796),Germany E02 Bentley rest Europe (6E02),Japan E03 Bentley Japan (6E03),Korea, (South) E08 Bentley South Korea (6E08),United Arab Emirates E06 Bentley Middle East and Africa (6E06),United Kingdom E01 Bentley UK (6E01),United States E05 Bentley USA and rest America (6E05)
Brand	Bentley
Transaction No.	2065896/2
Level	EH
Status	Approval
Release date

New Continental GT - New Continental GTC and New Flying Spur

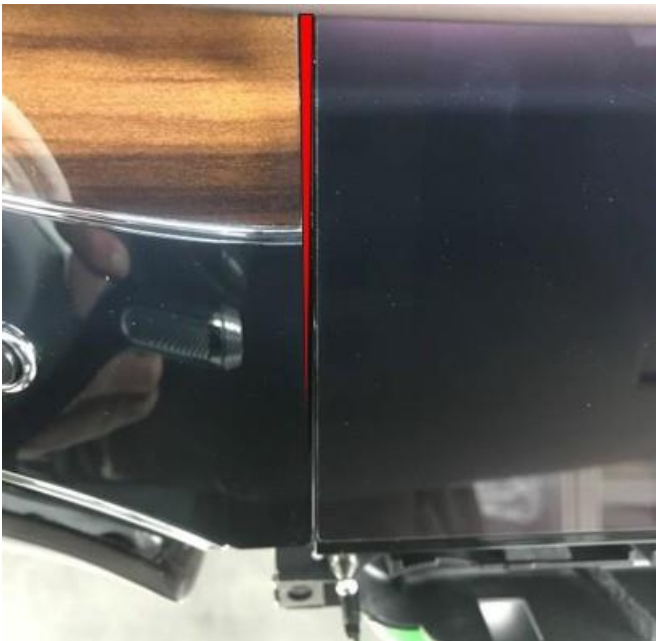
Figure 8

Tapered condition between the “veneer face” fascia panel of the Bentley Rotating Display (BRD) and the passenger/driver side fascia panels

In the event a tapered condition is evident as Figure 8, follow the onward instructions

- Remove the Driver's side fascia panel - Rep.Gr 70
